Visual Site Inspection Report

Project Name	H-600 Pipeline Spread G	AFE	124300137	Spread	H-600 Pipeline Spread G
Contractor	Precision			Report #	4470
Inspector	Jared Saunders			Date/Time	7/12/2018 2:33 PM
Permit #	TBD	Inspection Type	VA SWPP	Station Begin	11768+00
State	VA	Inspection Area	Partial	Station End	11900+00
County	Montgomery	Ground	Dusty	Temperature (°F)	90.00
Municipality	N/A	Weather	Sunny	Rain Gauge (in)	0.00
GPS Location	37.2878359957014, -80.3344036639485			Rain Accumulation Time (days)	1.00

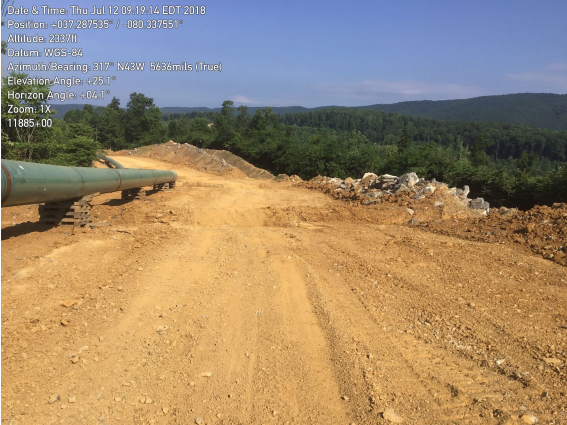
GPS Location	37.2878592135732, -80.3346135468039	GPS Location	37.2882373705303, -80.3339412722868		
Description	See photo for GPS location and station number. Observed waterbar in good working condition.	Description	See photo for GPS location and station number. RCE at AR 266.03 and Dry Run Rd.

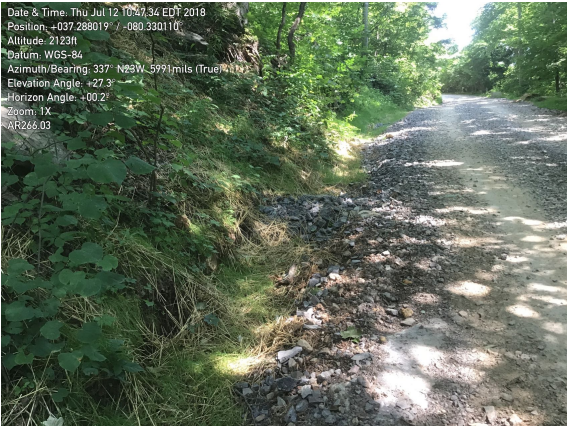
GPS Location	37.2881322237322, -80.3339524197633	GPS Location	37.2883442634116, -80.3339714826791		
Description	See photo for GPS location and station number. Rock check dam along access road 266.03.	Description	See photo for GPS location and station number. Dust control utilized using Morooka and water tank.

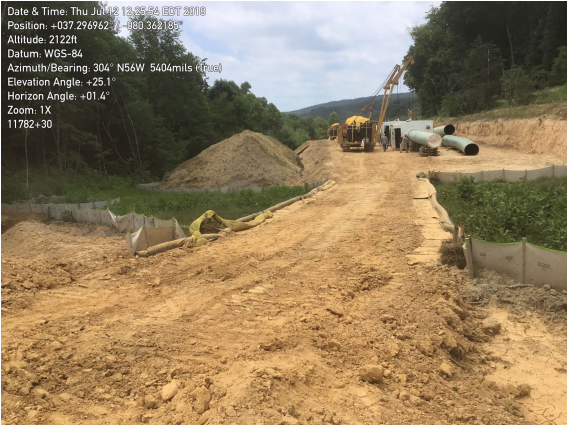
GPS Location	37.2884787029256, -80.3338914643653	GPS Location	37.2881905956818, -80.3342844841698		
Description	See photo for GPS location and station number. Mat bridge over clean natural water drainage.	Description	See photo for GPS location and station number. Slope pipe installed at fill section to prevent erosion.
