Visual Site Inspection Report

Project Name	H-600 Pipeline Spread G	AFE	124300137	Spread	H-600 Pipeline Spread G
Contractor	Precision			Report #	4802
Inspector	Jared Saunders			Date/Time	7/18/2018 5:01 PM
Permit #	TBD	Inspection Type	VA SWPP	Station Begin	12002+00
State	VA	Inspection Area	Partial	Station End	11788+00
County	Montgomery	Ground	Damp	Temperature (°F)	86.00
Municipality	N/A	Weather	Cloudy	Rain Gauge (in)	0.00
GPS Location	37.27029469, -80.37449651			Rain Accumulation Time (days)	1.00

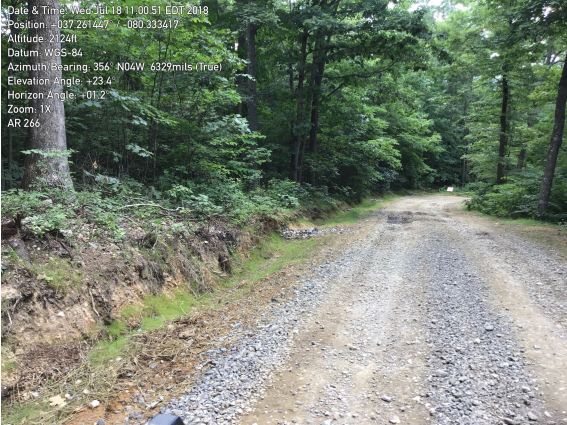
GPS Location	37.2676425241281, -80.3193745762858	GPS Location	37.2676425241281, -80.3193745762858		
Description	See photo for GPS location and station number. Rock check dam in bar ditch along access road 266.	Description	See photo for GPS location and station number. Upgraded ECDs near karst feature on access road 266.

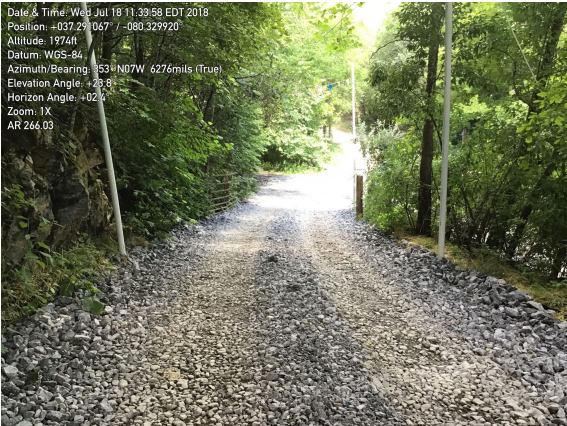
GPS Location	37.2674711561178, -80.3183957376334	GPS Location	37.2674726229508, -80.3184084781262		
Description	See photo for GPS location and station number. RCE at Dry Run Road and access road 266.03.	Description	See photo for GPS location and station number. Buffer zone seeded and mulched with P-1 silt fence installed at wetland boundary.
