Visual Site Inspection Report

Project Name	H-600 Pipeline Spread G		AFE	124300137	Spread	H-600 Pipeline Spread G	
Contractor	Precision				Report #	5745	
Inspector	Jared Saunders				Date/Time	8/3/2018 2:24 PM	
Permit #	TBD	Inspection Type	VA SWPP		Station Begin	10883+56	
State	VA	Inspection Area	Partial		Station End	11027+00	
County	Giles	Ground	Muddy		Temperature (°F)	75.00	
Municipality	N/A	Weather	Heavy Rain		Rain Gauge (in)	3.50	
GPS Location	37.2060173903103, -80.3942297441596				Rain Accumulation Time (days)	2.00

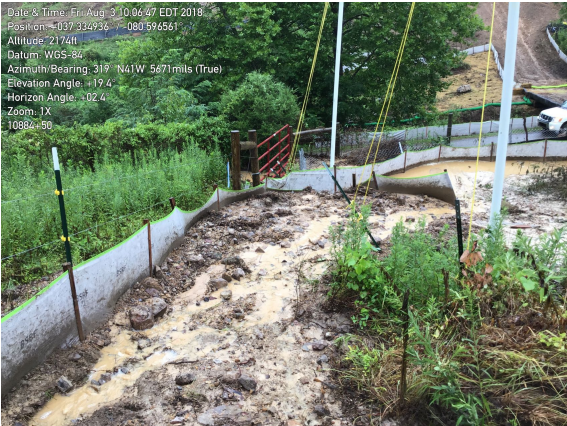
GPS Location	37.2060401158287, -80.394214707048	GPS Location	37.2059726259655, -80.3942846750127		
Description	See photo for GPS location and station number. CFS end treatment undermined.	Description	See photo for GPS location and station number. CFS and super silt fence undermined.

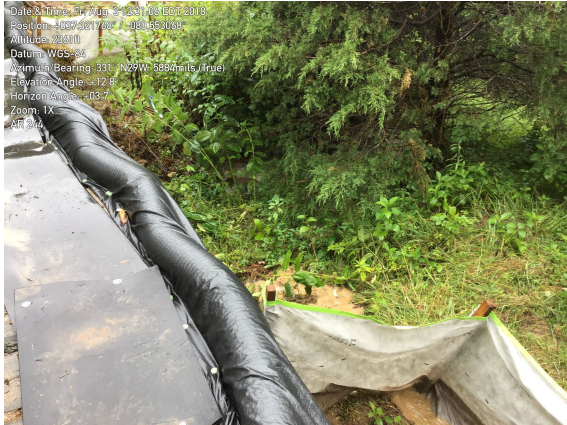
GPS Location	37.2059726259655, -80.3942846750127	GPS Location	37.2059625624115, -80.3941690132819		
Description	See photo for GPS location and station number. P-1 silt fence and super silt fence over topped learning to off ROW sediment.	Description	See photo for GPS location and station number. P-1 silt fence nearly overtopped. Maintenance is needed.
