# Visual Site Inspection Report

<b>Project Name</b>	H-600 Pipeline Spread G		<b>AFE</b>	124300137	<b>Spread</b>	H-600 Pipeline Spread G	
<b>Contractor</b>	Precision				<b>Report #</b>	7769	
<b>Inspector</b>	Jared Saunders				<b>Date/Time</b>	9/12/2018 5:34 PM	
<b>Permit #</b>	TBD	<b>Inspection Type</b>	VA SWPP		<b>Station Begin</b>	10883+50	
<b>State</b>	VA	<b>Inspection Area</b>	Partial		<b>Station End</b>	11237+00	
<b>County</b>	Giles	<b>Ground</b>	Muddy		<b>Temperature (°F)</b>	73.00	
<b>Municipality</b>	N/A	<b>Weather</b>	Cloudy		<b>Rain Gauge (in)</b>	0.75	
<b>GPS Location</b>	37.2060994512927, -80.3941749154891				<b>Rain Accumulation Time (days)</b>	1.00

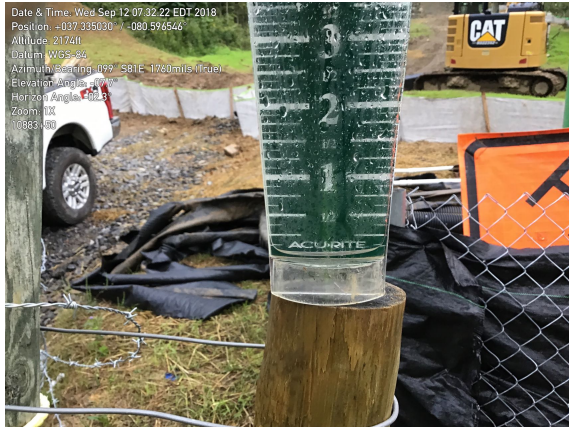
<b>GPS Location</b>	37.2060829117994, -80.3943187667152	<b>GPS Location</b>	37.2060418177428, -80.394292404734		
<b>Description</b>	See photo for GPS location and station number. 0.1 inches of rain fall at a Kow Camp road crossing.	<b>Description</b>	See photo for GPS location and station number. 0.75 inches of rain fall at access road 244.

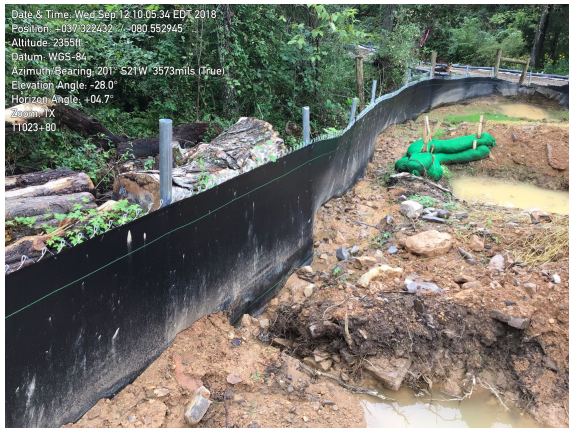
<p>Date &amp; Time: Wed Sep 12 10:05:34 EDT 2018 Position: +037.202632 / -080.552945 Altitude: 235ft Datum: WGS-84 Azimuth/Bearing: 201° S21W 3573mils (True) Elevation Angle: -28.0° Horizon Angle: +04.7° Zoom: 1X T1023+80</p>

<b>GPS Location</b>	37.205996419203, -80.3943095990033	<b>GPS Location</b>	37.2060381028342, -80.3942900062259		
<b>Description</b>	See photo for GPS location and station number. Channeling along super silt fence.	<b>Description</b>	See photo for GPS location and station number. Sensitive resource buffer.		
<p>Date &amp; Time: Wed Sep 12 2018, 09:33:43 EDT Position: +037.307342 / -080.512177 Altitude: 195ft Datum: WGS-84 Azimuth/Bearing: 052° N52E 0924mils (True) Elevation Angle: -40.3° Horizon Angle: -01.3° Zoom: 1X Stall 1184+00, washed out under triple stack &amp; 55F punch list item, MP-111.5</p>

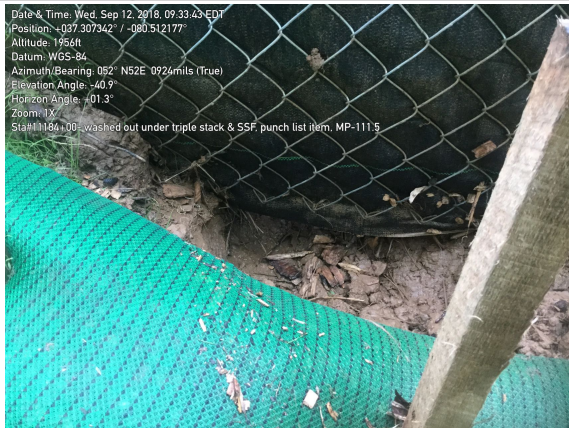
<b>GPS Location</b>	37.2060532170217, -80.394283012642	<b>GPS Location</b>	37.2060536045847, -80.3942834891186		
<b>Description</b>	See photo for GPS location and station number. Super silt fence undermined.	<b>Description</b>	See photo for GPS location and station number. Rock inlet contaminated with sediment.

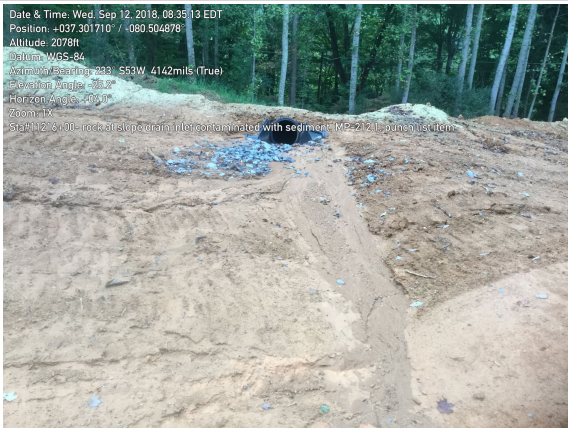
<p>Date &amp; Time: Wed Sep 12 2018, 08:35:13 EDT Position: +037.301710 / -080.504878 Altitude: 207ft Datum: WGS-84 Azimuth/Bearing: 333° S53W 4142mils (True) Elevation Angle: -33.2° Horizon Angle: -00.0° Zoom: 1X Stall 112+00 - road slip point in fill area adjacent to segment MP-212 (punch list item)</p>
