# Visual Site Inspection Report

<b>Project Name</b>	H-600 Pipeline Spread G	<b>AFE</b>	124300137	<b>Spread</b>	H-600 Pipeline Spread G
<b>Contractor</b>	Precision			<b>Report #</b>	8331
<b>Inspector</b>	Jared Saunders			<b>Date/Time</b>	9/24/2018 6:03 PM
<b>Permit #</b>	TBD	<b>Inspection Type</b>	VA SWPP	<b>Station Begin</b>	11670+00
<b>State</b>	VA	<b>Inspection Area</b>	Partial	<b>Station End</b>	11766+80
<b>County</b>	Montgomery	<b>Ground</b>	Muddy	<b>Temperature (°F)</b>	64.00
<b>Municipality</b>	N/A	<b>Weather</b>	Cloudy	<b>Rain Gauge (in)</b>	0.00
<b>GPS Location</b>	37.2060401006069, -80.3942913914326			<b>Rain Accumulation Time (days)</b>	1.00

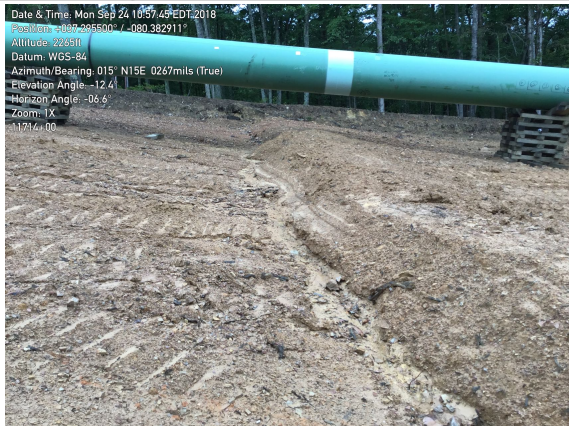
GPS Location	37.2060557362039, -80.3941646219048	GPS Location	37.2060557362039, -80.3941646219048		
Description	See photo for GPS location and station number. P-1 silt fence end treatment undermined.	Description	See photo for GPS location and station number. Top soil pile sloughed.		
<p>Date &amp; Time: Mon Sep 24 10:57:45 EDT 2018 Position: +037.295500 / -080.382911 Altitude: 2265ft Datum: WGS-84 Azimuth/Bearing: 015° N15E 0287mils (True) Elevation Angle: -12.4° Horizon Angle: -04.6° Zoom: 1X 11721+00</p>
