Visual Site Inspection Report

Project Name	H-600 Pipeline Spread G		AFE	124300137	Spread	H-600 Pipeline Spread G	
Contractor	Precision				Report #	8334	
Inspector	Jared Saunders				Date/Time	9/24/2018 6:49 PM	
Permit #	TBD	Inspection Type	VA SWPP		Station Begin	11600+00	
State	VA	Inspection Area	Partial		Station End	11670+00	
County	Montgomery	Ground	Muddy		Temperature (°F)	64.00	
Municipality	N/A	Weather	Cloudy		Rain Gauge (in)	0.00	
GPS Location	37.2060067340961, -80.3942961489221				Rain Accumulation Time (days)	1.00

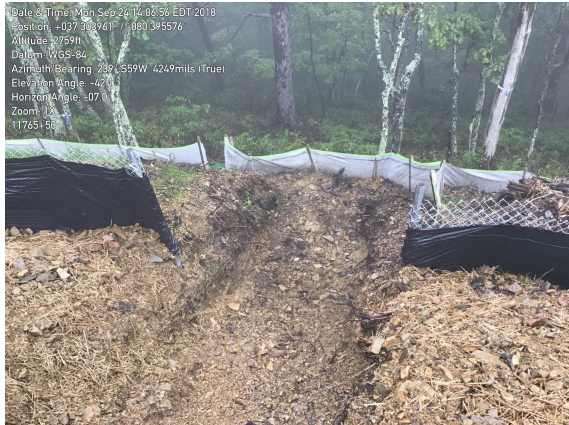
A/E	124300137	Date/Time	9/24/2018 6:49 PM	Report #	8334
Pictures					
<p>Date & Time: Mon Sep 24 12:00:56 EDT 2018 Position: +037.3069617 / -080.395576 Altitude: 2759ft Datum: WGS-84 Azimuth/Bearing: 230° S59W 4249mils (True) Elevation Angle: -40.1° Horizon Angle: -07.1° Zoom: 1X 11765+00</p>

GPS Location	37.2060124719172, -80.3942920001956	GPS Location	37.2061138928161, -80.3943280315601		
Description	See photo for GPS location and station number. Sump pit and end treatment.	Description	See photo for GPS location and station number. Sediment on ROW but outside perimeter controls.		
<p>Date & Time: Mon Sep 24 14:40:29 EDT 2018 Position: +037.3072917 / -080.397530 Altitude: 2284ft Datum: WGS-84 Azimuth/Bearing: 343° N17W 6098mils (True) Elevation Angle: -26.5° Horizon Angle: +01.7° Zoom: 1X 11749+00, P-1 undermined, sediment off ROW</p>

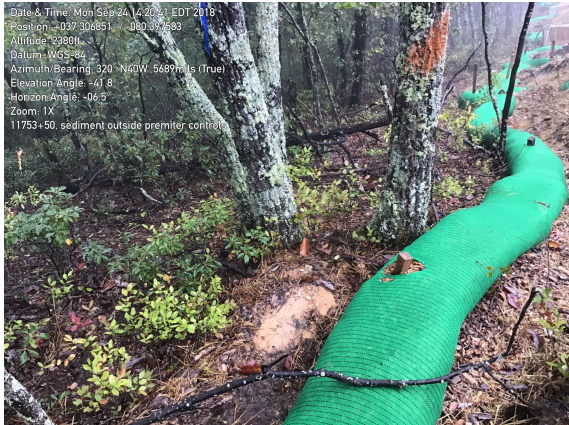
<p>Date & Time: Mon Sep 24 14:20:41 EDT 2018 Position: +037.3068517 / -080.397583 Altitude: 2380ft Datum: WGS-84 Azimuth/Bearing: 320° N60W 5689mils (True) Elevation Angle: -41.8° Horizon Angle: -04.9° Zoom: 1X 11753+00, sediment outside perimeter controls</p>

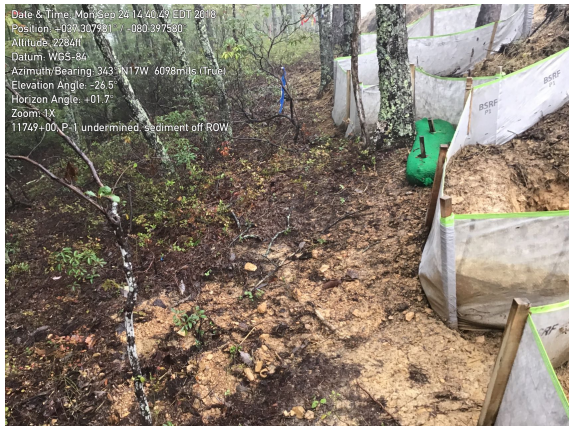
GPS Location	37.2062051017184, -80.3942187689994	GPS Location	37.2062051017184, -80.3942187689994		
Description	See photo for GPS location and station number. Silt fence undermined and sediment off ROW.	Description	See photo for GPS location and station number. Slope drain over two-tone, rock inlet and outlet in place.		
<p>Date & Time: Mon Sep 24 14:57:35 EDT 2018 Position: +037.3140127 / -080.398498 Altitude: 1923ft Datum: WGS-84 Azimuth/Bearing: 085° S09W 6096mils Elevation Angle: +38.4° Horizon Angle: +16.0° Zoom: 1X 11624+04 S-HH18</p>

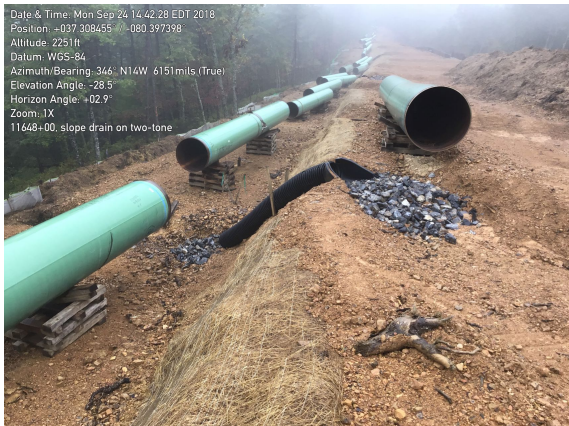
<p>Date & Time: Mon Sep 24 14:42:28 EDT 2018 Position: +037.3084557 / -080.397398 Altitude: 2251ft Datum: WGS-84 Azimuth/Bearing: 346° N14W 6151mils (True) Elevation Angle: -28.5° Horizon Angle: +02.9° Zoom: 1X 11648+00, slope drain on two-tone</p>

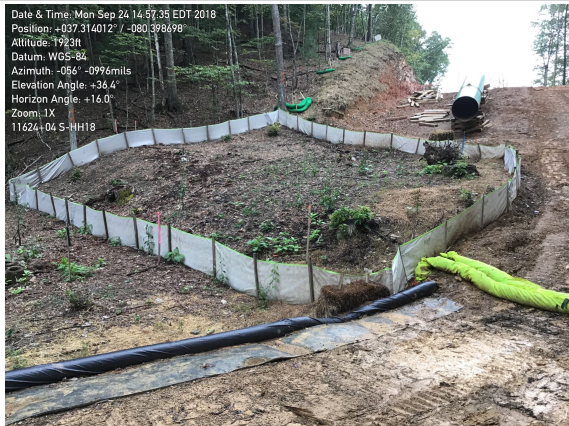
GPS Location	37.2062051017184, -80.3942187689994	GPS Location	37.2062051017184, -80.3942187689994		
Description	See photo for GPS location and station number. Sensitive resource buffer in place.	Description	See photo for GPS location and station number. Plunge pool in place.
