# Visual Site Inspection Report

<b>Project Name</b>	H-600 Pipeline Spread G	<b>AFE</b>	124300137	<b>Spread</b>	H-600 Pipeline Spread G
<b>Contractor</b>	Precision			<b>Report #</b>	8858
<b>Inspector</b>	Jared Saunders			<b>Date/Time</b>	10/4/2018 4:16 PM
<b>Permit #</b>	TBD	<b>Inspection Type</b>	VA SWPP	<b>Station Begin</b>	11600+00
<b>State</b>	VA	<b>Inspection Area</b>	Partial	<b>Station End</b>	11670+00
<b>County</b>	Montgomery	<b>Ground</b>	Damp	<b>Temperature (°F)</b>	83.00
<b>Municipality</b>	N/A	<b>Weather</b>	Sunny	<b>Rain Gauge (in)</b>	0.00
<b>GPS Location</b>	37.2233091594043, -80.4041039402276			<b>Rain Accumulation Time (days)</b>	1.00

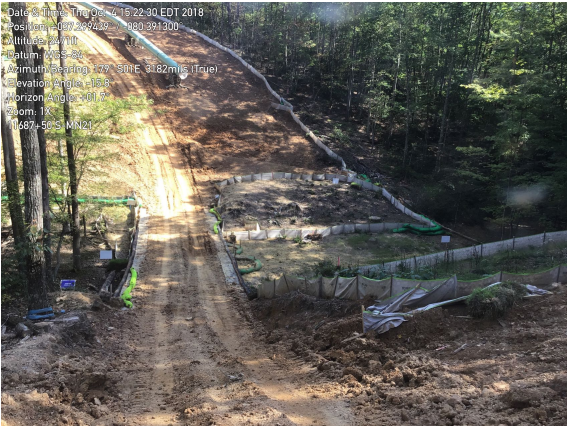
<b>GPS Location</b>	37.2233527154077, -80.4039628990743	<b>GPS Location</b>	37.223347544387, -80.4041734095288		
<b>Description</b>	Environmental crew upgrading ECDs at end treatments that previously failed.	<b>Description</b>	Water bar and end treatment in place.

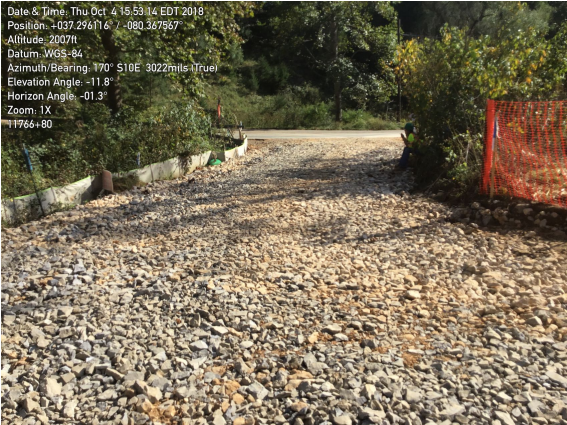
<b>GPS Location</b>	37.2232844867159, -80.4039760586623	<b>GPS Location</b>	37.2232844867159, -80.4039760586623		
<b>Description</b>	ECDs installed at stream S-MN21. Sensitive resource buffer in place.	<b>Description</b>	Slope drain and ECDs in place. Environmental crew upgraded to triple 12" CFS behind priority one silt fence.
