Visual Site Inspection Report

Project Name	H-600 Pipeline Spread G		AFE	124300137	Spread	H-600 Pipeline Spread G	
Contractor	Precision				Report #	8859	
Inspector	Jared Saunders				Date/Time	10/4/2018 4:45 PM	
Permit #	TBD	Inspection Type	VA SWPP		Station Begin	11670+00	
State	VA	Inspection Area	Partial		Station End	11766+80	
County	Montgomery	Ground	Damp		Temperature (°F)	85.00	
Municipality	N/A	Weather	Sunny		Rain Gauge (in)	0.00	
GPS Location	37.2233883992397, -80.4042471321244				Rain Accumulation Time (days)	1.00

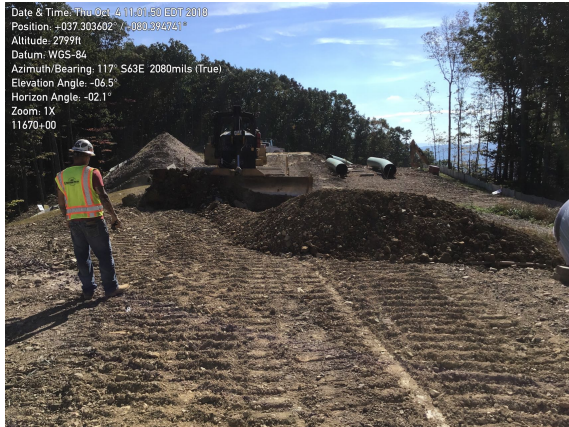
A/E	124300137	Date/Time	10/4/2018 4:45 PM	Report #	8859
Pictures					
<p>Date & Time: Thu Oct 4 11:31:50 EDT 2018 Position: +037.303602 / -080.395261* Altitude: 279ft Datum: WGS-84 Azimuth/Bearing: 117° S63E 2080mils (True) Elevation Angle: -06.5° Horizon Angle: -02.1° Zoom: 1X 11670+00</p>

GPS Location	37.2235272685413, -80.4040236678723	GPS Location	37.2234782662308, -80.4043647845716		
Description	Environmental crew installing unpassable berm to prevent traffic from area that will be stabilized.	Description	Reinforced silt fence used to separate top soil from subsoil spoil piles.		
<p>Date & Time: Thu Oct 4 11:28:02 EDT 2018 Position: +037.310308 / -080.397357* Altitude: 2117ft Datum: WGS-84 Azimuth/Bearing: 021° N71E 0373mils (True) Elevation Angle: -25.3° Horizon Angle: -04.0° Zoom: 1X 11622+00</p>

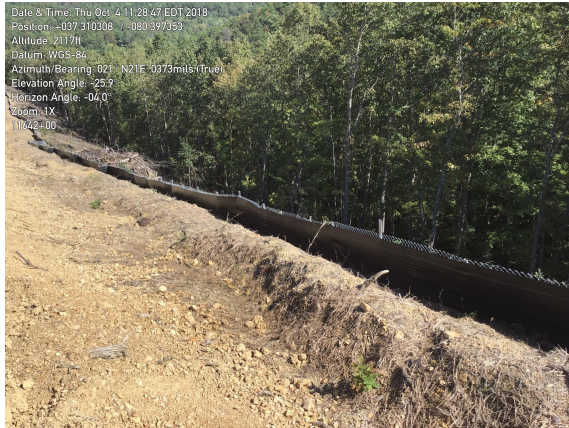
GPS Location	37.2233516257603, -80.4040749651197	GPS Location	37.2233516257603, -80.4040749651197		
Description	Reinforced silt fence ECD in place.	Description	100 foot buffer zone stabilized with seed and mulch. Priority one silt fence installed in travel lane to protect stream.		
<p>Date & Time: Thu Oct 4 11:39:35 EDT 2018 Position: +037.314248 / -080.400745* Altitude: 1925ft Datum: WGS-84 Azimuth/Bearing: 010° N60W 5511mils (True) Elevation Angle: -29.5° Horizon Angle: -02.3° Zoom: 1X 11619+00</p>

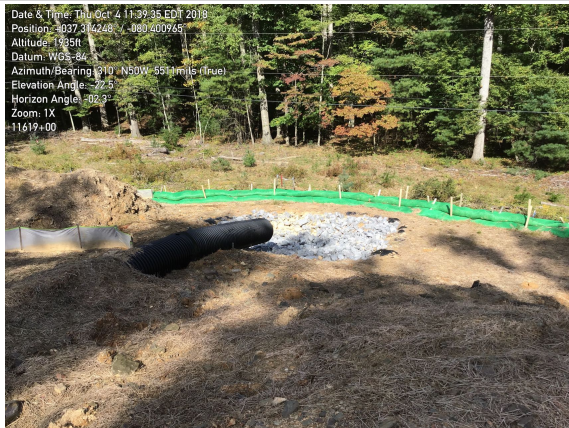
GPS Location	37.2233516257603, -80.4040749651197	GPS Location	37.2233516257603, -80.4040749651197		
Description	Plunge pool in place	Description	Area blocked off for stabilization and pipe is wrapped in plastic in preparation for stabilization.
