# Visual Site Inspection Report

<b>Project Name</b>	H-600 Pipeline Spread G	<b>AFE</b>	124300137	<b>Spread</b>	H-600 Pipeline Spread G
<b>Contractor</b>	Precision			<b>Report #</b>	8505
<b>Inspector</b>	Len Kruizenga			<b>Date/Time</b>	9/28/2018 6:23 AM
<b>Permit #</b>	TBD	<b>Inspection Type</b>	VA SWPP	<b>Station Begin</b>	11237+00
<b>State</b>	VA	<b>Inspection Area</b>	Full	<b>Station End</b>	1050+00
<b>County</b>	Giles	<b>Ground</b>	Muddy	<b>Temperature (°F)</b>	75.00
<b>Municipality</b>	N/A	<b>Weather</b>	Cloudy	<b>Rain Gauge (in)</b>	1.90
<b>GPS Location</b>	37.3010367845548, -80.5532045035215			<b>Rain Accumulation Time (days)</b>	1.00

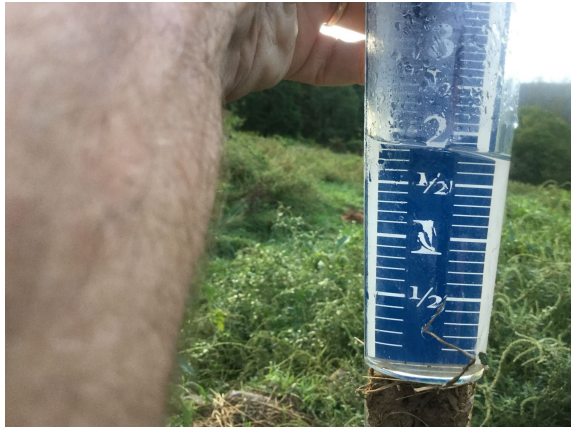
GPS Location	37.31809558816, -80.5538954493409		GPS Location	37.3141098255639, -80.5512994062906	
Description	AR- 244.00- rain gauge total - 1.80"		Description	Winding Way- AR-25- rain gauge total- 1.90"

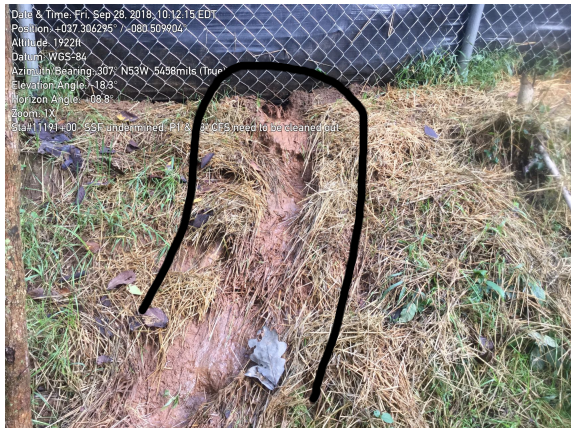
GPS Location	37.3063406814237, -80.509911077172		GPS Location	37.3075317079549, -80.5121332873409	
Description	Sta#11191+00- SSF undermined, P1 & CFS need to be cleaned.		Description	Sta#11183+00- sump pit full, needs to be cleaned.

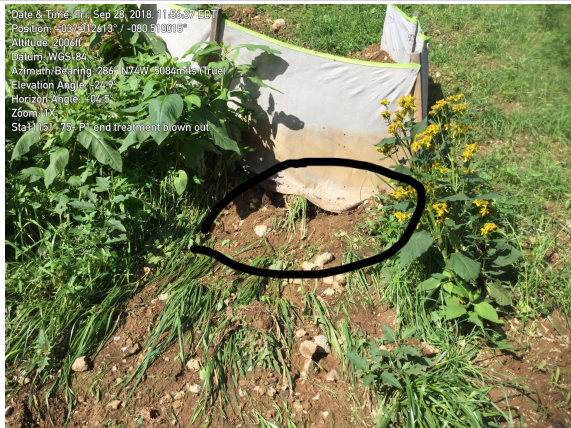
GPS Location	37.312640645576, -80.5179706123476		GPS Location	37.300247037818, -80.5031942390655	
Description	Sta#11151+75- P1 end treatment blown out, SSF contained sediment on row.		Description	Sta#11122+50; 11122+00; 11121+50, three water bars blown out in front of sump pit.
