Visual Site Inspection Report

Project Name	H-600 Pipeline Spread G	AFE	124300137	Spread	H-600 Pipeline Spread G
Contractor	Precision			Report #	5098
Inspector	Rob Robertson			Date/Time	7/24/2018 3:47 PM
Permit #	TBD	Inspection Type	VA SWPP	Station Begin	11553+66
State	VA	Inspection Area	Full	Station End	11596+94
County	Montgomery	Ground	Muddy	Temperature (°F)	80.00
Municipality	N/A	Weather	Cloudy	Rain Gauge (in)	0.60
GPS Location	37.29261022, -80.4096003			Rain Accumulation Time (days)	1.00

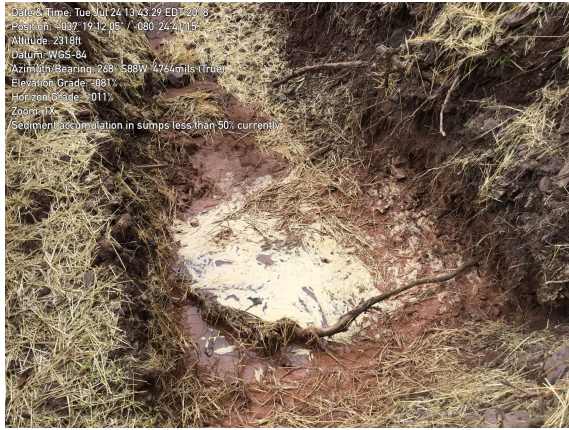
<p>Date & Time: Tue Jul 24 13:42:29 EDT 2018 Position: +037°19'12.05" / -080°24'21.15" Altitude: 2318ft Datum: WGS-84 Azimuth/Bearing: 230° S58W 474mils (True) Elevation Grade: +081% Horizon Grade: +011% Zoom: 1X Sediment accumulation in sumps less than 50% currently</p>

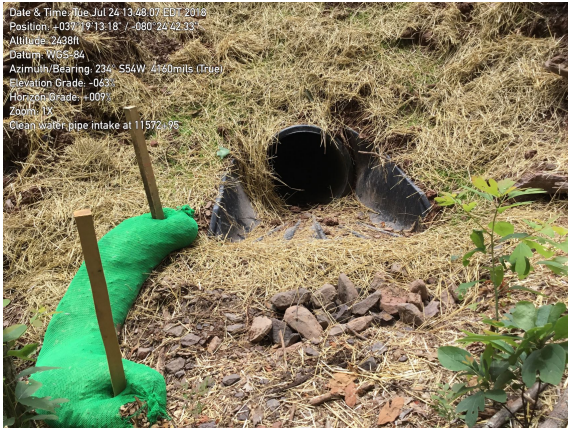
<p>Date & Time: Tue Jul 24 13:48:07 EDT 2018 Position: +037°19'13.18" / -080°24'22.13" Altitude: 2428ft Datum: WGS-84 Azimuth/Bearing: 230° S54W 436mils (True) Elevation Grade: +045% Horizon Grade: +009% Zoom: 1X Clean water pipe intake at 11572-76</p>			
GPS Location	37.3141303612267, -80.4065849260245		GPS Location	37.3141446942811, -80.4065922182802	
Description	Sumps currently less than half full		Description	Plunge pool intake acceptable

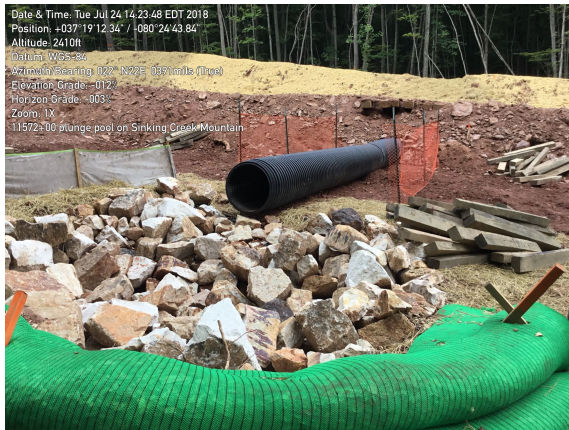
<p>Date & Time: Tue Jul 24 14:23:48 EDT 2018 Position: +037°19'12.34" / -080°24'43.84" Altitude: 2410ft Datum: WGS-84 Azimuth/Bearing: 193° S13W 343mils (True) Elevation Grade: +012% Horizon Grade: +003% Zoom: 1X 11572-00 plunge pool on Sinking Creek Mountain</p>

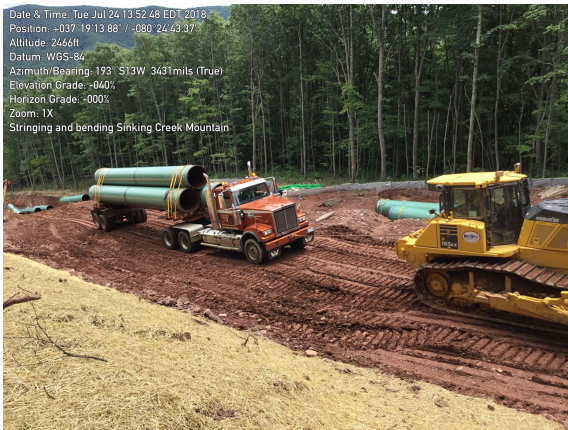
<p>Date & Time: Tue Jul 24 13:52:48 EDT 2018 Position: +037°19'13.88" / -080°24'43.17" Altitude: 2444ft Datum: WGS-84 Azimuth/Bearing: 193° S13W 343mils (True) Elevation Grade: +040% Horizon Grade: +000% Zoom: 1X Stringing and bending Sinking Creek Mountain</p>
