# Visual Site Inspection Report

<b>Project Name</b>	H-600 Pipeline Spread G	<b>AFE</b>	124300137	<b>Spread</b>	H-600 Pipeline Spread G
<b>Contractor</b>	Precision			<b>Report #</b>	5101
<b>Inspector</b>	Rob Robertson			<b>Date/Time</b>	7/24/2018 5:04 PM
<b>Permit #</b>	TBD	<b>Inspection Type</b>	VA SWPP	<b>Station Begin</b>	10458+91
<b>State</b>	VA	<b>Inspection Area</b>	Full	<b>Station End</b>	10459+03
<b>County</b>	Giles	<b>Ground</b>	Damp	<b>Temperature (°F)</b>	81.00
<b>Municipality</b>	N/A	<b>Weather</b>	Cloudy	<b>Rain Gauge (in)</b>	1.60
<b>GPS Location</b>	37.1331526344485, -80.3944674533384			<b>Rain Accumulation Time (days)</b>	2.00

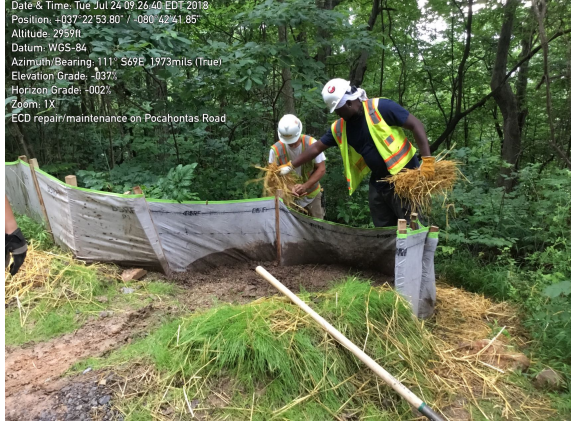
AFE	124300137	Date/Time	7/24/2018 5:04 PM	Report #	5101		
Pictures							
<div><div><div>Date &amp; Time: Tue Jul 24 09:26:40 EDT 2018 Position: +037.22 53.80° / -080.42 41.85° Altitude: 2959ft Datum: WGS-84 Azimuth/Bearing: 111° S69E 1973mils (True) Elevation Grade: -032% Horizon Grade: -002% Zoom: 1X ECD repair/maintenance on Pocahontas Road</div><div>

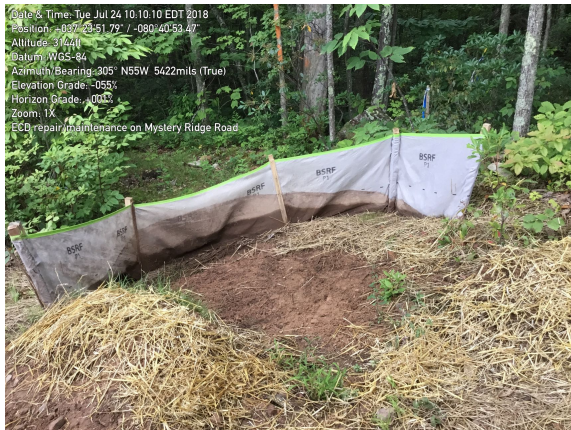
</div></div></div>		<div><div><div>Date &amp; Time: Tue Jul 24 09:20:20 EDT 2018 Position: +037.22 55.47° / -080.42 39.73° Altitude: 3019ft Datum: WGS-84 Azimuth/Bearing: 115° S65E 2044mils (True) Elevation Grade: -023% Horizon Grade: -007% Zoom: 1X ECD repair/maintenance on Pocahontas Road 164+29</div><div> </div></div></div>					
GPS Location		37.1331454833987, -80.3945133409733		GPS Location		37.1331452472289, -80.3945117036947	
Description		ECD maintenance on Pocahontas Road		Description		ECD maintenance on Pocahontas Road	
<div><div><div>Date &amp; Time: Tue Jul 24 10:10:10 EDT 2018 Position: +037.23 51.79° / -080.40 53.47° Altitude: 3120ft Datum: WGS-84 Azimuth/Bearing: 305° N55W 5422mils (True) Elevation Grade: -055% Horizon Grade: -000% Zoom: 1X ECD repair/maintenance on Mystery Ridge Road</div><div>

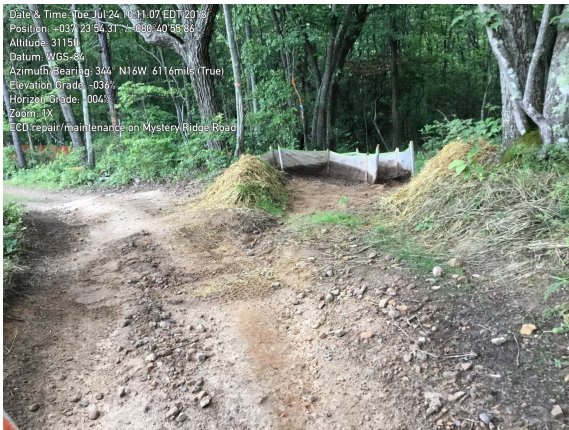
</div></div></div>		<div><div><div>Date &amp; Time: Tue Jul 24 11:11:07 EDT 2018 Position: +037.23 54.31° / -080.40 56.84° Altitude: 3115ft Datum: WGS-84 Azimuth/Bearing: 344° N16W 6116mils (True) Elevation Grade: -036% Horizon Grade: -004% Zoom: 1X ECD repair/maintenance on Mystery Ridge Road</div><div>
