# Visual Site Inspection Report

<b>Project Name</b>	H-600 Pipeline Spread G		<b>A/E</b>	124300137	<b>Spread</b>	H-600 Pipeline Spread G	
<b>Contractor</b>	Precision				<b>Report #</b>	5756	
<b>Inspector</b>	Rob Robertson				<b>Date/Time</b>	8/3/2018 5:59 PM	
<b>Permit #</b>	TBD	<b>Inspection Type</b>	VA SWPP		<b>Station Begin</b>	10458+91	
<b>State</b>	VA	<b>Inspection Area</b>	Full		<b>Station End</b>	10459+03	
<b>County</b>	Giles	<b>Ground</b>	Muddy		<b>Temperature (°F)</b>	73.00	
<b>Municipality</b>	N/A	<b>Weather</b>	Light Rain		<b>Rain Gauge (in)</b>	5.90	
<b>GPS Location</b>	37.1331867150178, -80.3945042916671				<b>Rain Accumulation Time (days)</b>	4.00

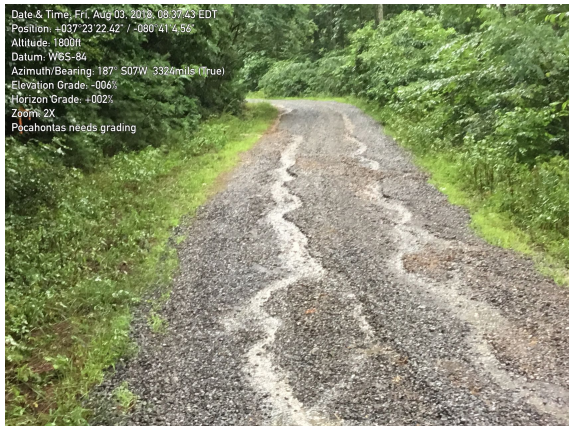
GPS Location	37.133180320337, -80.3944578596334	GPS Location	37.1331224516951, -80.3944914523834		
Description	Maintenance needed on Pocahontas Road.	Description	Controls failed on Pocahontas Road		
<div><div><div>Date &amp; Time: Fri, Aug 03, 2018 13:23:27 EDT Position: +037° 22' 56.88" / -080° 42' 28.00" Altitude: 3067ft Datum: WGS-84 Azimuth/Bearing: 306° N54W 5440mils (True) Elevation Grade: -0.34% Horizon Grade: -0.00% Zoom: 1X Pocahontas Road 334.75 enlarged</div><div> </div></div></div>		Insert image here			
GPS Location	37.1331231102135, -80.3944912068861	GPS Location			
Description	Maintenance in progress.	Description
