# Visual Site Inspection Report

<b>Project Name</b>	H-600 Pipeline Spread G	<b>AFE</b>	124300137	<b>Spread</b>	H-600 Pipeline Spread G
<b>Contractor</b>	Precision			<b>Report #</b>	6112
<b>Inspector</b>	Rob Robertson			<b>Date/Time</b>	8/9/2018 7:10 PM
<b>Permit #</b>	TBD	<b>Inspection Type</b>	VA SWPP	<b>Station Begin</b>	11618+91
<b>State</b>	VA	<b>Inspection Area</b>	Partial	<b>Station End</b>	11660+00
<b>County</b>	Montgomery	<b>Ground</b>	Damp	<b>Temperature (°F)</b>	83.00
<b>Municipality</b>	N/A	<b>Weather</b>	Cloudy	<b>Rain Gauge (in)</b>	0.00
<b>GPS Location</b>	37.1331809554595, -80.3946793545786			<b>Rain Accumulation Time (days)</b>	1.00

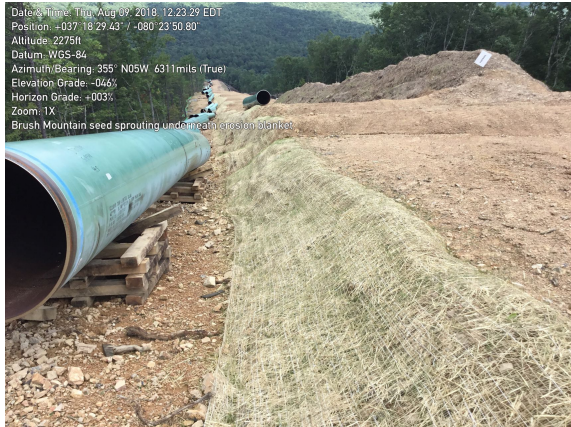
A/E	124300137	Date/Time	8/9/2018 7:10 PM	Report #	6112
Pictures					
<div><p>Date &amp; Time: Thu, Aug 09, 2018, 12:23:29 EDT Position: +037° 18' 29.43" / -080° 23' 50.80" Altitude: 2275ft Datum: WGS-84 Azimuth/Bearing: 355° N05W 6311mils (True) Elevation Grade: -046% Horizon Grade: +003% Zoom: 1X Brush Mountain seed sprouting under newly installed erosion matting</p>

</div>			
GPS Location	37.1332011977556, -80.3945919313285		GPS Location	37.1332011977556, -80.3945919313285	
Description	Grass growing under recently installed erosion matting on 2-tone		Description	Over-seeding has improved soil storage piles

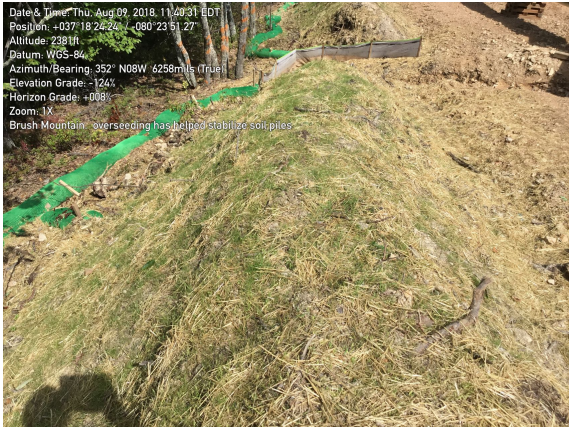
</div>		<div><p>Date &amp; Time: Thu, Aug 09, 2018, 11:40:31 EDT Position: +037° 18' 24.24" / -080° 23' 51.27" Altitude: 2381ft Datum: WGS-84 Azimuth/Bearing: 352° N08W 6258mils (True) Elevation Grade: -124% Horizon Grade: +008% Zoom: 1X Brush Mountain over-seeding has helped stabilize soil piles</p>

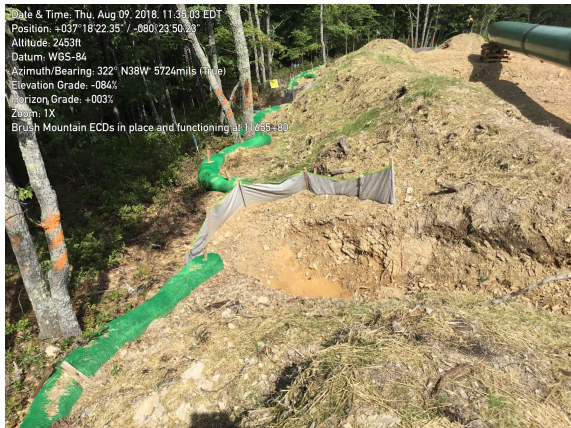
<div><p>Date &amp; Time: Thu, Aug 09, 2018, 11:31:03 EDT Position: +037° 18' 22.35" / -080° 23' 50.50" Altitude: 2453ft Datum: WGS-84 Azimuth/Bearing: 322° N38W 5724mils (True) Elevation Grade: -084% Horizon Grade: +003% Zoom: 1X Brush Mountain ECDs in place and functioning at 11658+80</p>

</div>			
GPS Location	37.1332011977556, -80.3945919313285		GPS Location	37.1332011977556, -80.3945919313285	
Description	Many sumps and end treatments found functional		Description	Many sumps and end treatments found functional	
<div><p>Date &amp; Time: Thu, Aug 09, 2018, 12:22:53 EDT Position: +037° 18' 29.47" / -080° 23' 51.11" Altitude: 2299ft Datum: WGS-84 Azimuth/Bearing: 261° E81W 4440mils (True) Elevation Grade: -067% Horizon Grade: -006% Zoom: 1X Brush Mountain silt fence maintenance needed. Small amount of sediment (red, 11648+76)</p>

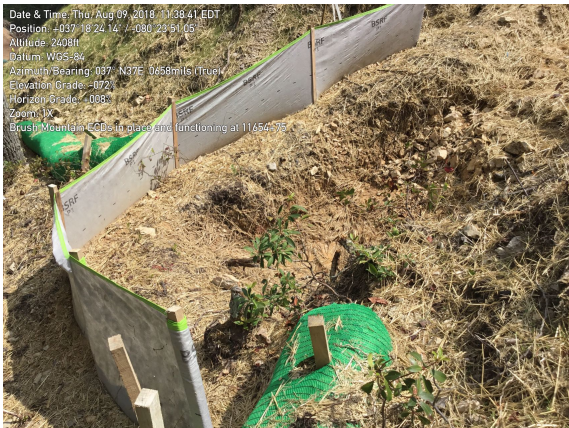
</div>		<div><p>Date &amp; Time: Thu, Aug 09, 2018, 11:38:41 EDT Position: +037° 18' 24.14" / -080° 23' 51.05" Altitude: 2428ft Datum: WGS-84 Azimuth/Bearing: 037° N37E 0458mils (True) Elevation Grade: -072% Horizon Grade: +008% Zoom: 1X Brush Mountain ECDs in place and functioning at 11654+75</p>
