Visual Site Inspection Report

Project Name	H-600 Pipeline Spread G	AFE	124300137	Spread	H-600 Pipeline Spread G
Contractor	Precision			Report #	6374
Inspector	Rob Robertson			Date/Time	8/15/2018 3:57 PM
Permit #	TBD	Inspection Type	VA SWPP	Station Begin	10458+91
State	VA	Inspection Area	Partial	Station End	10459+03
County	Giles	Ground	Damp	Temperature (°F)	82.00
Municipality	N/A	Weather	Sunny	Rain Gauge (in)	0.00
GPS Location	37.3197426980136, -80.6380863835176			Rain Accumulation Time (days)	1.00

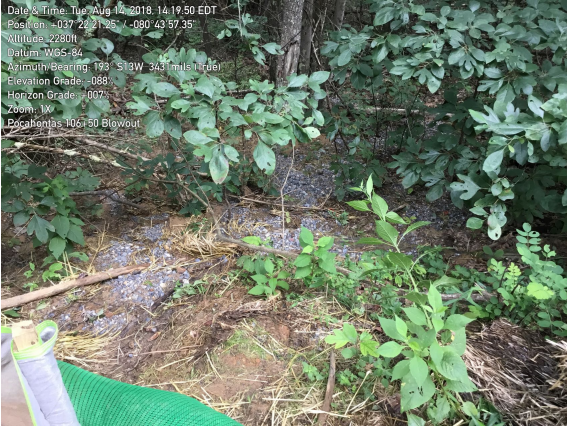
<p>Date & Time: Tue, Aug 14, 2018, 14:19:50 EDT Position: +037 22 21.25' / -080 43 57.35' Altitude: 2280ft Datum: WGS-84 Azimuth/Bearing: 193° S13W 343mils (True) Elevation Grade: -088° Horizon Grade: -007° Zoom: 1X Pocahontas 106+50 Blowout</p>

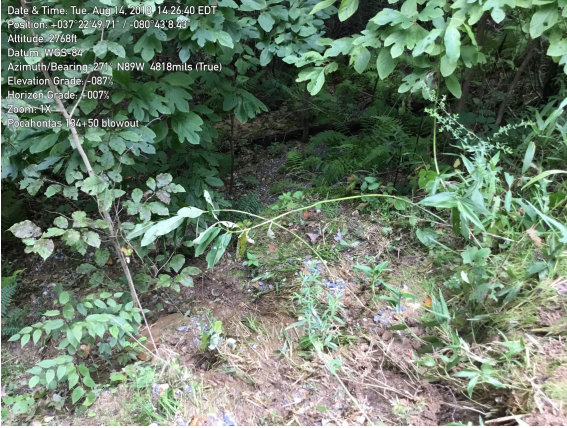
<p>Date & Time: Tue, Aug 14, 2018, 14:26:40 EDT Position: +037 22 29.71' / -080 43 8.43' Altitude: 2768ft Datum: WGS-84 Azimuth/Bearing: 223° N89W 4018mils (True) Elevation Grade: -087° Horizon Grade: -007° Zoom: 1X Pocahontas 134+50 blowout</p>		GPS Location 37.3199230490522, -80.638074589257	
Description		Description		Correct coordinates found on photos. Sediment and gravel beyond LOD at 106+50.

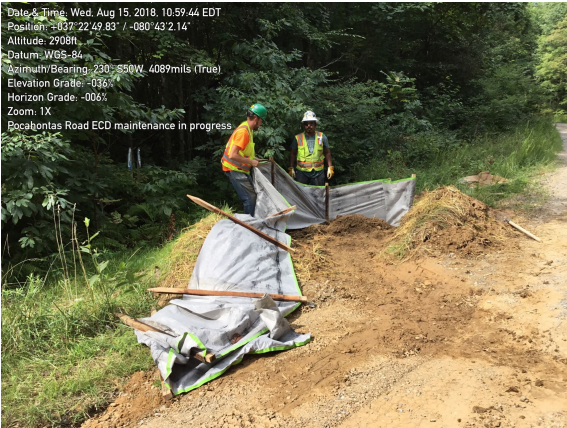
<p>Date & Time: Wed, Aug 15, 2018, 10:59:44 EDT Position: +037 22 49.83' / -080 43 2.14' Altitude: 2908ft Datum: WGS-84 Azimuth/Bearing: 230° S50W 4089mils (True) Elevation Grade: -036° Horizon Grade: -006° Zoom: 1X Pocahontas Road ECD maintenance in progress</p>		Insert image here		GPS Location 37.3197317941525, -80.6379798946737

Description		Description		Correct coordinates found on photos. Repair of damaged ECDs continued today on Pocahontas Road.	
Insert image here		Insert image here			
GPS Location		GPS Location			
Description		Description
