Visual Site Inspection Report

Project Name	H-600 Pipeline Spread G		AFE	124300137	Spread	H-600 Pipeline Spread G	
Contractor	Precision				Report #	6705	
Inspector	Rob Robertson				Date/Time	8/21/2018 7:17 PM	
Permit #	TBD	Inspection Type	VA SWPP		Station Begin	10458+91	
State	VA	Inspection Area	Partial		Station End	10459+03	
County	Giles	Ground	Damp		Temperature (°F)	80.00	
Municipality	N/A	Weather	Cloudy		Rain Gauge (in)	0.15	
GPS Location	37.1331422581039, -80.3944903222683				Rain Accumulation Time (days)	1.00

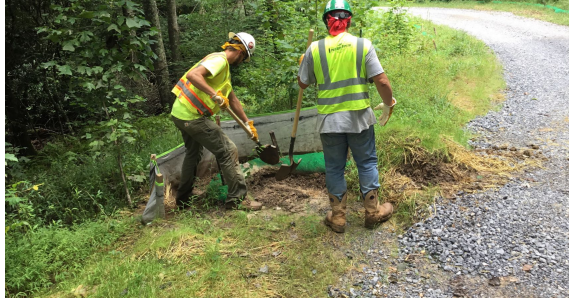
AFE	124300137	Date/Time	8/21/2018 7:17 PM	Report #	6705
Pictures					
<div><div><div>Date & Time: Tue, Aug 21, 2018, 11:21:09 EDT Position: +037°22'51.66" N -080°41'58.66" W Altitude: 2729ft Datum: WGS-84 Azimuth/Bearing: 234° N26W 5938mils (True) Elevation Grade: -027% Horizon Grade: +001% Zoom: 1X ECD maintenance on Pocahontas Road</div>

</div></div>			
GPS Location	37.1331504369094, -80.3945563281438		GPS Location	37.133183548591, -80.3944469278735	
Description	Coordinates on photo. ECD maintenance in progress.		Description	Coordinates on photo. Maintenance completed. Control functional.	
<div><div><div>Date & Time: Tue, Aug 21, 2018, 12:40:33 EDT Position: +037°23'07.94" N -080°42'36.70" W Altitude: 2633ft Datum: WGS-84 Azimuth/Bearing: 134° S45E 2382mils (True) Elevation Grade: -042% Horizon Grade: -001% Zoom: 1X ECD maintenance on Pocahontas Road</div>

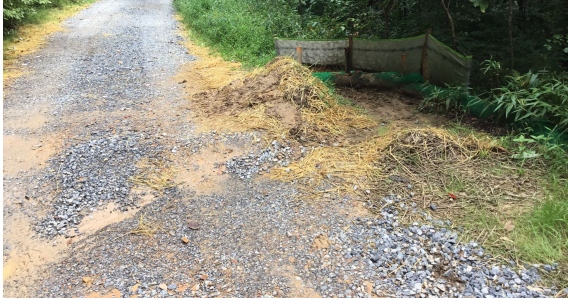
</div></div>		<div><div><div>Date & Time: Tue, Aug 21, 2018, 12:35:00 EDT Position: +037°23'41.04" N -080°41'58.95" W Altitude: 2635ft Datum: WGS-84 Azimuth/Bearing: 075° N35E 1333mils (True) Elevation Grade: -032% Horizon Grade: -004% Zoom: 1X ECD maintenance on Pocahontas Road at 256+75</div>

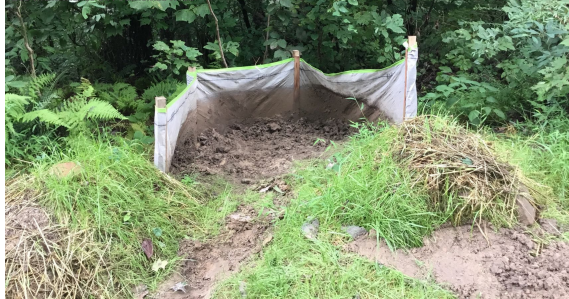
GPS Location	37.1331831899964, -80.3944460843567		GPS Location	37.1331831862418, -80.3944460822534	
Description	Coordinates on photo. Maintenance completed. Control functional.		Description	Coordinates on photo. Maintenance completed. Control functional.	
Insert image here		Insert image here			
GPS Location			GPS Location		
Description			Description

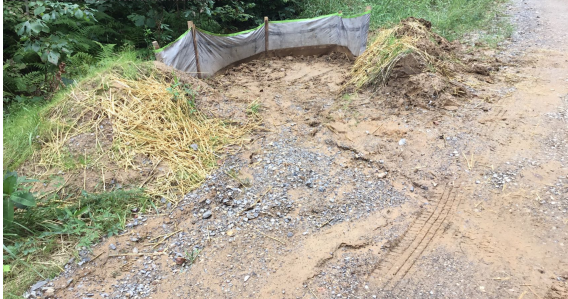
</div></div>		<div><div><div>Date & Time: Tue, Aug 21, 2018, 12:40:07 EDT Position: +037°22'50.12" N -080°43'19.66" W Altitude: 2878ft Datum: WGS-84 Azimuth/Bearing: 234° S54W 4160mils (True) Elevation Grade: -043% Horizon Grade: -002% Zoom: 1X ECD maintenance on Pocahontas Road at 139+50</div>
