Visual Site Inspection Report

Project Name	H-600 Pipeline Spread G	AFE	124300137	Spread	H-600 Pipeline Spread G
Contractor	Precision			Report #	7009
Inspector	Rob Robertson			Date/Time	8/27/2018 5:29 PM
Permit #	TBD	Inspection Type	VA SWPP	Station Begin	11553+66
State	VA	Inspection Area	Partial	Station End	11668+15
County	Montgomery	Ground	Dry	Temperature (°F)	86.00
Municipality	N/A	Weather	Sunny	Rain Gauge (in)	0.00
GPS Location	37.1331317606365, -80.3944629457378			Rain Accumulation Time (days)	1.00

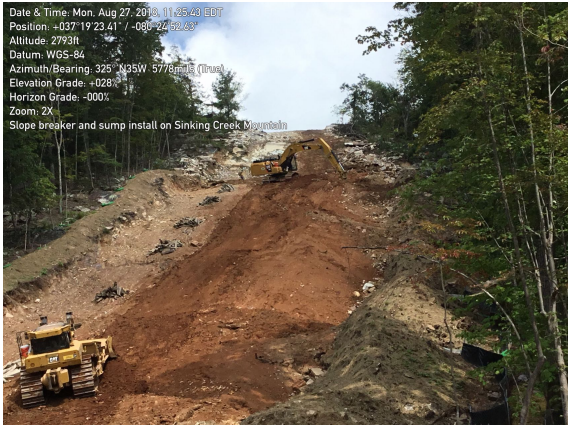
A/E	124300137	Date/Time	8/27/2018 5:29 PM	Report #	7009
Pictures					
<p>Date & Time: Mon, Aug 27, 2018, 09:34:52 EDT Position: +037°19'8.52" / -080°24'39.61" Altitude: 2298ft Datum: WGS-84 Azimuth/Bearing: 055° N 66E 1173mils (True) Elevation Grade: -075° Horizon Grade: -002° Zoom: 1X 11576+75 sump cleaning and ECD repair</p>  		<p>Date & Time: Mon, Aug 27, 2018, 11:25:40 EDT Position: +037°19'23.41" / -080°24'49.63" Altitude: 2793ft Datum: WGS-84 Azimuth/Bearing: 325° N 35W 5778mils (True) Elevation Grade: +028° Horizon Grade: -000° Zoom: 2X Slope breaker and sump install on Sinking Creek Mountain</p>

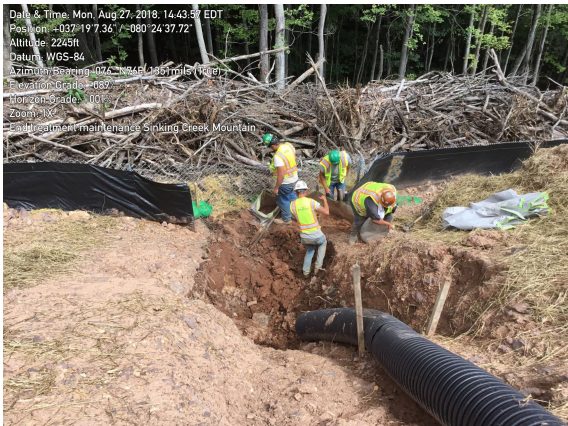
GPS Location	37.1331762855921, -80.394454340937	GPS Location	37.1331333780496, -80.3944629793383		
Description	Fill slope outlet pipe and end treatment maintenance observed on Sinking Creek Mountain.	Description	Slope breaker installation and maintenance on Sinking Creek Mountain.		
<p>Date & Time: Mon, Aug 27, 2018, 12:04:58 EDT Position: +037°19'28.71" / -080°24'35.19" Altitude: 3000ft Datum: WGS-84 Azimuth/Bearing: 164° S 16E 2916mils (True) Elevation Grade: -082° Horizon Grade: -002° Zoom: 1X End treatment maintenance 11555+00 Sinking Creek Mountain</p>  		<p>Date & Time: Mon, Aug 27, 2018, 14:43:37 EDT Position: +037°19'7.36" / -080°24'37.72" Altitude: 2245ft Datum: WGS-84 Azimuth/Bearing: 072° N 84E 1361mils (True) Elevation Grade: -032° Horizon Grade: -001° Zoom: 1X End treatment maintenance Sinking Creek Mountain</p>

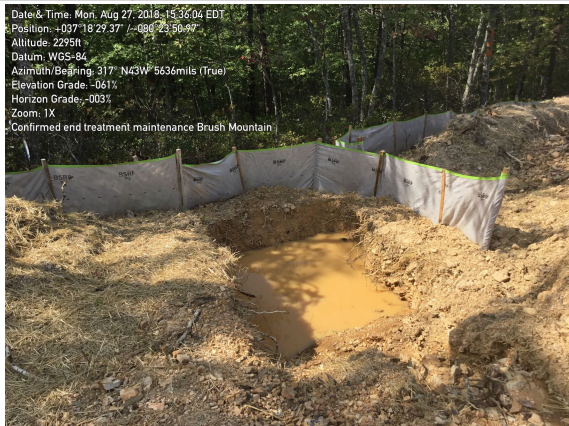
GPS Location	37.1331331511816, -80.3944624469794	GPS Location	37.1331331487966, -80.3944624409098		
Description	ECD maintenance in progress on Sinking Creek Mountain.	Description	Maintenance of ECDs on Sinking Creek Mountain.		
<p>Date & Time: Mon, Aug 27, 2018, 15:36:04 EDT Position: +037°18'29.37" / -080°23'50.47" Altitude: 2295ft Datum: WGS-84 Azimuth/Bearing: 317° N 43W 5636mils (True) Elevation Grade: -041° Horizon Grade: -003° Zoom: 1X Confirmed end treatment maintenance Brush Mountain</p>

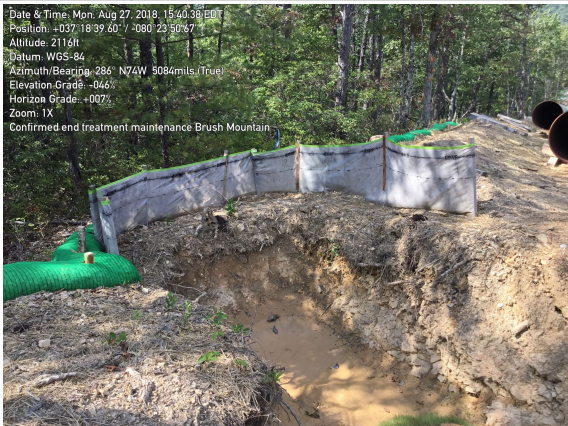
<p>Date & Time: Mon, Aug 27, 2018, 15:40:39 EDT Position: +037°18'39.40" / -080°23'50.37" Altitude: 2116ft Datum: WGS-84 Azimuth/Bearing: 288° N 74W 5084mils (True) Elevation Grade: -046° Horizon Grade: -007° Zoom: 1X Confirmed end treatment maintenance Brush Mountain</p>

GPS Location	37.1330960040928, -80.3944210593165	GPS Location	37.1330960040928, -80.3944210593165		
Description	Inspection of sumps and end treatments on Brush Mountain.	Description	Inspection of sumps and end treatments on Brush Mountain.
