Visual Site Inspection Report

Project Name	H-600 Pipeline Spread G		AFE	124300137	Spread	H-600 Pipeline Spread G	
Contractor	Precision				Report #	7227	
Inspector	Rob Robertson				Date/Time	8/31/2018 5:04 PM	
Permit #	TBD	Inspection Type	VA SWPP		Station Begin	11553+66	
State	VA	Inspection Area	Partial		Station End	11596+94	
County	Montgomery	Ground	Muddy		Temperature (°F)	84.00	
Municipality	N/A	Weather	Cloudy		Rain Gauge (in)	1.25	
GPS Location	37.1331268452127, -80.3944633315708				Rain Accumulation Time (days)	1.00

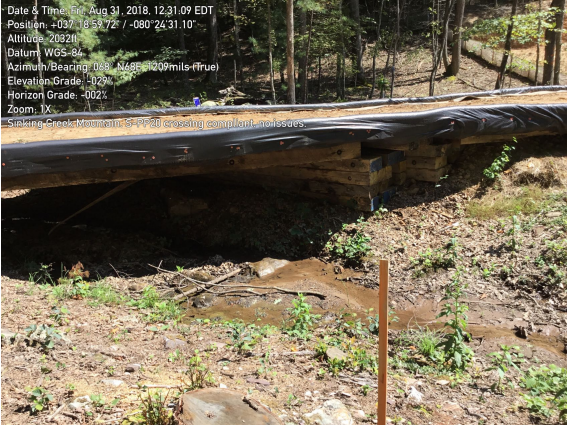
AFE	124300137	Date/Time	8/31/2018 5:04 PM	Report #	7227
Pictures					
<p>Date & Time: Fri, Aug 31, 2018, 12:31:09 EDT Position: +037°18'53.72" / -080°24'31.10" Altitude: 2032ft Datum: WGS-84 Azimuth/Bearing: 028° NDBE 0109mils (True) Elevation Grade: -022° Horizon Grade: -011° Zoom: 1X Sinking Creek Mountain, S-PP20 crossing/compliant, no issues.</p>

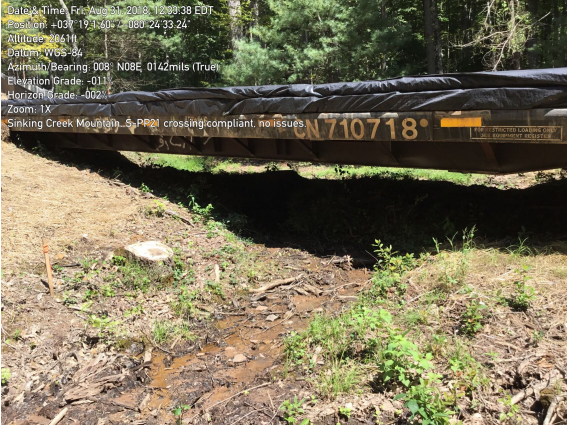
<p>Date & Time: Fri, Aug 31, 2018, 12:30:38 EDT Position: +037°19'14.0" / -080°24'33.24" Altitude: 2141ft Datum: WGS-84 Azimuth/Bearing: 008° NDBE 0142mils (True) Elevation Grade: -011° Horizon Grade: -002° Zoom: 1X Sinking Creek Mountain, S-PP21 crossing/compliant, no issues.</p>

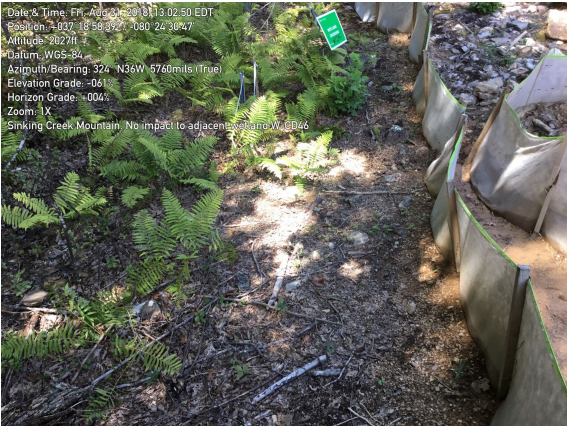
GPS Location	37.1331225335944, -80.3944677115235	GPS Location	37.1331225335944, -80.3944677115235		
Description	Correct coordinates on photo. No resource impact S-PP20.	Description	Correct coordinates on photo. No resource impact S-PP21.		
<p>Date & Time: Fri, Aug 31, 2018, 12:50:50 EDT Position: +037°19'4.76" / -080°24'30.47" Altitude: 2027ft Datum: WGS-84 Azimuth/Bearing: 324° N36W 5760mils (True) Elevation Grade: -061° Horizon Grade: +004° Zoom: 1X Sinking Creek Mountain, No impact to adjacent road and W-CD46</p>

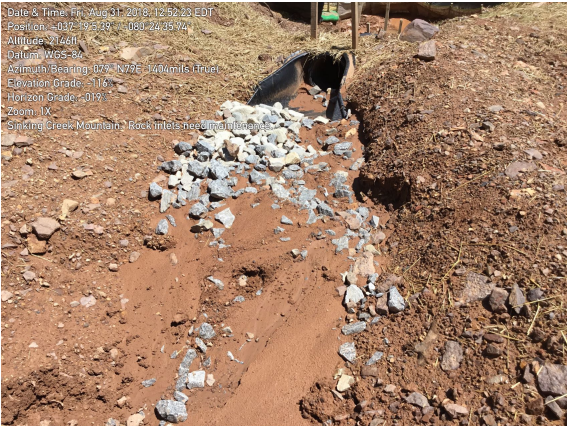
<p>Date & Time: Fri, Aug 31, 2018, 12:50:25 EDT Position: +037°19'5.38" / -080°24'33.74" Altitude: 2146ft Datum: WGS-84 Azimuth/Bearing: 028° N79E 1400mils (True) Elevation Grade: -116° Horizon Grade: -017° Zoom: 1X Sinking Creek Mountain, Rock inlets needing maintenance.</p>

GPS Location	37.1331225335944, -80.3944677115235	GPS Location	37.1331225335944, -80.3944677115235		
Description	Correct coordinates on photo. No resource impact W-CD46.	Description	Correct coordinates on photo. Rock clogged with sediment at all inlets.		
<p>Date & Time: Fri, Aug 31, 2018, 12:47:42 EDT Position: +037°19'4.76" / -080°24'35.74" Altitude: 2134ft Datum: WGS-84 Azimuth/Bearing: 247° S67W 4391mils (True) Elevation Grade: -027° Horizon Grade: +009° Zoom: 1X Sinking Creek Mountain, 11579+50 Slope breakers need maintenance.</p>

4. E&S BMPs (List BMPs and note if installed and maintained as per the plan. If corrective action is needed, a picture is required.)							
E&S BMPs		Compliance Level		Corrective Action		Corrective Time Frame	
Compost Filter Sock		Acceptable					
Housekeeping		Acceptable					
Stone Inlet Protection		Communication		Rock at inlet clogged with sediment		48 Hours	
Silt Fence (Filter Fabric Fence)		Acceptable					
Silt Fence (Reinforced Filter Fabric Fence)		Acceptable					
Sump Pit		Communication		Maintenance needed		48 Hours	
Vegetative Stabilization (Temporary)		Acceptable					
Waterbar		Communication		Maintenance needed		48 Hours	
Waterbar Outlet Protection		Communication		Maintenance needed		48 Hours

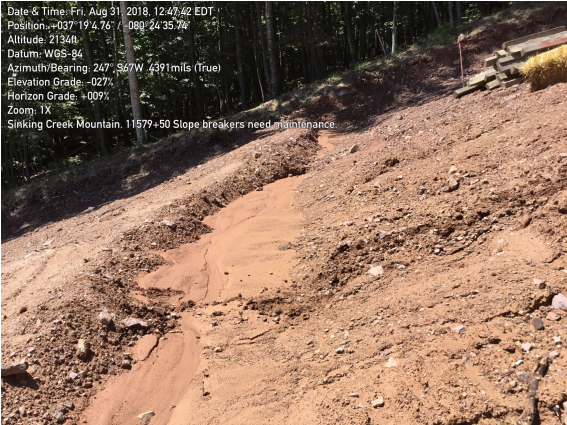
Description	Correct coordinates on photo. Slope breakers in need of maintenance.	Description	Correct coordinates on photo. End treatments in need of maintenance.

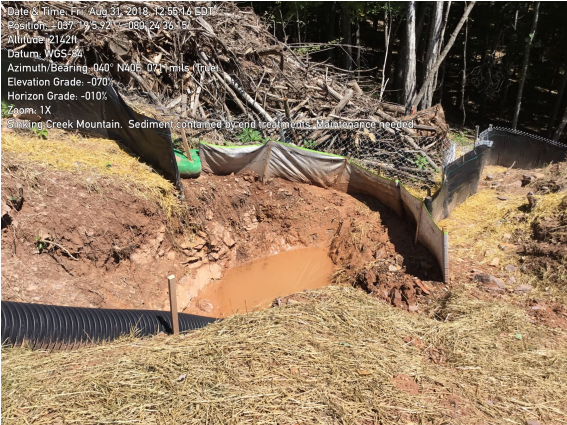
<p>Date & Time: Fri, Aug 31, 2018, 12:56:14 EDT Position: +037°19'5.74" / -080°24'36.15" Altitude: 2122ft Datum: WGS-84 Azimuth/Bearing: 040° N40E 0147mils (True) Elevation Grade: -070° Horizon Grade: -010° Zoom: 1X Sinking Creek Mountain, Sediment contained beyond end treatments. Maintenance needed.</p>
