# Visual Site Inspection Report

<b>Project Name</b>	H-600 Pipeline Spread G	<b>AFE</b>	124300137	<b>Spread</b>	H-600 Pipeline Spread G
<b>Contractor</b>	Precision			<b>Report #</b>	8553
<b>Inspector</b>	Rob Robertson			<b>Date/Time</b>	9/28/2018 6:13 PM
<b>Permit #</b>	TBD	<b>Inspection Type</b>	VA SWPP	<b>Station Begin</b>	11596+94
<b>State</b>	VA	<b>Inspection Area</b>	Full	<b>Station End</b>	11553+66
<b>County</b>	Montgomery	<b>Ground</b>	Muddy	<b>Temperature (°F)</b>	75.00
<b>Municipality</b>	N/A	<b>Weather</b>	Sunny	<b>Rain Gauge (in)</b>	2.00
<b>GPS Location</b>	37.1340274, -80.3935611			<b>Rain Accumulation Time (days)</b>	1.00

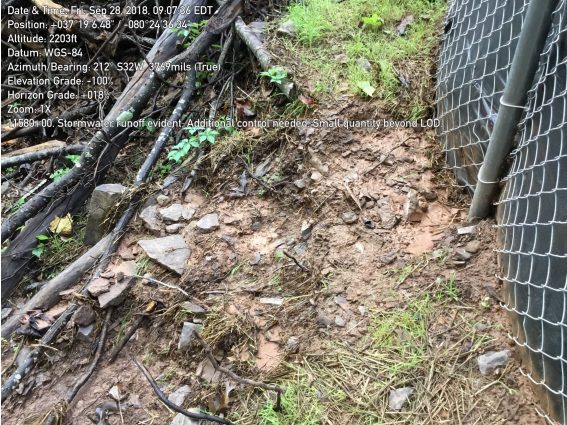
<b>A/E</b>	124300137	<b>Date/Time</b>	9/28/2018 6:13 PM	<b>Report #</b>	8553
<b>Pictures</b>					
<p>Date &amp; Time: Fri, Sep 28, 2018, 09:07:36 EDT  Position: +037°19'6.45" / -080°24'36.29"  Altitude: 2203ft  Datum: WGS-84  Azimuth/Bearing: 121° 53'21" 2151mils (True)  Elevation Grade: +00%  Horizon Grade: +01%  Zoom: 1X  11580-00, Stormwater runoff evident. Additional control needed. Small quantity beyond LOD.</p>

<b>GPS Location</b>	37.1331836376685, -80.3943523765359	<b>GPS Location</b>	37.1340274, -80.3935611		
<b>Description</b>	Correct coordinates on photo. ECD failed allowing sediment to migrate beyond the LOD.	<b>Description</b>	Correct coordinates on photo. ECD failed allowing sediment to migrate beyond the LOD.

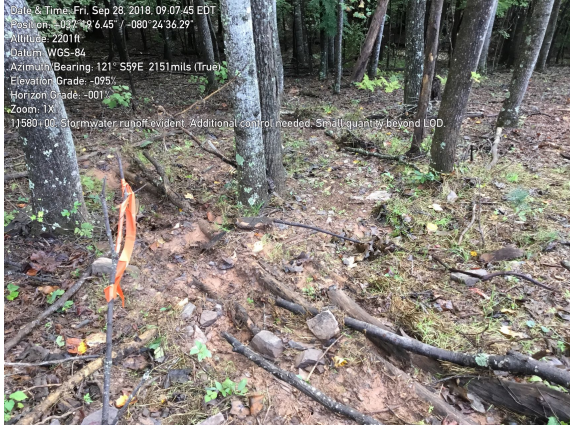
<p>Date &amp; Time: Fri, Sep 28, 2018, 09:07:45 EDT  Position: +037°19'6.45" / -080°24'36.29"  Altitude: 2201ft  Datum: WGS-84  Azimuth/Bearing: 121° 58'59" 2151mils (True)  Elevation Grade: +09%  Horizon Grade: +00%  Zoom: 1X  11580-00, Stormwater runoff evident. Additional control needed. Small quantity beyond LOD.</p>

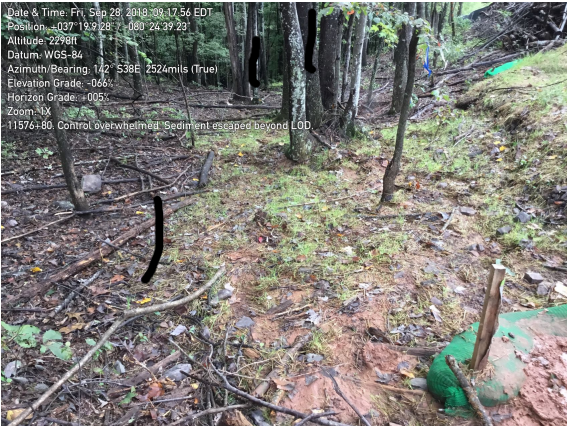
<p>Date &amp; Time: Fri, Sep 28, 2018, 10:57:26 EDT  Position: +037°19'25.70" / -080°24'33.23"  Altitude: 2228ft  Datum: WGS-84  Azimuth/Bearing: 142° 53'38" 2324mils (True)  Elevation Grade: +06%  Horizon Grade: +00%  Zoom: 1X  11556-00, Controls overwhelmed. Sediment escaped beyond LOD.</p>

<b>GPS Location</b>	37.1332759224224, -80.3944145702574	<b>GPS Location</b>	37.1332759224224, -80.3944145702574		
<b>Description</b>	Correct coordinates on photo. ECD failed allowing sediment to migrate beyond the LOD.	<b>Description</b>	Correct coordinates on photo. ECD failed allowing sediment to migrate beyond the LOD.

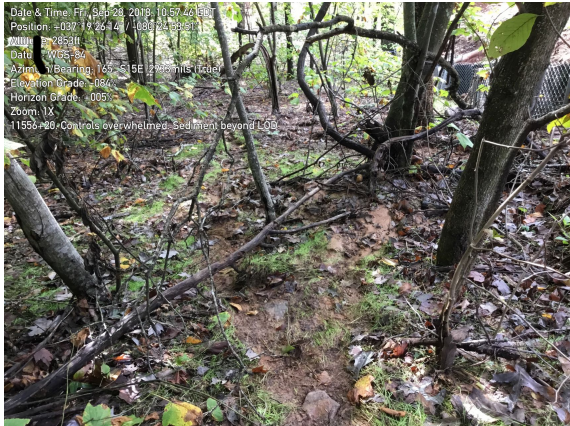
<p>Date &amp; Time: Fri, Sep 28, 2018, 10:57:26 EDT  Position: +037°19'25.70" / -080°24'33.23"  Altitude: 2228ft  Datum: WGS-84  Azimuth/Bearing: 142° 53'38" 2324mils (True)  Elevation Grade: +06%  Horizon Grade: +00%  Zoom: 1X  11556-00, Controls overwhelmed. Sediment escaped beyond LOD.</p>

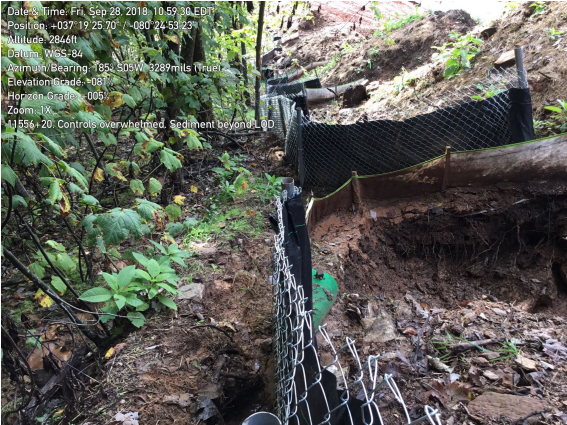
<p>Date &amp; Time: Fri, Sep 28, 2018, 10:59:30 EDT  Position: +037°19'25.70" / -080°24'33.23"  Altitude: 2246ft  Datum: WGS-84  Azimuth/Bearing: 165° 50'59" 2329mils (True)  Elevation Grade: +08%  Horizon Grade: +00%  Zoom: 1X  11556-20, Controls overwhelmed. Sediment beyond LOD.</p>

<b>GPS Location</b>	37.1332759224224, -80.3944145702574	<b>GPS Location</b>	37.1332759224224, -80.3944145702574		
<b>Description</b>	Correct coordinates on photo. ECD failed allowing sediment to migrate beyond the LOD.	<b>Description</b>	Correct coordinates on photo. Improper repair of silt fence.
