Visual Site Inspection Report

Project Name	H-600 Pipeline Spread G		AFE	124300137	Spread	H-600 Pipeline Spread G	
Contractor	Precision				Report #	4132	
Inspector	Tim Bowen				Date/Time	7/6/2018 12:05 PM	
Permit #	TBD	Inspection Type	VA SWPP		Station Begin	11618+91	
State	VA	Inspection Area	Full		Station End	11668+15	
County	Montgomery	Ground	Dusty		Temperature (°F)	80.00	
Municipality	N/A	Weather	Cloudy		Rain Gauge (in)	0.05	
GPS Location	37.3064513762373, -80.5259789007467				Rain Accumulation Time (days)	1.00

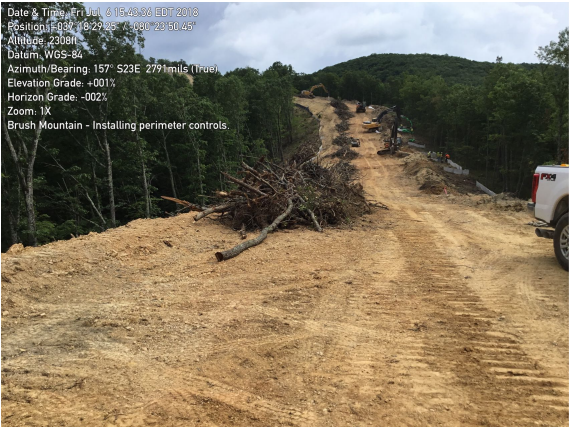
AFE	124300137	Date/Time	7/6/2018 12:05 PM	Report #	4132
Pictures					
<div><div><div>Date & Time: Fri Jul 6 15:25:55 EDT 2018 Position: +037° 18' 29.45" N, -81° 06' 23.42" W Altitude: 2301ft Datum: WGS-84 Azimuth/Bearing: 157° S23E 2791mils (True) Elevation Grade: +001% Horizon Grade: -002% Zoom: 1X Brush Mountain - Installing perimeter controls.</div>

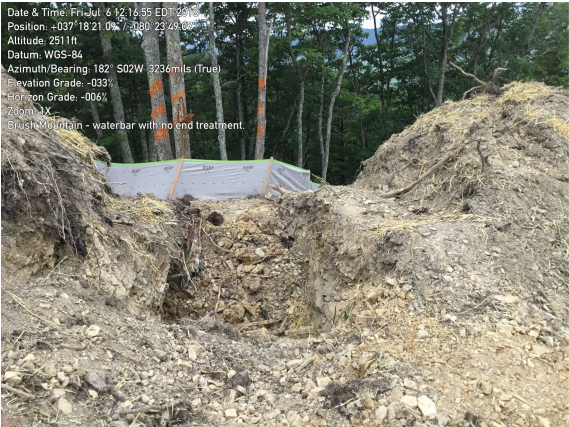
</div></div>		<div><div><div>Date & Time: Fri Jul 6 12:16:55 EDT 2018 Position: +037° 18' 21.04" N, -81° 06' 23.42" W Altitude: 2511ft Datum: WGS-84 Azimuth/Bearing: 182° S02W 3236mils (True) Elevation Grade: -033% Horizon Grade: -006% Zoom: 1X Brush Mountain - waterbar with no end treatment.</div>

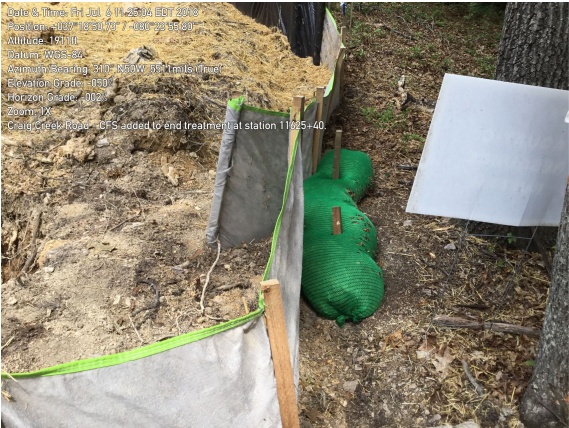
<div><div><div>Date & Time: Fri Jul 6 14:25:00 EDT 2018 Position: +037° 18' 21.04" N, -81° 06' 23.42" W Altitude: 1971ft Datum: WGS-84 Azimuth/Bearing: 150° S06W 3541mils (True) Elevation Grade: +001% Horizon Grade: -012% Zoom: 1X CFS added to end treatment at station 11025+40.</div>
