Visual Site Inspection Report

Project Name	H-600 Pipeline Spread G		AFE	124300137	Spread	H-600 Pipeline Spread G	
Contractor	Precision				Report #	4468	
Inspector	Timothy Watson				Date/Time	7/12/2018 1:31 PM	
Permit #	TBD	Inspection Type	VA SWPP		Station Begin	10510+78	
State	VA	Inspection Area	Partial		Station End	11236+10	
County	Giles	Ground	Dry		Temperature (°F)	82.00	
Municipality	N/A	Weather	Sunny		Rain Gauge (in)	0.01	
GPS Location	37.3115467653026, -80.5162240751837				Rain Accumulation Time (days)	1.00

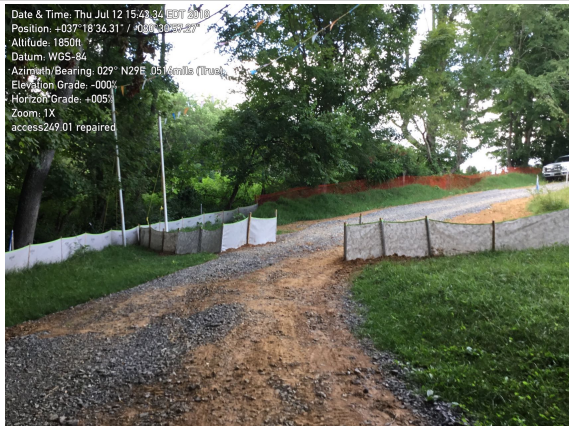
<p>Date & Time: Thu Jul 12 15:43:34 EDT 2018 Position: +037° 18' 36.31" / -080° 30' 29.29" Altitude: 1850ft Datum: WGS-84 Azimuth/Bearing: 022° N29E 6516mils (True) Elevation Grade: +000% Horizon Grade: +005% Zoom: 1X access249.01 repaired</p>		Insert image here			
GPS Location	37.320784621428, -80.637625298036	GPS Location			
Description	Use photo gps access 249.01 repaired silt fence 7-8-18	Description
