# Visual Site Inspection Report

<b>Project Name</b>	H-600 Pipeline Spread G		<b>AFE</b>	124300137	<b>Spread</b>	H-600 Pipeline Spread G	
<b>Contractor</b>	Precision				<b>Report #</b>	6133	
<b>Inspector</b>	Timothy Watson				<b>Date/Time</b>	8/9/2018 5:52 PM	
<b>Permit #</b>	TBD	<b>Inspection Type</b>	VA SWPP		<b>Station Begin</b>	11064+28	
<b>State</b>	VA	<b>Inspection Area</b>	Partial		<b>Station End</b>	11227+59	
<b>County</b>	Giles	<b>Ground</b>	Dry		<b>Temperature (°F)</b>	89.00	
<b>Municipality</b>	N/A	<b>Weather</b>	Sunny		<b>Rain Gauge (in)</b>	0.01	
<b>GPS Location</b>	37.3192751216255, -80.6578400469295				<b>Rain Accumulation Time (days)</b>	1.00

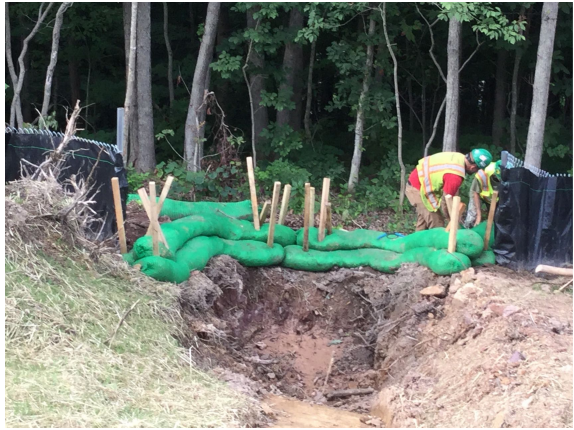
GPS Location		37.3193159094428, -80.6580304541445		GPS Location		37.3193159094428, -80.6580304541445	
Description		Repair outlet controls 11067+50		Description		Damaged j hook 11082+00

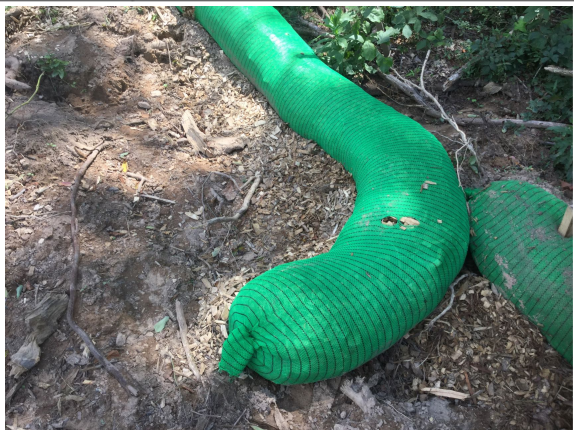
GPS Location		37.3192765632913, -80.6578388657635		GPS Location		37.3192762295847, -80.65784102265	
Description		J hook not staked 11089+12		Description		Top soil not stabilized . 11113+00 to 11111+00

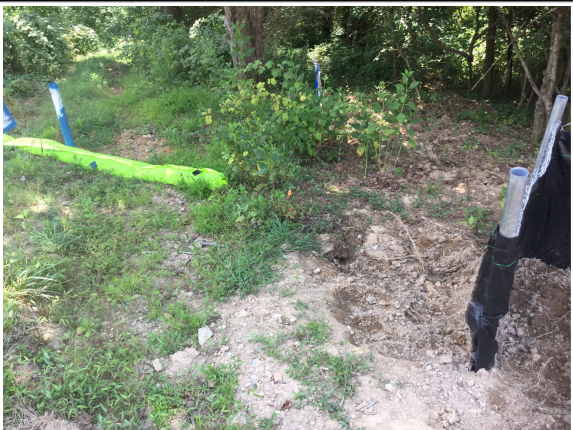
<b>A/E</b>	124300137	<b>Date/Time</b>	8/9/2018 5:52 PM	<b>Report #</b>	6133
<b>6. PCSM BMPs</b> (List BMPs and note if installed and maintained as per the plan. If corrective action is needed, a picture is required.)					
<b>PCSM BMPs</b>		<b>Compliance Level</b>	<b>Corrective Action</b>	<b>Corrective Time Frame</b>	
<b>7. Identify all remedial measures that have been taken since the previous inspection was conducted.</b>					
<b>Comments</b> (Reference above questions as appropriate.)					
Checked area from MP 209.4to 212.5 Winding way to Access road 245.01 off Brickyard Rd Station 11067+50 crew repairing outlet controls, added to punch list. Station 11082+00 j hook damaged and needs repair. Added to punch list. Station 11078+00 super silt fence short of farmers driveway access protected with waddles super silt needs extended, Added to punch list. 11113+00 to 11111+00 no straw or seed added to topsoil pile. Added to punch list. 11089+12 j hook not staked in ground added to punch list. 11194+50 outlet controls and sump not correct, added to punch list. No other issues in this area spread 9

GPS Location		37.3193159094428, -80.6580304541445		GPS Location		37.3192824186964, -80.6578331596547	
Description		Outlet and sump not correct added to punch list station 11194+50		Description		Gap in super silt fence to waddle at farmer access rd 11078+00
