# Visual Site Inspection Report

<b>Project Name</b>	H-600 Pipeline Spread G	<b>AFE</b>	124300137	<b>Spread</b>	H-600 Pipeline Spread G
<b>Contractor</b>	Precision			<b>Report #</b>	8038
<b>Inspector</b>	Timothy Watson			<b>Date/Time</b>	9/18/2018 9:57 AM
<b>Permit #</b>	TBD	<b>Inspection Type</b>	VA SWPP	<b>Station Begin</b>	10510+78
<b>State</b>	VA	<b>Inspection Area</b>	Partial	<b>Station End</b>	10883+50
<b>County</b>	Giles	<b>Ground</b>	Wet	<b>Temperature (°F)</b>	77.00
<b>Municipality</b>	N/A	<b>Weather</b>	Cloudy	<b>Rain Gauge (in)</b>	0.50
<b>GPS Location</b>	37.1193505098817, -80.6680094454508			<b>Rain Accumulation Time (days)</b>	1.00

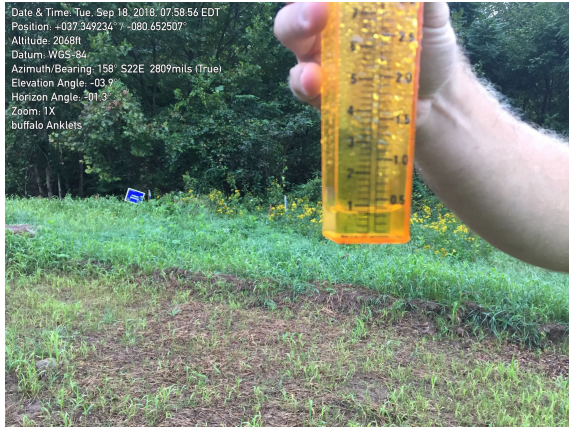
AFE	124300137	Date/Time	9/18/2018 9:57 AM	Report #	8038
Pictures					
<p>Date &amp; Time: Tue, Sep 18, 2018, 07:58:56 EDT Position: +037.349234° / -080.652507° Altitude: 2068ft Datum: WGS-84 Azimuth/Bearing: 158° S22E 2809mils (True) Elevation Angle: -03.9° Horizon Angle: -01.3° Zoom: 1X buffalo Anklets</p>

GPS Location	37.1191747149549, -80.6680562887647	GPS Location	37.1191747149549, -80.6680562887647		
Description	Buffalo Anklets Rain Gauge .5 over night	Description	Access 234 rain gauge over night .25 Mp 199		
<p>Date &amp; Time: Tue, Sep 18, 2018, 08:08:12 EDT Position: +037.349172° / -080.685217° Altitude: 2068ft Datum: WGS-84 Azimuth/Bearing: 120° S40E 4133mils (True) Elevation Angle: +04.7° Horizon Angle: +00.8° Zoom: 1X buffalo Anklets</p>

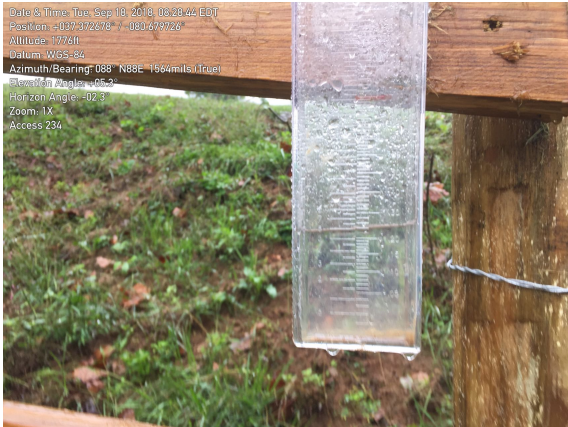
<p>Date &amp; Time: Tue, Sep 18, 2018, 08:28:44 EDT Position: +037.372478° / -080.679726° Altitude: 1776ft Datum: WGS-84 Azimuth/Bearing: 088° N88E 1564mils (True) Elevation Angle: -05.2° Horizon Angle: -02.3° Zoom: 1X Access 234</p>

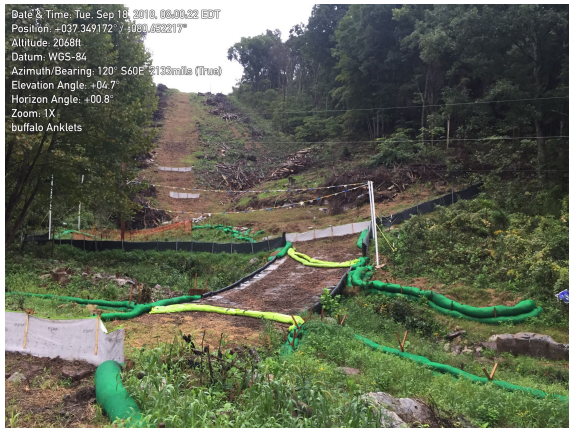
GPS Location	37.1191747149549, -80.6680562887647	GPS Location	37.1191747149549, -80.6680562887647		
Description	Buffalo Anklets at stream and area above stream S G32 MP 205.5	Description	Access 237 some rutting on road by gravel movement		
<p>Date &amp; Time: Tue, Sep 18, 2018, 08:08:26 EDT Position: +037.348601° / -080.647562° Altitude: 2312ft Datum: WGS-84 Azimuth/Bearing: 108° S72E 1920mils (True) Elevation Angle: +07.0° Horizon Angle: -02.0° Zoom: 1X buffalo Anklets</p>

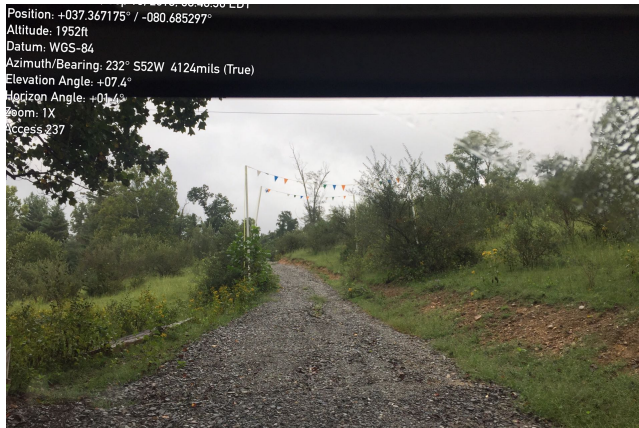
<p>Position: +037.367175° / -080.685297° Altitude: 1952ft Datum: WGS-84 Azimuth/Bearing: 232° S52W 4124mils (True) Elevation Angle: +07.4° Horizon Angle: +01.4° Zoom: 1X Access 237</p>

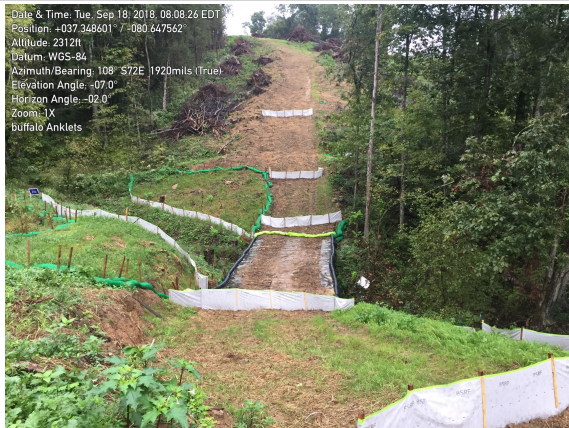
GPS Location	37.3475738926623, -80.6073855423253	GPS Location	37.3475780266361, -80.6073875979423		
Description	Buffalo Anklets and Row stream S G33 no Issues MP 205.6	Description	Access 236 no issues

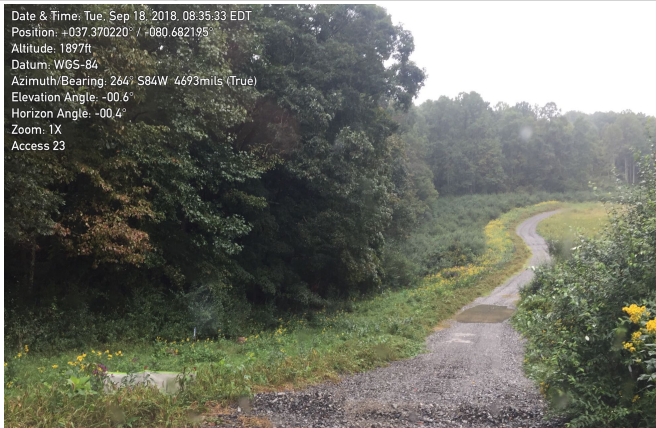
<p>Date &amp; Time: Tue, Sep 18, 2018, 08:35:33 EDT Position: +037.370220° / -080.682195° Altitude: 1897ft Datum: WGS-84 Azimuth/Bearing: 284° S84W 4693mils (True) Elevation Angle: -00.6° Horizon Angle: -00.4° Zoom: 1X Access 23</p>
