# Visual Site Inspection Report

<b>Project Name</b>	H-600 Pipeline Spread G	<b>AFE</b>	124300137	<b>Spread</b>	H-600 Pipeline Spread G
<b>Contractor</b>	Precision			<b>Report #</b>	8313
<b>Inspector</b>	Timothy Watson			<b>Date/Time</b>	9/24/2018 11:39 AM
<b>Permit #</b>	TBD	<b>Inspection Type</b>	VA SWPP	<b>Station Begin</b>	10510+78
<b>State</b>	VA	<b>Inspection Area</b>	Partial	<b>Station End</b>	10929+40
<b>County</b>	Giles	<b>Ground</b>	Damp	<b>Temperature (°F)</b>	66.00
<b>Municipality</b>	N/A	<b>Weather</b>	Cloudy	<b>Rain Gauge (in)</b>	0.00
<b>GPS Location</b>	37.34361105529, -80.7602635946162			<b>Rain Accumulation Time (days)</b>	1.00

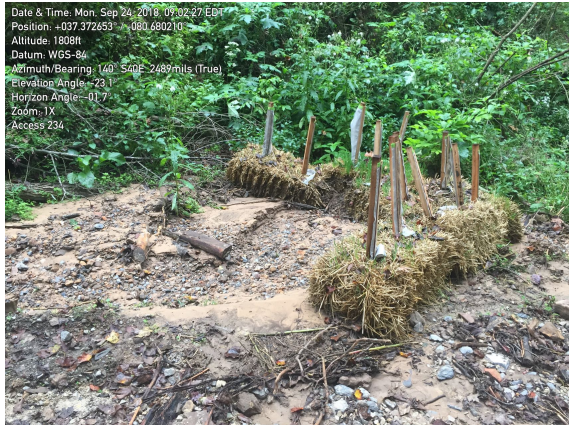
GPS Location	37.34361105529, -80.7602635946162	GPS Location	37.34361105529, -80.7602635946162		
Description	Access 234 And hay bales placed have sediment before stream along Access 234	Description	Access 238 and yard 29 crew repaired filter sock damage by drive		
<p>PREF MAP 09/24/18 09:29:47 LOG</p>

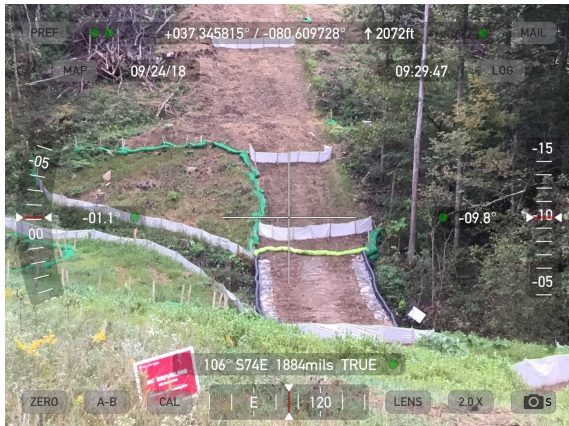
GPS Location	37.34361105529, -80.7602635946162	GPS Location	37.34361105529, -80.7602635946162		
Description	Buffalo Anklets Rd and Row station 10712+00 Stream S G33	Description	Berm repaired after Saturday rain event yard 37		
<p>Date &amp; Time: Mon, Sep 24, 2018, 10:14:18 EDT Position: +037.415732° / -080.44506° Altitude: 1361ft Datum: WGS-84 Azimuth/Bearing: 238° S 56° W 4196mils (True) Elevation Angle: -01.2° Horizon Angle: -00.5° Zoom: 4X yard 37</p>

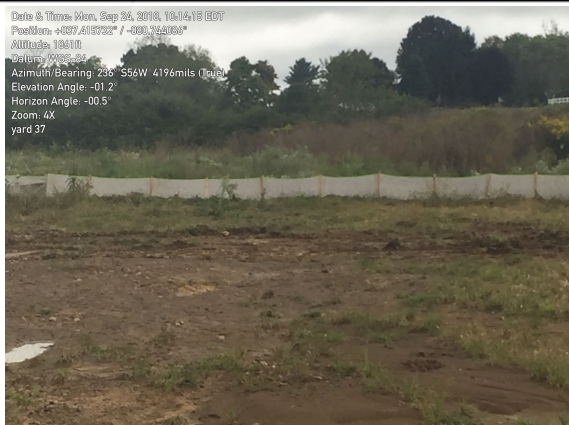
GPS Location	37.34361105529, -80.7602635946162	GPS Location	37.34361105529, -80.7602635946162		
Description	Yard 37 repaired damaged P1 replaced	Description	Kow Camp Rd. 2 stream S A33
