# Visual Site Inspection Report

<b>Project Name</b>	H-600 Pipeline Spread G		<b>AFE</b>	124300137	<b>Spread</b>	H-600 Pipeline Spread G	
<b>Contractor</b>	Precision				<b>Report #</b>	2360	
<b>Inspector</b>	Trey Ingram				<b>Date/Time</b>	5/29/2018 3:00 PM	
<b>Permit #</b>	TBD	<b>Inspection Type</b>	VA SWPP		<b>Station Begin</b>	12000+00	
<b>State</b>	VA	<b>Inspection Area</b>	Full		<b>Station End</b>	11800+00	
<b>County</b>	Montgomery	<b>Ground</b>	Muddy		<b>Temperature (°F)</b>	72.00	
<b>Municipality</b>	N/A	<b>Weather</b>	Cloudy		<b>Rain Gauge (in)</b>	0.15	
<b>GPS Location</b>	37.2776210541253, -80.3334238194677				<b>Rain Accumulation Time (days)</b>	1.00

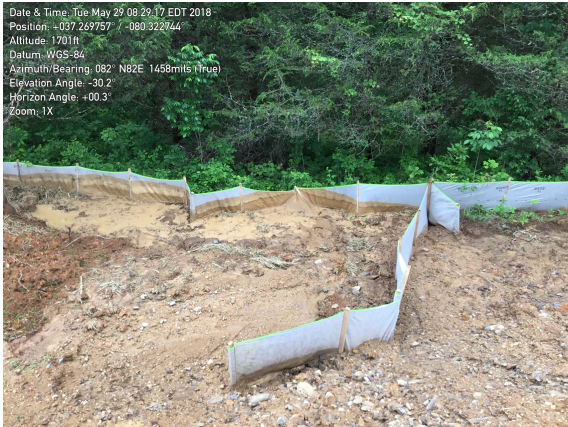
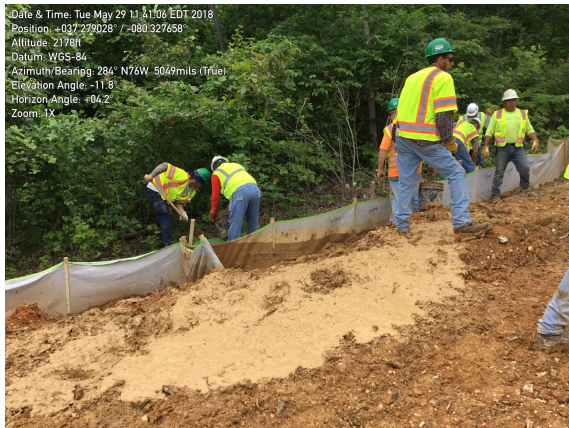
GPS Location	37.2639123676692, -80.4145163019005	GPS Location	37.2639632877309, -80.4145271145556		
Description	Plung pool cleaned out and new stone added. Coordinates located in picture above	Description	Water over topped ECDs. Coordinates located in picture above		
<p>Date &amp; Time: Tue May 29 11:11:06 EDT 2018 Position: +037.270028° / -080.326658° Altitude: 2178ft Datum: WGS-84 Azimuth/Bearing: 284° N76W 5049mils (True) Elevation Angle: -11.8° Horizon Angle: +04.2° Zoom: 1X</p>

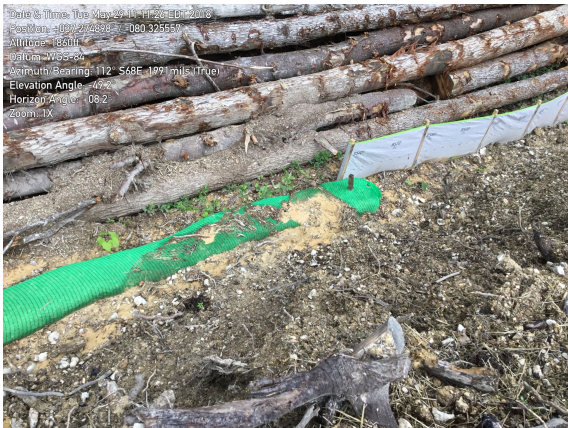
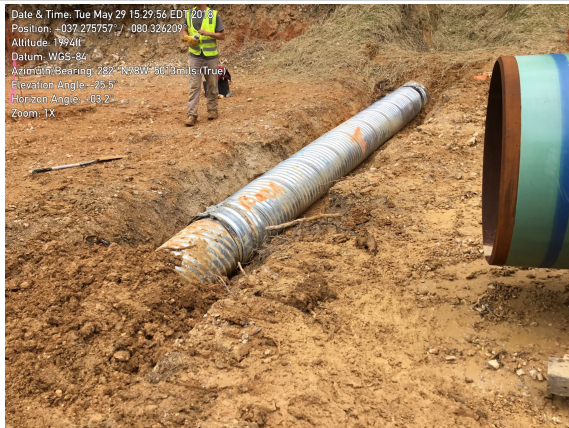
GPS Location	37.2639813507323, -80.4146165494625	GPS Location	37.2640167223637, -80.4143251945082		
Description	Crew reclaiming off row sediment. Coordinates located in picture above	Description	Sock needing maintenance. Coordinates located in picture above		
<p>Date &amp; Time: Tue May 29 15:29:56 EDT 2018 Position: +037.275757° / -080.326209° Altitude: 1994ft Datum: WGS-84 Azimuth/Bearing: 282° N76W 5049mils (True) Elevation Angle: -15.5° Horizon Angle: +03.2° Zoom: 1X</p>

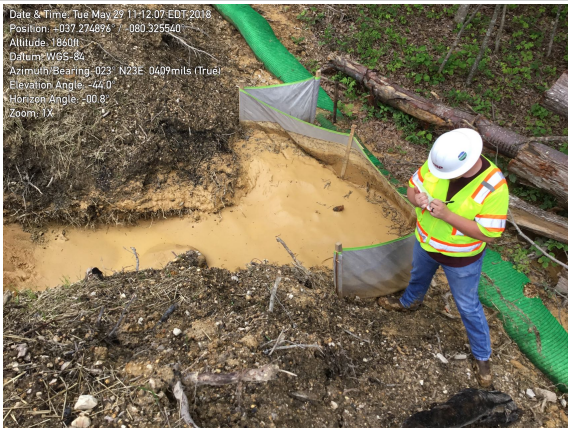
GPS Location	37.2639709990819, -80.4144747276608	GPS Location	37.2639709990819, -80.4144747276608		
Description	Clean water diversion pipe repaired. Coordinates located in picture above	Description	Water breaker end treatments full of sediment. Coordinates located in picture above
