# Visual Site Inspection Report

<b>Project Name</b>	H-600 Pipeline Spread G		<b>AFE</b>	124300137	<b>Spread</b>	H-600 Pipeline Spread G	
<b>Contractor</b>	Precision				<b>Report #</b>	2631	
<b>Inspector</b>	Trey Ingram				<b>Date/Time</b>	6/4/2018 12:29 PM	
<b>Permit #</b>	TBD	<b>Inspection Type</b>	VA SWPP		<b>Station Begin</b>	11900+00	
<b>State</b>	VA	<b>Inspection Area</b>	Full		<b>Station End</b>	11980+00	
<b>County</b>	Montgomery	<b>Ground</b>	Dry		<b>Temperature (°F)</b>	75.00	
<b>Municipality</b>	N/A	<b>Weather</b>	Sunny		<b>Rain Gauge (in)</b>	0.00	
<b>GPS Location</b>	37.2435958895403, -80.3673614598188				<b>Rain Accumulation Time (days)</b>	1.00

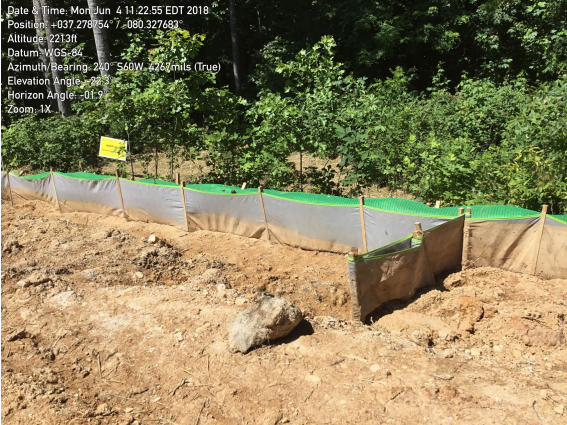
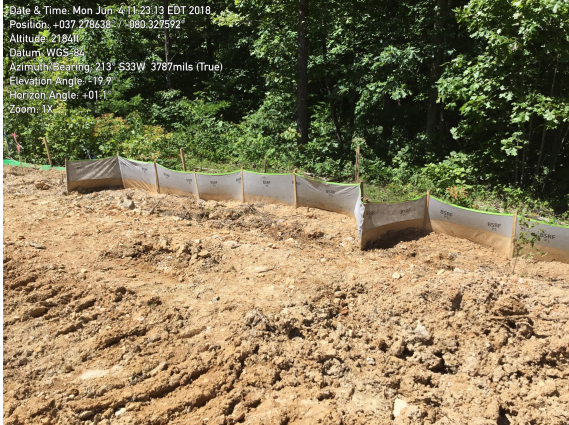
<b>GPS Location</b>	37.2435202123635, -80.3671131660213	<b>GPS Location</b>	37.2437066925579, -80.3673684426208		
<b>Description</b>	Filter sock in good working condition. Coordinates located in picture above	<b>Description</b>	Filter sock in good working condition. Coordinates located in picture above.

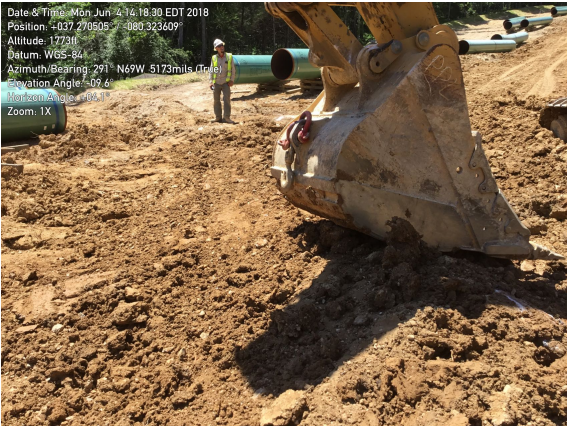
<b>GPS Location</b>	37.2700291034181, -80.3230552376065	<b>GPS Location</b>	37.2700291034181, -80.3230552376065		
<b>Description</b>	Crew reworking water breakers. Coordinates located in picture above	<b>Description</b>	Plung pool in good working condition. Coordinates located in picture above

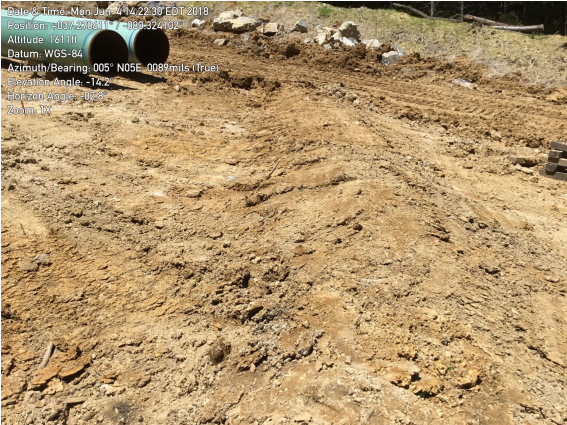
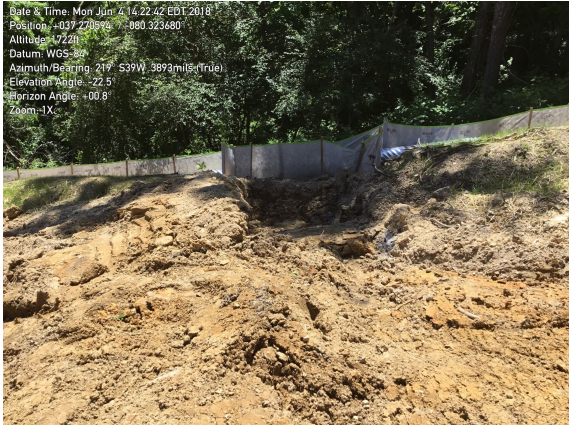
<b>GPS Location</b>	37.2700291034181, -80.3230552376065	<b>GPS Location</b>	37.2700291034181, -80.3230552376065		
<b>Description</b>	Water breaker. Coordinates located in picture above	<b>Description</b>	Water breaker end treatment and sump clear of sediment. Coordinates located in picture above
