Visual Site Inspection Report

Project Name	H-600 Pipeline Spread G	AFE	124300137	Spread	H-600 Pipeline Spread G
Contractor	Precision			Report #	3069
Inspector	Trey Ingram			Date/Time	6/14/2018 2:07 PM
Permit #	TBD	Inspection Type	VA SWPP	Station Begin	11900+00
State	VA	Inspection Area	Full	Station End	11980+00
County	Montgomery	Ground	Dry	Temperature (°F)	80.00
Municipality	N/A	Weather	Sunny	Rain Gauge (in)	0.00
GPS Location	37.2805810813208, -80.3305607289824			Rain Accumulation Time (days)	1.00

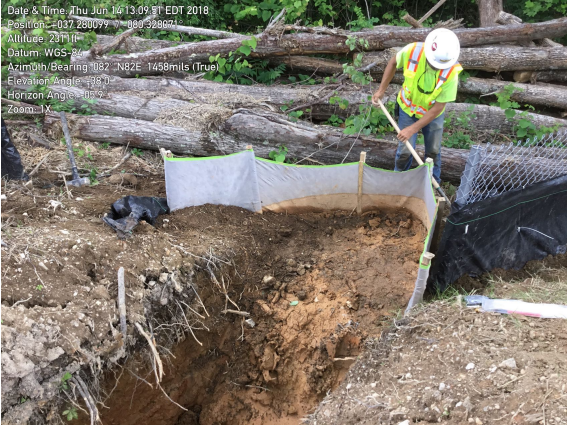
GPS Location	37.2804273153071, -80.3305635788295	GPS Location	37.2805721126844, -80.3303598985824		
Description	Reworking end treatments on water breakers. Coordinates located in picture above	Description	Super silt fence in good working condition. Coordinates located in picture above

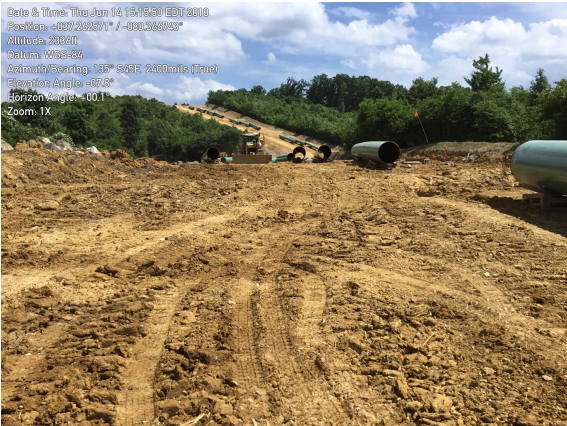
GPS Location	37.2849999787633, -80.3324068431559	GPS Location	37.2804968851034, -80.3304970265183		
Description	Water breaker in good working condition. Coordinates located in picture above	Description	ECDs in good condition		
<p>Insert image here</p>		<p>Insert image here</p>			
GPS Location		GPS Location			
Description		Description
