# Visual Site Inspection Report

| <b>Project Name</b> | H-600 Pipeline Spread G | <b>AFE</b> | 124300137 | <b>Spread</b> | H-600 Pipeline Spread G |
| <b>Contractor</b> | Precision | | | <b>Report #</b> | 3323 |
| <b>Inspector</b> | Trey Ingram | | | <b>Date/Time</b> | 6/20/2018 4:12 PM |

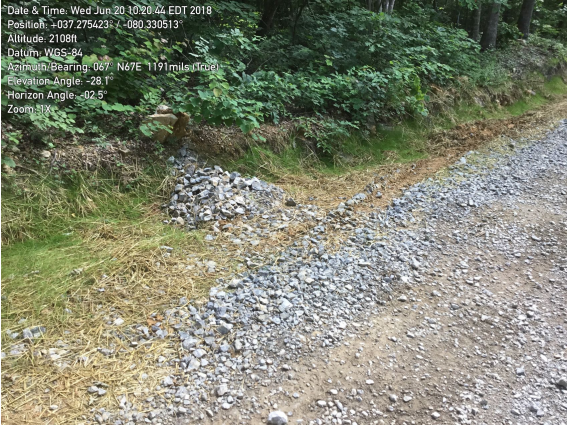
| <b>Description</b> | Rock checks in good condition. Coordinates located in picture above | <b>Description</b> | P1 in good condition. Coordinates located in picture above | | |

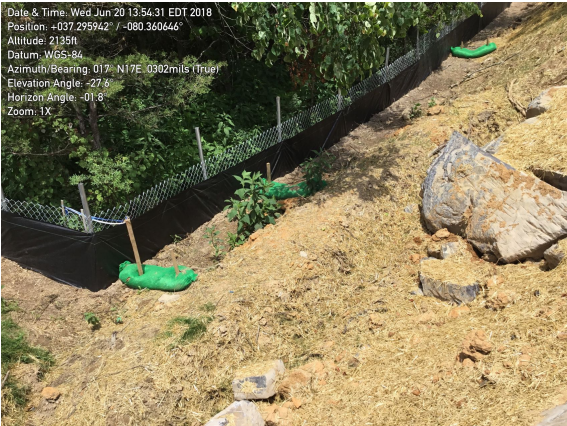
| <b>Description</b> | Super silt fence in good condition. | <b>Description</b> | Super silt fence in good condition | | |
