Visual Site Inspection Report

Project Name	H-600 Pipeline Spread G	AFE	124300137	Spread	H-600 Pipeline Spread G
Contractor	Precision			Report #	3940
Inspector	Trey Ingram			Date/Time	7/2/2018 9:55 AM
Permit #	TBD	Inspection Type	VA SWPP	Station Begin	12005+00
State	VA	Inspection Area	Partial	Station End	11788+00
County	Montgomery	Ground	Dry	Temperature (°F)	90.00
Municipality	N/A	Weather	Sunny	Rain Gauge (in)	0.00
GPS Location	37.2875818983068, -80.337943844572			Rain Accumulation Time (days)	1.00

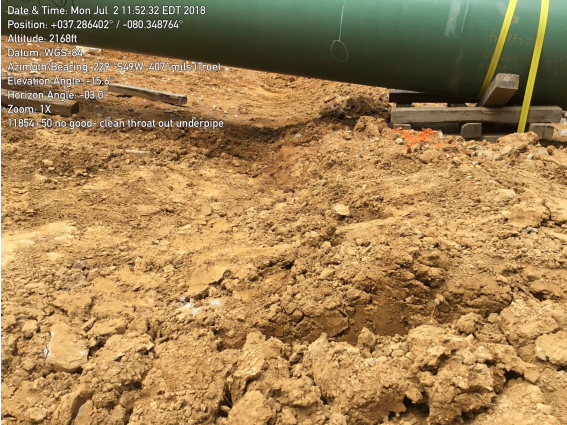
A/E	124300137	Date/Time	7/2/2018 9:55 AM	Report #	3940
Pictures					
<p>Date & Time: Mon Jul 2 11:52:32 EDT 2018 Position: +037.286402° / -080.348764° Altitude: 2168ft Datum: WGS-84 Azimuth/Bearing: 229° S69W 4071mils (True) Elevation Angle: +15.4° Horizon Angle: -03.0° Zoom: 1X 11854+00 no good- clean throat out underpipe</p>

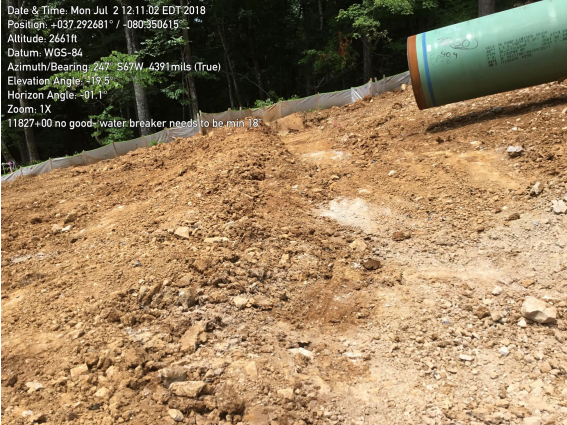
<p>Date & Time: Mon Jul 2 12:11:02 EDT 2018 Position: +037.292681° / -080.350615° Altitude: 2661ft Datum: WGS-84 Azimuth/Bearing: 247° S67W 4391mils (True) Elevation Angle: +19.5° Horizon Angle: -01.1° Zoom: 1X 11827+00 no good- water breaker needs to be min 18"</p>

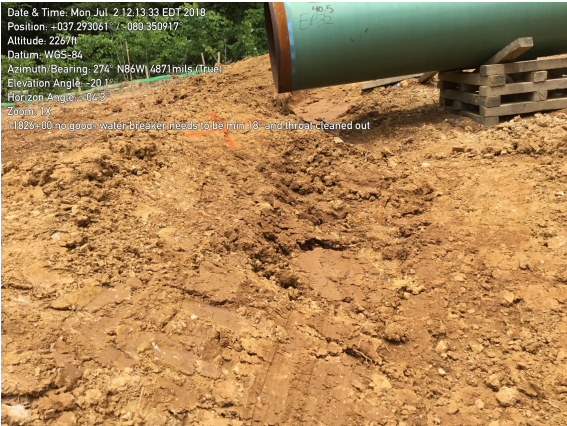
GPS Location	37.2879474168998, -80.2937624764546	GPS Location	37.2694963077743, -80.3255682159963		
Description	Water breaker before maintenance. Location located in picture above	Description	Water breaker before maintenance. Location located in picture above		
<p>Date & Time: Mon Jul 2 12:13:33 EDT 2018 Position: +037.292061° / -080.350917° Altitude: 2277ft Datum: WGS-84 Azimuth/Bearing: 274° N86W 4871mils (True) Elevation Angle: +20.1° Horizon Angle: -06.3° Zoom: 1X 11826+00 no good- water breaker needs to be min 18" and throat cleaned out</p>

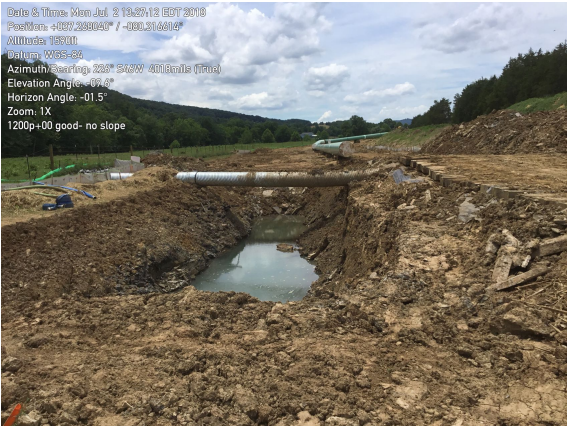
<p>Date & Time: Mon Jul 2 12:39:13 EDT 2018 Position: +037.269494° / -080.321660° Altitude: 1570ft Datum: WGS-84 Azimuth/Bearing: 228° S45W 4016mils (True) Elevation Angle: -07.6° Horizon Angle: -01.5° Zoom: 1X 1200p+00 good- no slope</p>

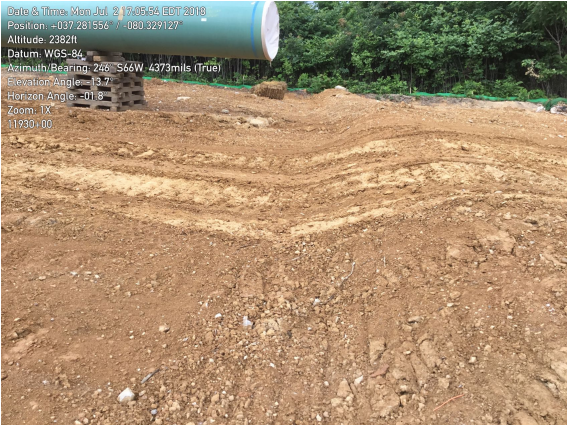
GPS Location	37.2772407671784, -80.332668609992	GPS Location	37.2772023361523, -80.3330616374317		
Description	Water breaker built to specs	Description	End treatment in good condition
