# Visual Site Inspection Report

<b>Project Name</b>	H-600 Pipeline Spread G	<b>AFE</b>	124300137	<b>Spread</b>	H-600 Pipeline Spread G
<b>Contractor</b>	Precision			<b>Report #</b>	4471
<b>Inspector</b>	Trey Ingram			<b>Date/Time</b>	7/12/2018 2:34 PM
<b>Permit #</b>	TBD	<b>Inspection Type</b>	VA SWPP	<b>Station Begin</b>	12005+00
<b>State</b>	VA	<b>Inspection Area</b>	Partial	<b>Station End</b>	11900+00
<b>County</b>	Montgomery	<b>Ground</b>	Dusty	<b>Temperature (°F)</b>	85.00
<b>Municipality</b>	N/A	<b>Weather</b>	Sunny	<b>Rain Gauge (in)</b>	0.00
<b>GPS Location</b>	37.2881672904243, -80.333900330663			<b>Rain Accumulation Time (days)</b>	1.00

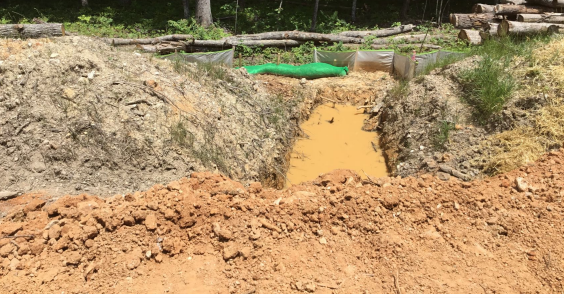
GPS Location	37.2881459584807, -80.3338872548941			GPS Location	37.2881459584807, -80.3338872548941
Description	End treatment in good condition			Description	ECDs protecting Karst
<div data-bbox="167 785 381 915"> Date &amp; Time: Thu Jul 12 14:34:48 EDT 2018  Position: +037.287943° / -080.333497°  Altitude: 2303ft  Datum: WGS-84  Azimuth/Bearing: 094° S86E 1671mils (True)  Elevation Angle: -13.8°  Horizon Angle: -01.3°  Zoom: 1X  11907+00 </div>  			<div data-bbox="865 785 1079 915"> Date &amp; Time: Thu Jul 12 14:34:22 EDT 2018  Position: +037.281585° / -080.329695°  Altitude: 2347ft  Datum: WGS-84  Azimuth/Bearing: 207° S27W 3680mils (True)  Elevation Angle: -10.4°  Horizon Angle: -01.7°  Zoom: 1X  AR266 </div>

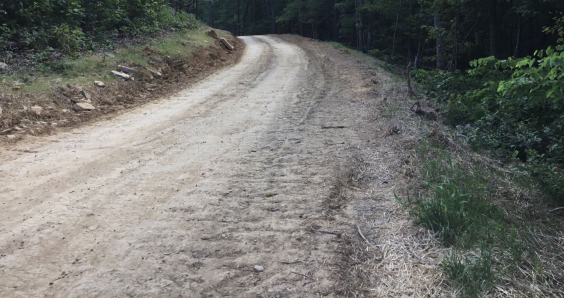
GPS Location	37.2881459584807, -80.3338872548941			GPS Location	37.2881459584807, -80.3338872548941
Description	Water breaker in good condition			Description	AR266
<div data-bbox="342 1560 553 1591">Insert image here</div>			<div data-bbox="1044 1560 1255 1591">Insert image here</div>		
GPS Location				GPS Location	
Description				Description
