Visual Site Inspection Report

Project Name	H-600 Pipeline Spread G	AFE	124300137	Spread	H-600 Pipeline Spread G
Contractor	Precision			Report #	5737
Inspector	Trey Ingram			Date/Time	8/3/2018 11:05 AM
Permit #	TBD	Inspection Type	VA SWPP	Station Begin	12005+00
State	VA	Inspection Area	Partial	Station End	11788+00
County	Montgomery	Ground	Wet	Temperature (°F)	75.00
Municipality	N/A	Weather	Light Rain	Rain Gauge (in)	2.10
GPS Location	37.3423073022043, -80.6769178156561			Rain Accumulation Time (days)	2.00

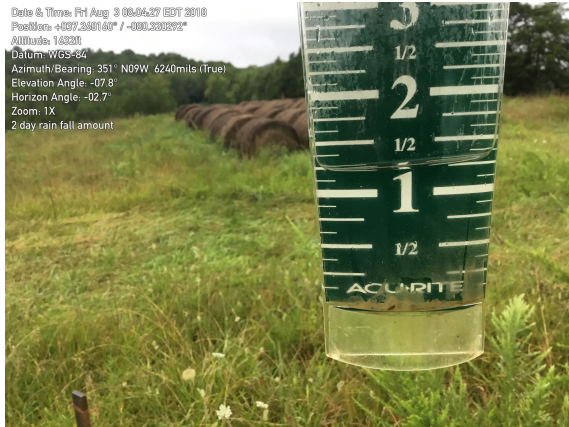
A/E	124300137	Date/Time	8/3/2018 11:05 AM	Report #	5737
Pictures					
<p>Date & Time: Fri Aug 3 08:56:27 EDT 2018 Position: +037.268160° / -080.320296° Altitude: 1632ft Datum: WGS-84 Azimuth/Bearing: 351° N09W 6240mils (True) Elevation Angle: -07.8° Horizon Angle: -02.7° Zoom: 1X 2 day rain fall amount</p>

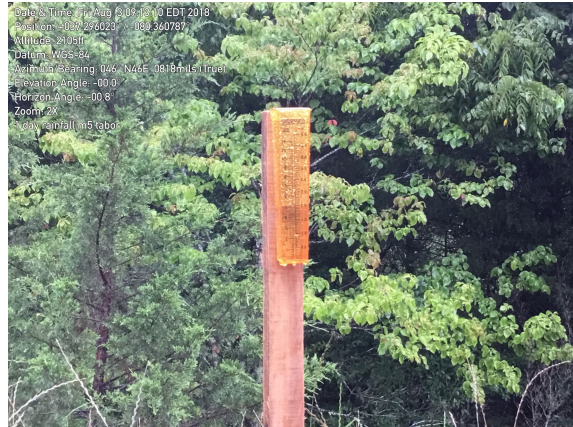
<p>Date & Time: Fri Aug 3 08:15:40 EDT 2018 Position: +037.268230° / -080.360787° Altitude: 1655ft Datum: WGS-84 Azimuth/Bearing: 000° N44E 0818mils (True) Elevation Angle: -00.8° Horizon Angle: -00.8° Zoom: 1X Rain gauge Mt tabor</p>

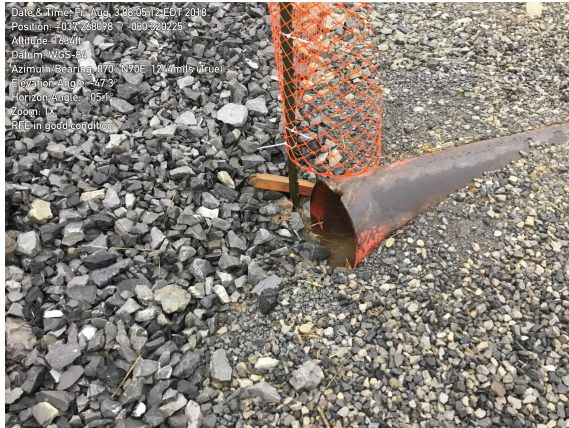
<p>Date & Time: Fri Aug 3 08:05:47 EDT 2018 Position: +037.268078° / -080.320296° Altitude: 1630ft Datum: WGS-84 Azimuth/Bearing: 176° S04E 3129mils (True) Elevation Angle: -15.3° Horizon Angle: -02.3° Zoom: 1X RFE in good condition</p>

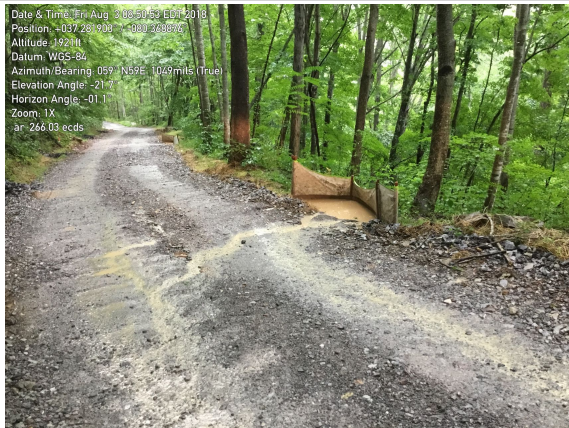
GPS Location	37.3421810707425, -80.6768817734725	GPS Location	37.3421810707425, -80.6768817734725		
Description	RFE AR266	Description	RCE Catawba		
<p>Date & Time: Fri Aug 3 08:50:53 EDT 2018 Position: +037.261905° / -080.268876° Altitude: 1921ft Datum: WGS-84 Azimuth/Bearing: 059° N59E 1049mils (True) Elevation Angle: -21.1° Horizon Angle: -01.1° Zoom: 1X ar 266.03 ecds</p>
