Visual Site Inspection Report

Project Name	H-600 Pipeline Spread G	AFE	124300137	Spread	H-600 Pipeline Spread G
Contractor	Precision			Report #	6387
Inspector	Trey Ingram			Date/Time	8/15/2018 5:31 PM
Permit #	TBD	Inspection Type	VA SWPP	Station Begin	12005+00
State	VA	Inspection Area	Partial	Station End	11766+00
County	Montgomery	Ground	Dry	Temperature (°F)	80.00
Municipality	N/A	Weather	Sunny	Rain Gauge (in)	0.00
GPS Location	37.3425393971031, -80.6767443102604			Rain Accumulation Time (days)	1.00

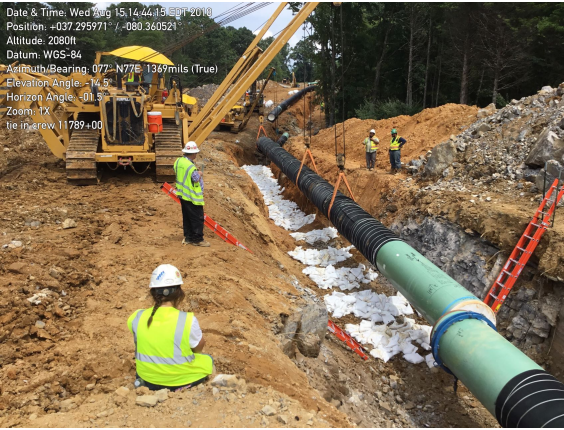
AFE	124300137	Date/Time	8/15/2018 5:31 PM	Report #	6387
Pictures					
<div><div><div>Date & Time: Wed Aug 15 14:44:15 EDT 2018 Position: +037.295971° / -080.360521° Altitude: 2080ft Datum: WGS-84 Azimuth/Bearing: 072° N77E 1369mils (True) Elevation Angle: -10.5° Horizon Angle: -01.5° Zoom: 1X Location: 11789+00</div>

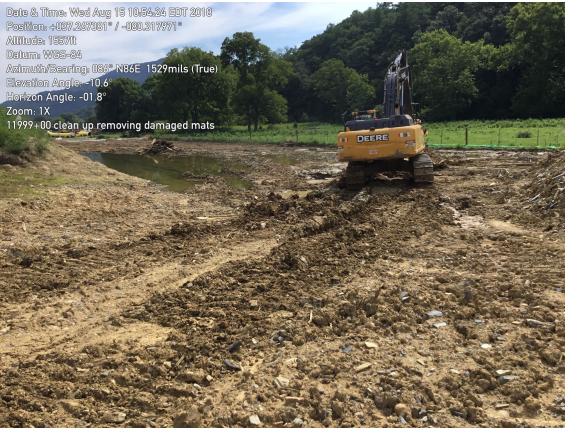
</div></div>			<div><div><div>Date & Time: Wed Aug 15 16:54:34 EDT 2018 Position: +037.267081° / -080.317971° Altitude: 1937ft Datum: WGS-84 Azimuth/Bearing: 081° N86E 1529mils (True) Elevation Angle: -10.4° Horizon Angle: -01.8° Zoom: 1X Location: 11999+00 clean up removing damaged mats</div>

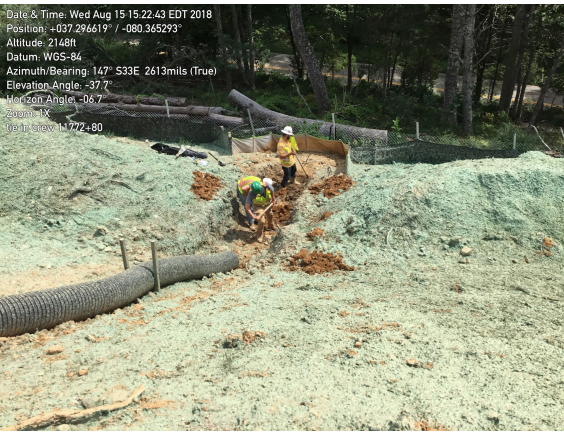
GPS Location	37.3422888201078, -80.6771805045015		GPS Location		
Description	Crew cleaning out sumps 11777+80		Description		
Insert image here			Insert image here		
GPS Location			GPS Location		
Description			Description
