# Visual Site Inspection Report

<b>Project Name</b>	H-600 Pipeline Spread G		<b>AFE</b>	124300137	<b>Spread</b>	H-600 Pipeline Spread G	
<b>Contractor</b>	Precision				<b>Report #</b>	7228	
<b>Inspector</b>	Trey Ingram				<b>Date/Time</b>	8/31/2018 5:11 PM	
<b>Permit #</b>	TBD	<b>Inspection Type</b>	VA SWPP		<b>Station Begin</b>	12005+00	
<b>State</b>	VA	<b>Inspection Area</b>	Full		<b>Station End</b>	11766+00	
<b>County</b>	Montgomery	<b>Ground</b>	Wet		<b>Temperature (°F)</b>	85.00	
<b>Municipality</b>	N/A	<b>Weather</b>	Sunny		<b>Rain Gauge (in)</b>	0.75	
<b>GPS Location</b>	37.3423003452246, -80.6770627387619				<b>Rain Accumulation Time (days)</b>	1.00

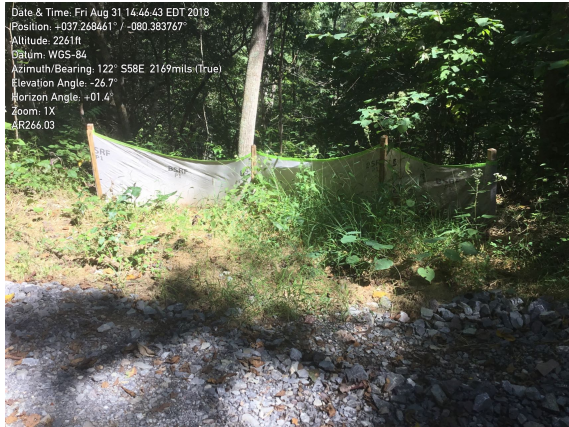
</div></div></div>			
GPS Location	37.3422957351779, -80.6770607271052		GPS Location	37.3421555897569, -80.6770449691272	
Description	ECDs on AR266.03		Description	Rain gauge Catawba .75"	
<div><div><div>Date &amp; Time: Fri Aug 31 09:13:40 EDT 2018 Position: +037 270481° / -080 327359° Altitude: 2179ft Datum: WGS-84 Azimuth/Bearing: 100° S80E 1778mils (True) Elevation Angle: -22.2° Horizon Angle: -03.7° Zoom: 1X 11942+00</div><div>

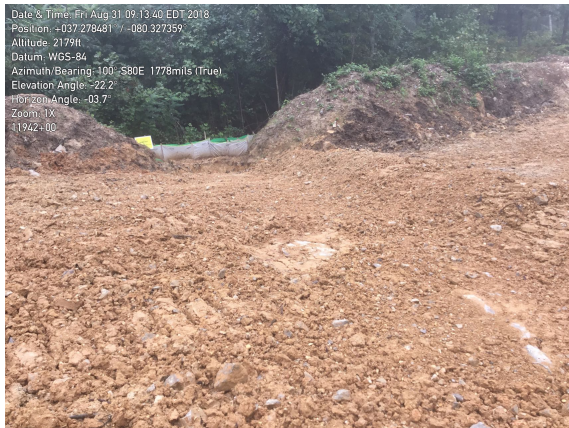
GPS Location	37.3422990041201, -80.6770076696581		GPS Location	37.3423016863292, -80.6770067476487	
Description	11942+00 end treatment in good condition		Description	Hydro seed on slope 11970+00	
<div><div><div>Date &amp; Time: Fri Aug 31 09:28:43 EDT 2018 Position: +037 264034° / -080 332709° Altitude: 1923ft Datum: WGS-84 Azimuth/Bearing: 051° N45E 1027mils (True) Elevation Angle: -27.1° Horizon Angle: -01.1° Zoom: 1X 11968+00</div><div>

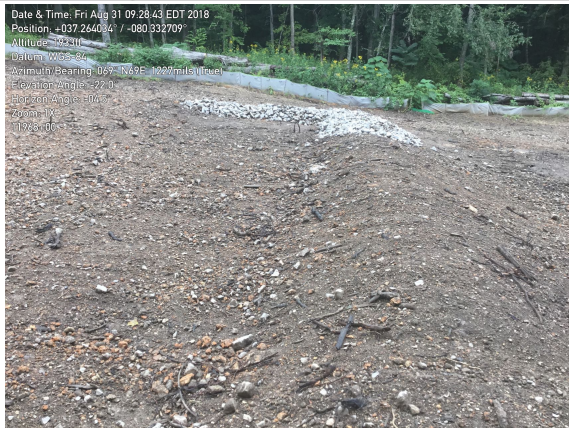
</div></div></div>			
GPS Location	37.3423032369812, -80.6769371778524		GPS Location	37.3422964895492, -80.6769723818457	
Description	Permanent water breaker 11968+00		Description	11976+00 row after rain event
