# Visual Site Inspection Report

<b>Project Name</b>	H-600 Pipeline Spread G	<b>AFE</b>	124300137	<b>Spread</b>	H-600 Pipeline Spread G
<b>Contractor</b>	Precision			<b>Report #</b>	8862
<b>Inspector</b>	Trey Ingram			<b>Date/Time</b>	10/4/2018 5:28 PM
<b>Permit #</b>	TBD	<b>Inspection Type</b>	VA SWPP	<b>Station Begin</b>	12005+00
<b>State</b>	VA	<b>Inspection Area</b>	Full	<b>Station End</b>	11766+00
<b>County</b>	Montgomery	<b>Ground</b>	Dry	<b>Temperature (°F)</b>	78.00
<b>Municipality</b>	N/A	<b>Weather</b>	Sunny	<b>Rain Gauge (in)</b>	0.00
<b>GPS Location</b>	37.3422697512781, -80.6767936796701			<b>Rain Accumulation Time (days)</b>	1.00

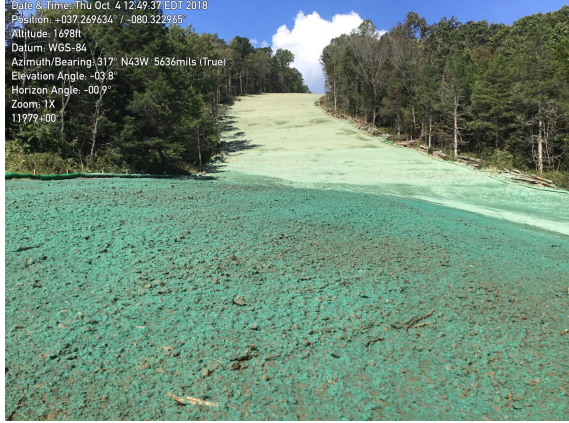
GPS Location	37.3421948589732, -80.6768817734725		GPS Location	37.3421948589732, -80.6768817734725	
Description	11979+00 slope hydroseeded		Description	ECDs around karst in good condition 11979+00	
<p>Date &amp; Time: Thu Oct 4 13:47:01 EDT 2018 Position: +037.294697° / -080.361506° Altitude: 1899ft Datum: WGS-84 Azimuth/Bearing: 76° S10E 3129mts (True) Elevation Angle: -03.0° Horizon Angle: -00.7° Zoom: 1X 11987+00</p>

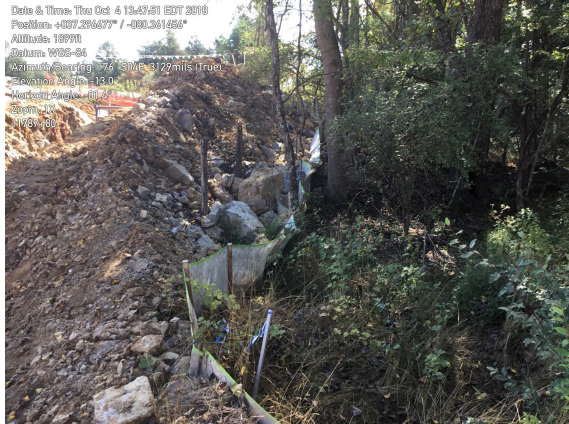
GPS Location	37.3422576813375, -80.6768932566798		GPS Location	37.3421948589732, -80.6768817734725	
Description	Damaged ECDs 11787+00		Description	Damaged ECDs 11787+00	
<p>Date &amp; Time: Thu Oct 4 15:32:43 EDT 2018 Position: +037.295912° / -080.360918° Altitude: 2130ft Datum: WGS-84 Azimuth/Bearing: 344° N10W 5816mts (True) Elevation Angle: -08.5° Horizon Angle: +00.3° Zoom: 1X 11788+00</p>

<b>A/E</b>	124300137	<b>Date/Time</b>	10/4/2018 5:28 PM	<b>Report #</b>	8862
<b>6. PCSM BMPs</b> (List BMPs and note if installed and maintained as per the plan. If corrective action is needed, a picture is required.)					
<b>PCSM BMPs</b>	<b>Compliance Level</b>	<b>Corrective Action</b>	<b>Corrective Time Frame</b>	<b>Date Repaired</b>	
<b>7. Identify all remedial measures that have been taken since the previous inspection was conducted.</b> 2 PARs wrote at 11950+00 and 11941+00 due to sediment off row near karst area.- completed Other Notable areas of concern from last swppp- 11930+00 P1 on end treatment undermined/sump full-complete All Sediment build up on sock on both sides of LOD-completed Triple stacked sock recommended on J hook to protect karst-competed P1 undermined near karst area and sediment off row, recommending upgraded ecds Sock overwhelmed near karst area and sediment off row, recommending upgraded ecds Super silt fence undermined-completed 11787+00 top soil slipping re-stabilize topsoil-completed

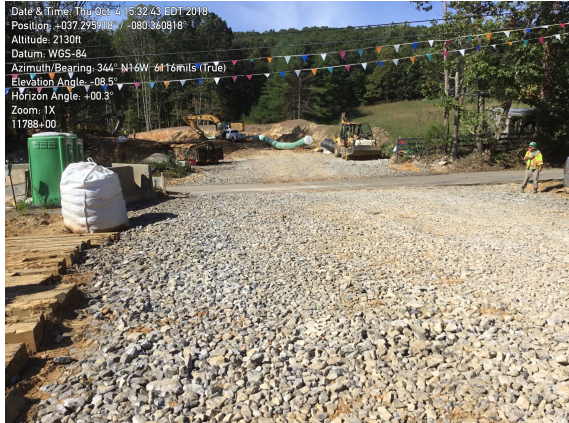
GPS Location	37.3422697512781, -80.6767936796701		GPS Location	37.3422599863609, -80.6768768281496	
Description	RCE in good condition 11788+00		Description	P1 in good condition 11788+00
