Visual Site Inspection Report

Project Name	H-600 Pipeline Spread H	AFE	124300138	Spread	H-600 Pipeline Spread H
Contractor	Precision			Report #	1783
Inspector	Dawn McCullough			Date/Time	5/15/2018 8:16 PM
Permit #	TBD	Inspection Type	Weekly	Station Begin	12993+76
State	VA	Inspection Area	Partial	Station End	13063+10
County	Franklin	Ground	Dry	Temperature (°F)	86.00
Municipality	N/A	Weather	Cloudy	Rain Gauge (in)	0.00
GPS Location	37.2732683236671, -80.0573624693055			Rain Accumulation Time (days)	0.00

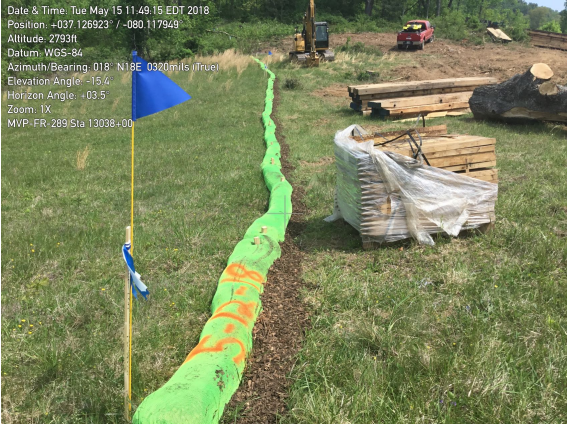
GPS Location	37.273259523419, -80.0573416746377	GPS Location	37.2732279650119, -80.0572191054232		
Description	Please see photo for coordinates. CFS installed at Sta 13038+00.	Description	Please see photo for coordinates. Timber mats to be installed at W-B24 adjacent to US HWY 221 (Sta 12994+02).		
<p>Date & Time: Tue May 15 14:57:14 EDT 2018 Position: +037.133708° / -080.130049° Altitude: 2666ft Datum: WGS-84 Azimuth/Bearing: 113° S67E 2009mils (True) Elevation Angle: -03.9° Horizon Angle: -02.2° Zoom: 1X MVP-FR-290</p>

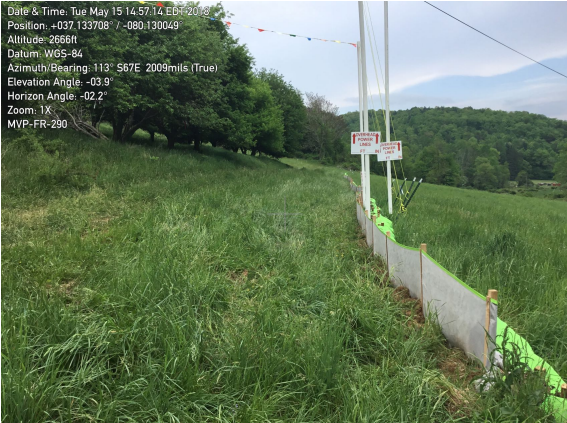
GPS Location	37.2732281795112, -80.057218350681	GPS Location	37.273367515526, -80.0574115677124		
Description	Please see photo for coordinates. CFS and Silt fence installed along MVP-FR-290.	Description	Please see photo for coordinates. Mat bridge installation across S-G26 (Sta 13061+89)
