Visual Site Inspection Report

Project Name	H-600 Pipeline Spread H	AFE	124300138	Spread	H-600 Pipeline Spread H
Contractor	Precision			Report #	2189
Inspector	Dawn McCullough			Date/Time	5/24/2018 7:19 PM
Permit #	TBD	Inspection Type	VA SWPP	Station Begin	+00
State	VA	Inspection Area	Full	Station End	+00
County	Montgomery	Ground	Damp	Temperature (°F)	83.00
Municipality	N/A	Weather	Sunny	Rain Gauge (in)	1.10
GPS Location	37.2731926516421, -80.0571205484035			Rain Accumulation Time (days)	4.00

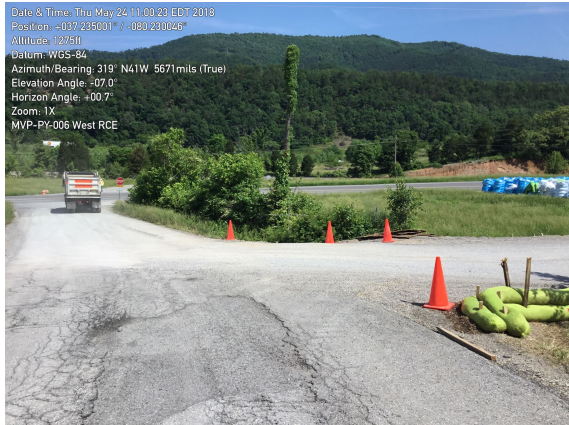
A/E	124300138	Date/Time	5/24/2018 7:19 PM	Report #	2189
Pictures					
<p>Date & Time: Thu May 24 11:00:23 EDT 2018 Position: +037.235001° / -080.230046° Altitude: 1258ft Datum: WGS-84 Azimuth/Bearing: 319° N41W 5671mils (True) Elevation Angle: +07.0° Horizon Angle: +00.7° Zoom: 1X MVP-PY-006 West RCE</p>

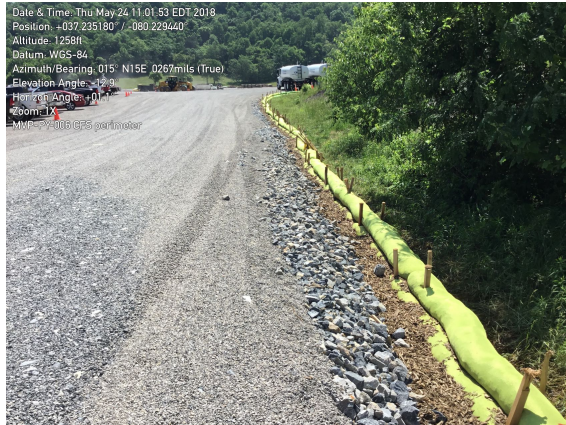
<p>Date & Time: Thu May 24 11:01:53 EDT 2018 Position: +037.235180° / -080.229440° Altitude: 1258ft Datum: WGS-84 Azimuth/Bearing: 015° N15E 0267mils (True) Elevation Angle: +0.9° Horizon Angle: +0.0° Zoom: 1X MVP-PY-006 GPS perimeter</p>

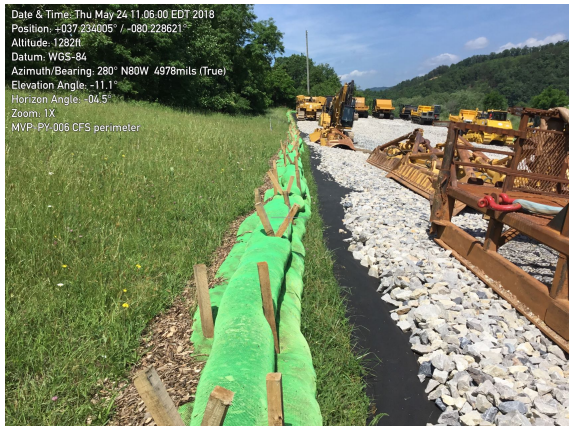
GPS Location	37.2731610398702, -80.0570231212204		GPS Location	37.2732021751792, -80.0570283064877	
Description	Please see photo for coordinates. MVP-PY-006, NW RCE.		Description	Please see photo for coordinates. MVP-PY-006, NW RCE, stacked CFS along edge of LOD.	
<p>Date & Time: Thu May 24 11:06:00 EDT 2018 Position: +037.234005° / -080.228521° Altitude: 1282ft Datum: WGS-84 Azimuth/Bearing: 280° N80W 4978mils (True) Elevation Angle: -11.1° Horizon Angle: -04.5° Zoom: 1X MVP-PY-006 CFS perimeter</p>

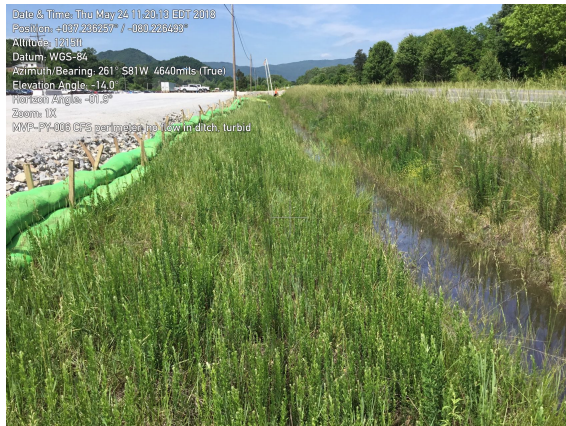
<p>Date & Time: Thu May 24 11:06:10 EDT 2018 Position: +037.233537° / -080.228437° Altitude: 1303ft Datum: WGS-84 Azimuth/Bearing: 261° S81W 4640mils (True) Elevation Angle: -14.0° Horizon Angle: -01.5° Zoom: 1X MVP-PY-006 CFS perimeter, low in ditch, turbid</p>

7. Identify all remedial measures that have been taken since the previous inspection was conducted. Additional compost filter sock was installed along the northern limit of disturbance when storm water was noted to be carrying limestone fines through the initial row of triple stacked 12" compost filter sock. This has since allowed the storm water to exit the site clear.					
Comments (Reference above questions as appropriate.) Attended morning inspectors meeting for Spread H. Discussed daily activities with Lead EI Randy Clark and EI team. Drove to MVP-PY-006. Performed site inspection of MVP-PY-006. Two RCE entrances have been installed by PPL. Rain events during the week have caused flow in the roadside ditch along North Fork Road. The RCE flume was functioning acceptably. ECDs have been installed per site E&S Plan throughout the site. Four small holes were noted in CFSs, one near W-008. These are superficial tears and the BMP remains stable and functional at this time. No off LOD impacts were observed. Standing water was observed in various locations along the north perimeter of the site, with no sediment or debris observed outside of LOD. Equipment stored and used on site inspected for leaks and dirt. No issues noted with equipment. Port-o-johns installed per E&S Plan within secondary containment. No fuel storage area has been established to date. No other environmental concerns were noted during today's inspection.

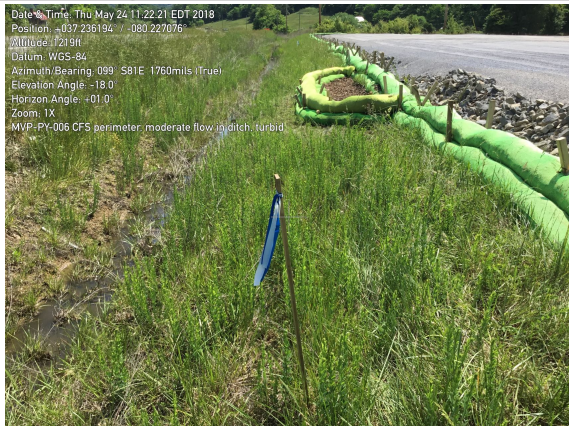
GPS Location	37.2732033743056, -80.0570269844252		GPS Location	37.2732034210127, -80.0570269329296	
Description	Please see photo for coordinates. MVP-PY-006, south perimeter stacked CFS and equip, net storage area.		Description	Please see photo for coordinates. MVP-PY-006, roadside ditch along North Fork Road and CFS inside LOD.	
<p>Date & Time: Thu May 24 11:22:21 EDT 2018 Position: +037.236194° / -080.227076° Altitude: 1209ft Datum: WGS-84 Azimuth/Bearing: 099° S81E 1760mils (True) Elevation Angle: -18.0° Horizon Angle: +01.0° Zoom: 1X MVP-PY-006 CFS perimeter, moderate flow in ditch, turbid</p>

Description	Please see photo for coordinates. MVP-PY-006, CFS added at existing swale where stormwater turbidity was noted		Description	Please see photo for coordinates. MVP-PY-006, North Fork Road RCE with flume, signage, and ECDs installed.

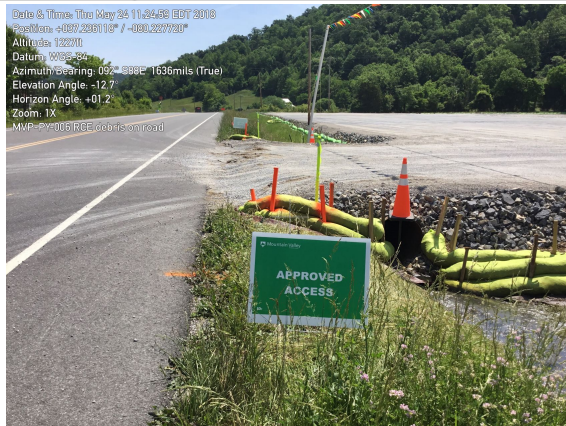
<p>Date & Time: Thu May 24 11:24:46 EDT 2018 Position: +037.236118° / -080.227720° Altitude: 1327ft Datum: WGS-84 Azimuth/Bearing: 022° S88E 1636mils (True) Elevation Angle: -12.7° Horizon Angle: +01.2° Zoom: 1X MVP-PY-006 RCE access road</p>
