Visual Site Inspection Report

Project Name	H-600 Pipeline Spread H	AFE	124300138	Spread	H-600 Pipeline Spread H
Contractor	Precision			Report #	2413
Inspector	Dawn McCullough			Date/Time	5/30/2018 5:10 PM
Permit #	TBD	Inspection Type	VA SWPP	Station Begin	+00
State	VA	Inspection Area	Full	Station End	+00
County	Montgomery	Ground	Wet	Temperature (°F)	79.00
Municipality	N/A	Weather	Cloudy	Rain Gauge (in)	1.30
GPS Location	37.2732576725082, -80.0573700454138			Rain Accumulation Time (days)	4.00

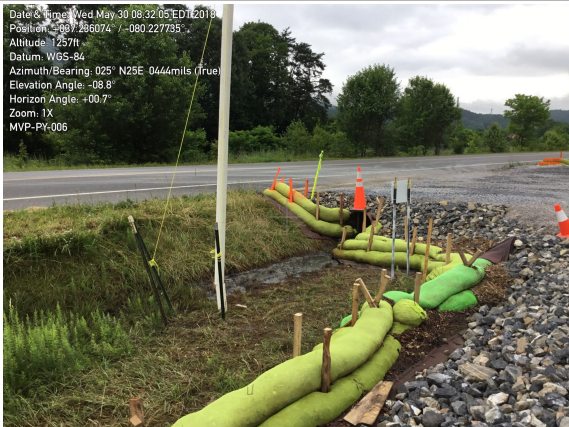
<p>Date & Time: Wed May 30 08:32:05 EDT 2018 Position: +037 236074° / -080.227735° Altitude: 1257ft Datum: WGS-84 Azimuth/Bearing: 025° N25E 0444mils (True) Elevation Angle: -08.8° Horizon Angle: -00.7° Zoom: 1X MVP-PY-006</p>		GPS Location 37.2932683984105, -80.0557900825785	
Description		Description		Please see photo for coordinates. MVP-PY-006, W-008.

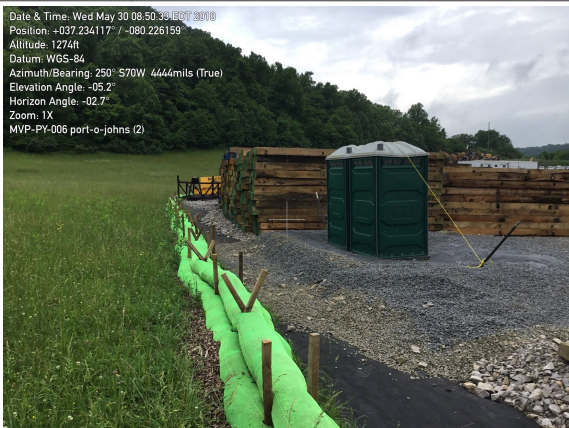
<p>Date & Time: Wed May 30 08:50:34 EDT 2018 Position: +037 234117° / -080.226159° Altitude: 1274ft Datum: WGS-84 Azimuth/Bearing: 250° 57'W 4444mils (True) Elevation Angle: -05.2° Horizon Angle: -02.7° Zoom: 1X MVP-PY-006 port-o-johns (2)</p>		GPS Location 37.2933280701165, -80.0557190459967

Description		Description		Please see photo for coordinates. MVP-PY-006, CFS along North Fork Rd.

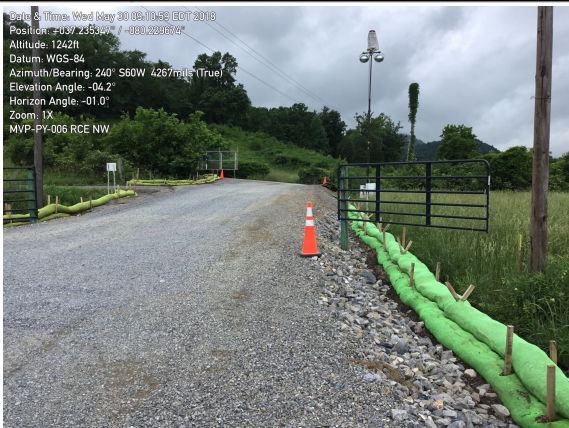
<p>Date & Time: Wed May 30 09:10:03 EDT 2018 Position: +037 235177° / -080.229674° Altitude: 1242ft Datum: WGS-84 Azimuth/Bearing: 240° 56'W 4267mils (True) Elevation Angle: -04.2° Horizon Angle: -01.0° Zoom: 1X MVP-PY-006 RCE NW</p>		GPS Location 37.2932952968751, -80.0558269210905	
Description		Description		Please see photo for coordinates. MVP-PY-006, CFS along south perimeter.	
GPS Location 37.2932952968751, -80.0558269210905		GPS Location 37.2933354042818, -80.0558762905002		Please see photo for coordinates. MVP-PY-006, NW RCE, ECDs installed.	
Description		Description		Please see photo for coordinates. MVP-PY-006, NW RCE, ECDs installed.
