Visual Site Inspection Report

Project Name	H-600 Pipeline Spread H	A/E	124300138	Spread	H-600 Pipeline Spread H
Contractor	Precision			Report #	2903
Inspector	Dawn McCullough			Date/Time	6/11/2018 2:57 PM
Permit #	TBD	Inspection Type	VA SWPP	Station Begin	+00
State	VA	Inspection Area	Full	Station End	+00
County	Montgomery	Ground	Dry	Temperature (°F)	74.00
Municipality	N/A	Weather	Cloudy	Rain Gauge (in)	0.10
GPS Location	37.2629848739031, -80.034143154716			Rain Accumulation Time (days)	1.00

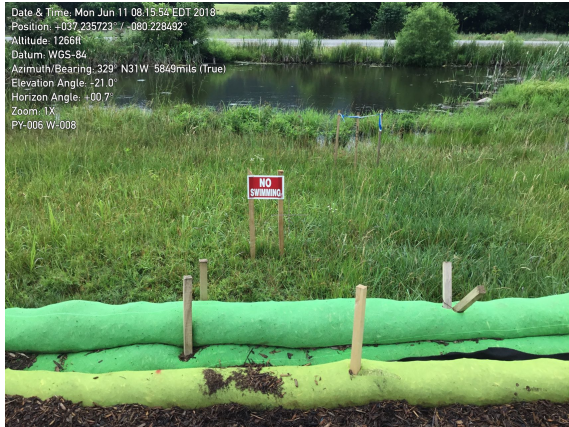
A/E	124300138	Date/Time	6/11/2018 2:57 PM	Report #	2903
Pictures					
<p>Date & Time: Mon Jun 11 08:15:54 EDT 2018 Position: +037.235723° / -080.228492° Altitude: 1266ft Datum: WGS-84 Azimuth/Bearing: 329° N31W 5849mils (True) Elevation Angle: +21.0° Horizon Angle: +00.7° Zoom: 1X PY-006 W-008</p>

GPS Location	37.2629668550694, -80.0341646054343	GPS Location	37.2630071254364, -80.0342204402345		
Description	Please see photo for coordinates. PY-006, CFS at W-008. No environmental concerns noted.	Description	Please see photo for coordinates. PY-006, RCE at North Fork Rd, water/sweeper truck in use.		
<p>Date & Time: Mon Jun 11 08:20:51 EDT 2018 Position: +037.234151° / -080.227607° Altitude: 1251ft Datum: WGS-84 Azimuth/Bearing: 255° S26W 1451mils (True) Elevation Angle: -20.8° Horizon Angle: +00.7° Zoom: 1X PY-006(N Fork Entrance)</p>

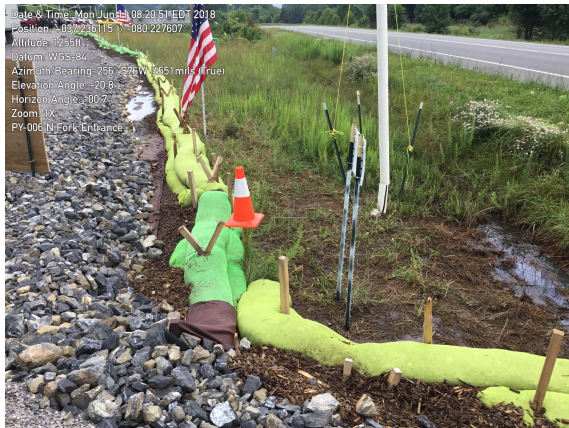
GPS Location	37.2630158379639, -80.0342315470114	GPS Location	37.2630218010447, -80.0341611459285		
Description	Please see photo for coordinates. PY-006, CFS repaired at North Fork Rd RCE.	Description	Please see photo for coordinates. PY-006, generators in containment, small generator not in use needs containment.		
<p>Date & Time: Mon Jun 11 09:40:59 EDT 2018 Position: +037.234165° / -080.226283° Altitude: 1260ft Datum: WGS-84 Azimuth/Bearing: 152° S28E 2702mils (True) Elevation Angle: -00.9° Horizon Angle: -01.3° Zoom: 1X PY-006 porta-johns</p>

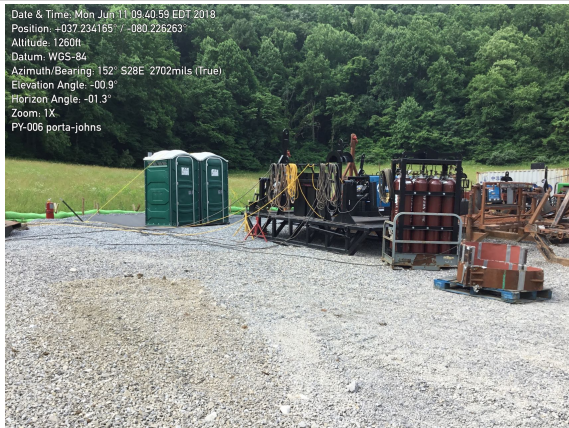
GPS Location	37.2630218010447, -80.0341611459285	GPS Location	37.2630218010447, -80.0341611459285		
Description	Please see photo for coordinates. PY-006, portable toilets in rear of yard in containment.	Description	Please see photo for coordinates. PY-006, CFS repairs at NW entrance.
