Visual Site Inspection Report

Project Name	H-600 Pipeline Spread H	AFE	124300138	Spread	H-600 Pipeline Spread H
Contractor	Precision			Report #	4046
Inspector	Dawn McCullough			Date/Time	7/3/2018 10:26 PM
Permit #	TBD	Inspection Type	VA SWPP	Station Begin	+00
State	VA	Inspection Area	Full	Station End	+00
County	Montgomery	Ground	Dry	Temperature (°F)	90.00
Municipality	N/A	Weather	Sunny	Rain Gauge (in)	0.00
GPS Location	37.23553466, -80.22956427			Rain Accumulation Time (days)	1.00

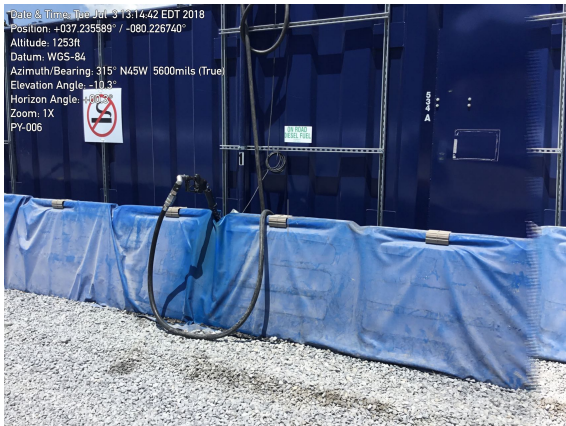
GPS Location	37.2355513514935, -80.2293464144475	GPS Location	37.2355513514935, -80.2293464144475		
Description	Please see photos for coordinates. MVP-PY-006, soil plug from power pole installation off LOD.	Description	Please see photos for coordinates. MVP-PY-006, diesel backsplash along fuel storage tank.		
<p>Date & Time: Tue Jul 3 13:22:18 EDT 2018 Position: +037.236071° / -080.226652° Altitude: 1291ft Datum: WGS-84 Azimuth/Bearing: 159° S52E 2276mils (True) Elevation Angle: +13.5° Horizon Angle: +00.7° Zoom: 1X PY-006</p>

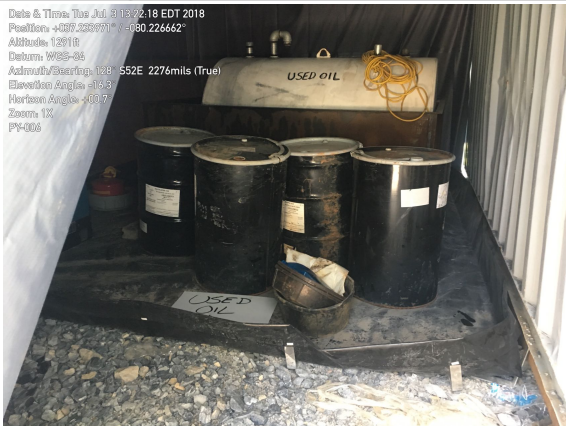
<p>Date & Time: Tue Jul 3 13:29:34 EDT 2018 Position: +037.234007° / -080.228376° Altitude: 1254ft Datum: WGS-84 Azimuth/Bearing: 056° N56W 2229mils (True) Elevation Angle: +03.8° Horizon Angle: +00.7° Zoom: 1X PY-006</p>  			
GPS Location	37.2355513514935, -80.2293464144475	GPS Location	37.2355513514935, -80.2293464144475		
Description	Please see photos for coordinates. MVP-PY-006, used oil tank in secondary containment.	Description	Please see photos for coordinates. MVP-PY-006, spill near parking area.
