A/E	124300138	Date/Time	8/16/2018 7:27 PM	Report #	6476
6. PCSM BMPs (List BMPs and note if installed and maintained as per the plan. If corrective action is needed, a picture is required.)					
PCSM BMPs		Compliance Level	Corrective Action	Corrective Time Frame

7. Identify all remedial measures that have been taken since the previous inspection was conducted.					
Comments (Reference above questions as appropriate.)					
Attended morning inspectors meeting for Spread H. Discussed daily tasks with environmental team. Inspected from Webster's corner crossing (Sta 13342+73) to Sta 13370+00 to document landowner complaint associated with non MVP logging activities. Off ROW logging activities were observed in this area, with non MVP tree felling across MVP ROW. Ground disturbance from off ROW activities was observed on MVP ROW between Sta 13360+00 to Sta 13370+00. Multiple logging roads were observed crossing the ROW. Evidence of equipment tracking on the ROW was noted. Sediment associated with this disturbance was observed to flow down the ROW, with no evidence of off ROW sediment impacts related to MVP activities. Logging roads crossing the ROW are open and would allow water to flow

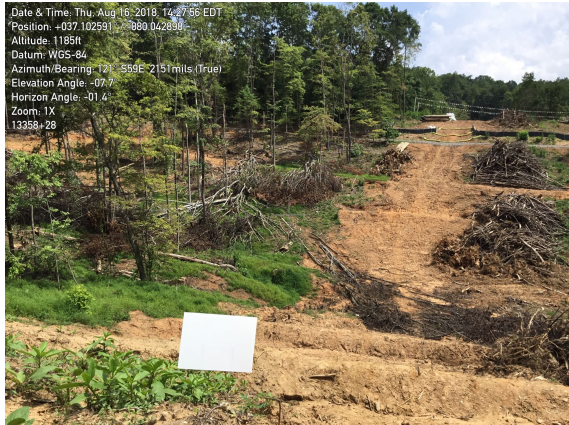
GPS Location	37.2355764122226, -80.2294029633554		GPS Location	37.2355790439505, -80.2293977771894	
Description	Please see photo for coordinates. Non MVP logging activities within MVP ROW.		Description	Please see photo for coordinates. GAS of S-RR11 looking uphill.	
<p>Date & Time: Thu, Aug 16, 2018, 14:55:14 EDT Position: +037.100985 / -88.039433 Altitude: 1515ft Datum: WGS-84 Azimuth/Bearing: 189° S09W 3360mils (True) Elevation Angle: -12.9 Horizon Angle: -02.4 Zoom: 1X 13360+00</p>

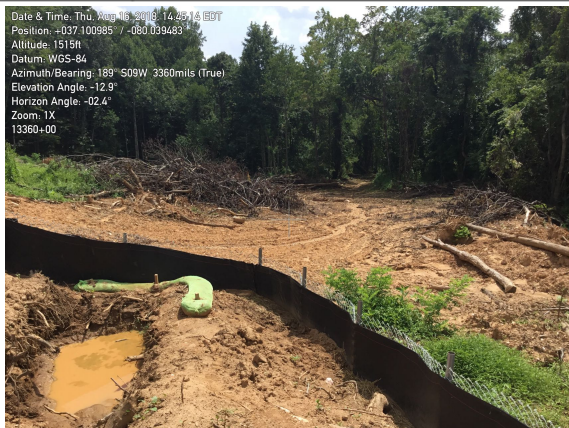
GPS Location	37.2355769156079, -80.2294019713685		GPS Location	37.2355748014813, -80.229406137533	
Description	Please see photo for coordinates. Ground disturbance from non MVP logging off MVP ROW.		Description	Please see photo for coordinates. Evidence of sediment flowing down ROW.	
<p>Date & Time: Thu, Aug 16, 2018, 14:57:40 EDT Position: +037.100641 / -88.037944 Altitude: 1625ft Datum: WGS-84 Azimuth/Bearing: 269° S85W 4711mils (True) Elevation Angle: -14.8 Horizon Angle: +00.6 Zoom: 1X 13366+0</p>

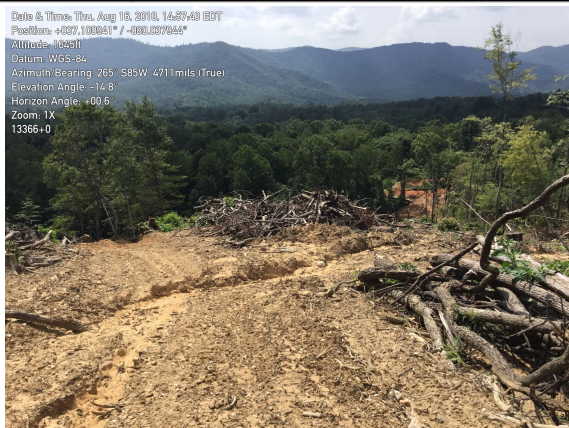
GPS Location	37.2355752956823, -80.229405163645		GPS Location	37.2355713379947, -80.2294129627887	
Description	Please see photo for coordinates. Looking downhill at Sta 13366+00. Water diverted away from logging road (left side of log pile).		Description	Please see photo for coordinates. Multiple logging roads adjacent to ROW.
