Visual Site Inspection Report

Project Name	H-600 Pipeline Spread H	AFE	124300138	Spread	H-600 Pipeline Spread H
Contractor	Precision			Report #	7049
Inspector	Dawn McCullough			Date/Time	8/28/2018 3:36 PM
Permit #	TBD	Inspection Type	VA SWPP	Station Begin	13343+22
State	VA	Inspection Area	Partial	Station End	13370+06
County	Franklin	Ground	Damp	Temperature (°F)	93.00
Municipality	N/A	Weather	Sunny	Rain Gauge (in)	0.80
GPS Location	37.3255545009888, -80.0287579965			Rain Accumulation Time (days)	1.00

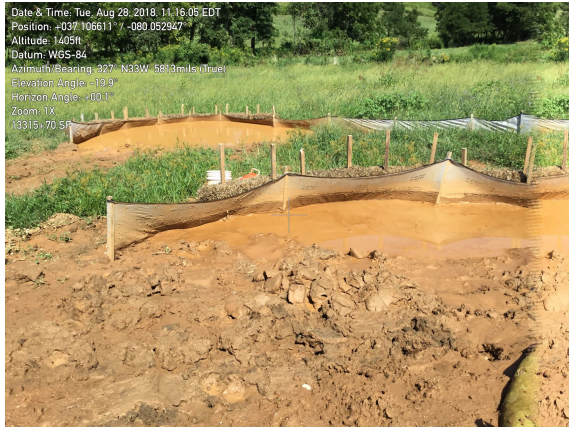
A/E	124300138	Date/Time	8/28/2018 3:36 PM	Report #	7049
Pictures					
<p>Date & Time: Tue, Aug 28, 2018, 11:16:05 EDT Position: +037.106611 / -080.052947 Altitude: 1405ft Datum: WGS-84 Azimuth/Bearing: 022° N33W 520mils (True) Elevation Angle: -19.9 Horizon Angle: -00.1 Zoom: 1X 13315+70 CFS</p>

GPS Location	37.2356062260595, -80.2289949126714		GPS Location	37.2356062260595, -80.2289949126714	
Description	Please see photo for coordinates. Sta. No. 13315+70, outlet draining ATWS-1412 requires maintenance; silt fence at capacity.		Description	Please see photo for coordinates. Sta. No. 13315+70, CFS at outlet needs repaired; undermining noted.	
<p>Date & Time: Tue, Aug 28, 2018, 11:10:08 EDT Position: +037.105370 / -080.054460 Altitude: 1377ft Datum: WGS-84 Azimuth/Bearing: 285° NWW 5084mils (True) Elevation Angle: -23.9 Horizon Angle: -00.9 Zoom: 1X 13308+45 S: Gully upstream RDB undercutting</p>

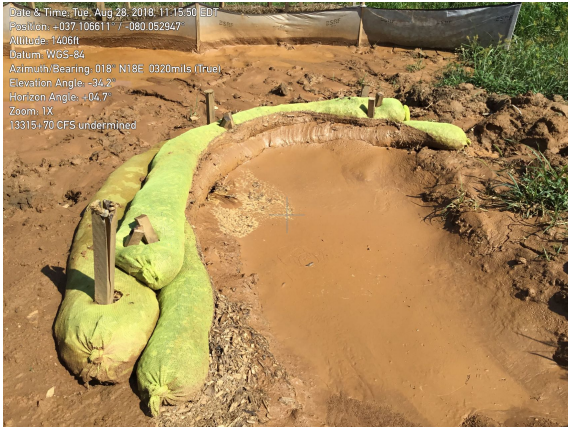
<p>Date & Time: Tue, Aug 28, 2018, 11:15:50 EDT Position: +037.106611 / -080.052947 Altitude: 1426ft Datum: WGS-84 Azimuth/Bearing: 018° N18E 0320mils (True) Elevation Angle: -34.7 Horizon Angle: -04.7 Zoom: 1X 13315+70 CFS undermined</p>

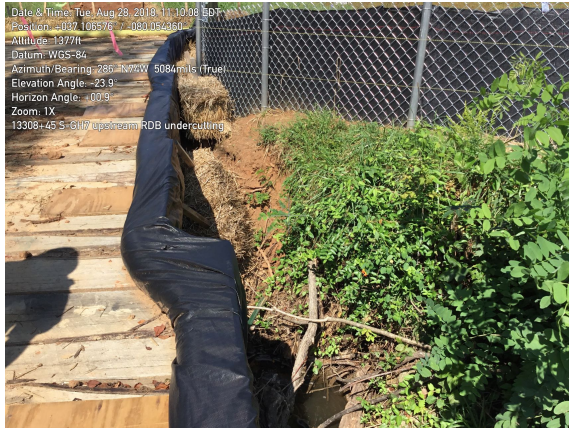
GPS Location	37.2356062260595, -80.2289949126714		GPS Location	37.2356062260595, -80.2289949126714	
Description	Please see photo for coordinates. Sta. No. 13308+45, undercutting on right descending bank of S-GH7.		Description	Please see photo for coordinates. Sta. No. 13339+30, sump requires maintenance.	
<p>Date & Time: Tue, Aug 28, 2018, 13:27:21 EDT Position: +037.103999 / -080.043029 Altitude: 1529ft Datum: WGS-84 Azimuth/Bearing: 124° S58E 2227mils (True) Elevation Angle: -22.8 Horizon Angle: -04.7 Zoom: 1X 13344+00 seeded</p>

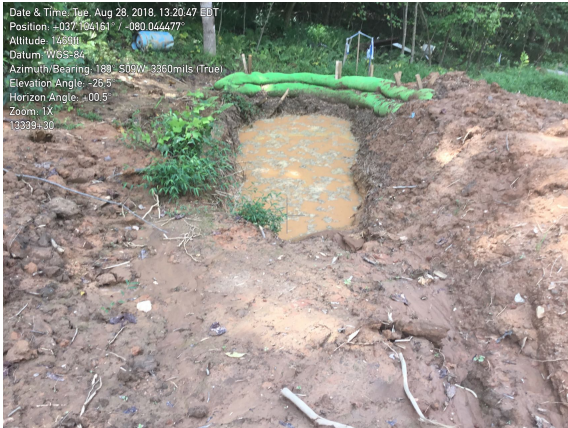
<p>Date & Time: Tue, Aug 28, 2018, 13:20:47 EDT Position: +037.106154 / -080.064477 Altitude: 1420ft Datum: WGS-84 Azimuth/Bearing: 189° S09W 3360mils (True) Elevation Angle: -26.5 Horizon Angle: -00.5 Zoom: 1X 13339+30</p>

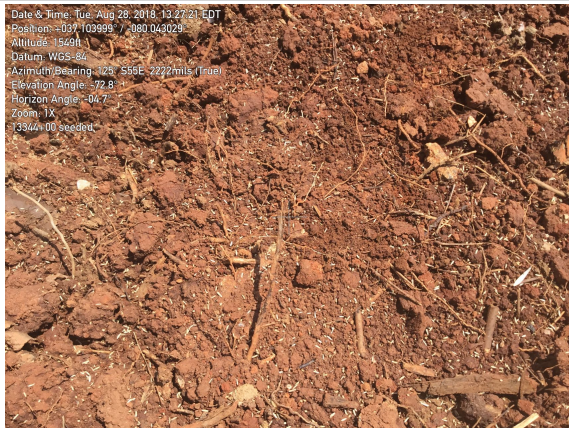
GPS Location	37.2356062260595, -80.2289949126714		GPS Location	37.2356062260595, -80.2289949126714	
Description	Please see photo for coordinates. Sta. No. 13344+00, ROW seeded.		Description	Please see photo for coordinates. Sta. No. 13344+00, contractor in progress stabilizing ROW.

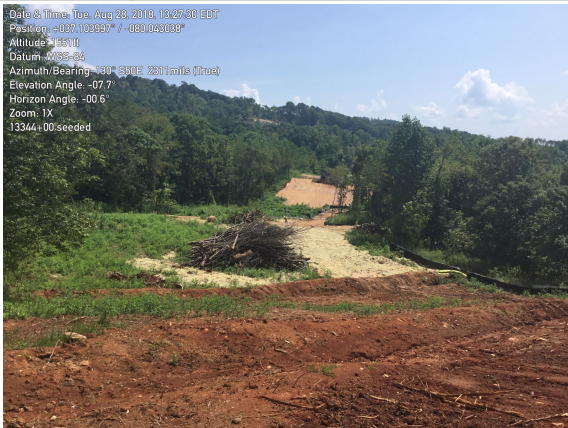
<p>Date & Time: Tue, Aug 28, 2018, 13:27:50 EDT Position: +037.103997 / -080.043038 Altitude: 1530ft Datum: WGS-84 Azimuth/Bearing: 130° S50E 2201mils (True) Elevation Angle: -07.7 Horizon Angle: -00.6 Zoom: 1X 13344+00 seeded</p>
