Visual Site Inspection Report

Project Name	H-600 Pipeline Spread H	AFE	124300138	Spread	H-600 Pipeline Spread H
Contractor	Precision			Report #	7383
Inspector	Dawn McCullough			Date/Time	9/4/2018 6:29 PM
Permit #	TBD	Inspection Type	VA SWPP	Station Begin	13198+33
State	VA	Inspection Area	Partial	Station End	13415+83
County	Franklin	Ground	Dry	Temperature (°F)	92.00
Municipality	N/A	Weather	Sunny	Rain Gauge (in)	0.40
GPS Location	37.2881112494322, -80.1210425155575			Rain Accumulation Time (days)	1.00

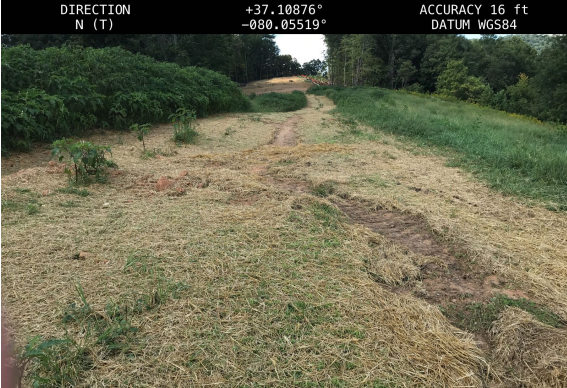
2018-09-04 15:38:25-04:00		DIRECTION SW (T) +37.10883° ACCURACY 16 ft -080.05512° DATUM WGS84   13298+60 sump ponding Water on TL 2018-09-04 15:35:23-04:00			
GPS Location	37.23562747, -80.22948463		GPS Location	37.23562747, -80.22948463	
Description	Please see photo for coordinates. Erosion noted down travel lane from Sta. No. 13295+82 to Sta. No. 13301+42.		Description	Please see photo for coordinates. Sump ponding at St. No. 13298+60.	
Date & Time: Tue, Sep 04, 2018, 13:23:19 EDT Position: +037.106487 / -080.054013 Altitude: 1361ft Datum: WGS-84 Azimuth/Bearing: 280° N80W 4978mils (True) Elevation Angle: -11.3° Horizon Angle: +02.0° Zoom: 1X 13310+00		Date & Time: Tue, Sep 04, 2018, 13:30:43 EDT Position: +037.106635 / -080.054329 Altitude: 1382ft Datum: WGS-84 Azimuth/Bearing: 221° S41W 3929mils (True) Elevation Angle: -5.45° Horizon Angle: +01.0° Zoom: 1X 13309+09 S-GH7

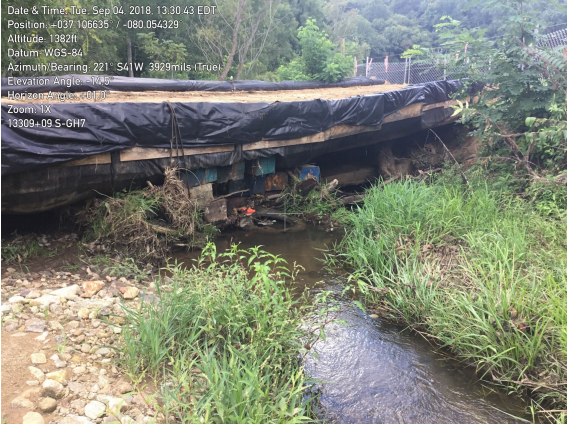
GPS Location	37.23562747, -80.22948463		GPS Location	37.23562747, -80.22948463	
Description	Please see photo for coordinates. Silt fence needing repair in travel lane between Sta. No. 13309+09 to Sta. No. 13315+70.		Description	Please see photo for coordinates. Bridge over S-GH7 needing repair; undercutting observed on right descending bank under bridge.	
Date & Time: Tue, Sep 04, 2018, 15:23:19 EDT Position: +037.106312 / -080.051050 Altitude: 1523ft Datum: WGS-84 Azimuth/Bearing: 093° S87E 1653mils (True) Elevation Angle: -19.7° Horizon Angle: -02.3° Zoom: 1X S-GH15		  10:30am 09-04-2018 Station # (13410+00)			
GPS Location	37.23562747, -80.22948463		GPS Location	37.23562747, -80.22948463	
Description	Please see photo for coordinates. Sta. No. 13321+47, silt fence needing maintenance at S-GH15.		Description	Please see photo for coordinates. Sta. No. 13410+00, ROW seeded, with earth guard binder applied.
