Visual Site Inspection Report

Project Name	H-600 Pipeline Spread H	AFE	124300138	Spread	H-600 Pipeline Spread H
Contractor	Precision			Report #	8143
Inspector	Dawn McCullough			Date/Time	9/19/2018 9:25 PM
Permit #	TBD	Inspection Type	VA SWPP	Station Begin	13198+33
State	VA	Inspection Area	Partial	Station End	13342+32
County	Franklin	Ground	Wet	Temperature (°F)	89.00
Municipality	N/A	Weather	Sunny	Rain Gauge (in)	0.00
GPS Location	37.325572012616, -80.0287910743038			Rain Accumulation Time (days)	1.00

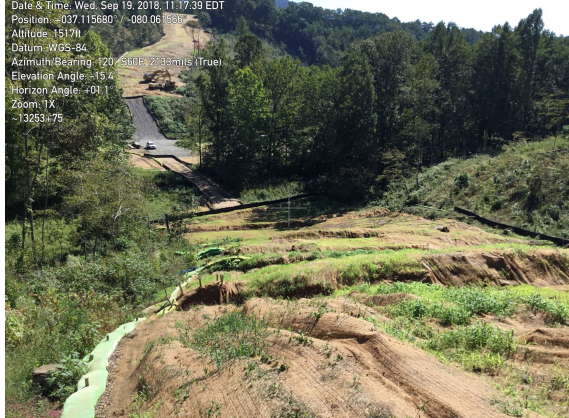
GPS Location	37.106515942176, -80.0544211082906	GPS Location	37.1064706379893, -80.0523831323535		
Description	Please see photo for coordinates. Erosion control blanket stable and vegetation establishing.	Description	Please see photo for coordinates. S-II4, ECDs installed along stream, drainage stabilized with little to no flow.		
<p>Date & Time: Tue, Sep 18, 2018, 09:53:30 EDT Position: +037.122844 / -080.074328 Altitude: 1350ft Datum: WGS-84 Azimuth/Bearing: 150.106E 0.889mils (True) Elevation Angle: +00.5 Horizon Angle: +00.0 Zoom: 1X Flanders</p>

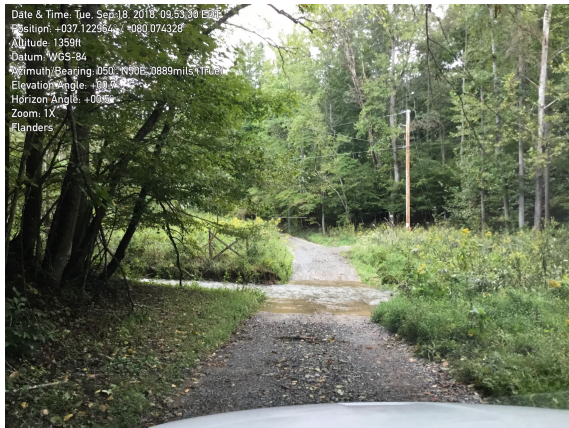
GPS Location	37.1064633038241, -80.0523007382453	GPS Location	37.1065082727346, -80.0523400493712		
Description	Please see photo for coordinates. S-MM27, stream at bank full crossing Flanders Road.	Description	Please see photo for coordinates. S-GH7, water level continuing to go down after storm event.		
<p>Date & Time: Tue, Sep 18, 2018, 11:27:33 EDT Position: +037.106054 / -080.048979 Altitude: 1476ft Datum: WGS-84 Azimuth/Bearing: 269.588W 4.764mils (True) Elevation Angle: -05.7 Horizon Angle: +00.4 Zoom: 1X 13323.145</p>

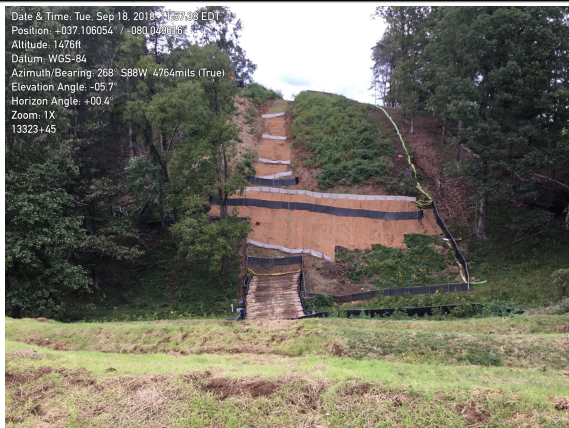
GPS Location	37.1064396249476, -80.0522406399996	GPS Location	37.1064396249476, -80.0522406399996		
Description	Please see photo for coordinates. S-GH15, ECDs functioning acceptable, ROW stabilized, no stream impacts observed.	Description	Please see photo for coordinates. S-GH14, ECDs functioning acceptable, ROW stabilized, no stream impacts observed.
