Visual Site Inspection Report

Project Name	H-600 Pipeline Spread H	AFE	124300138	Spread	H-600 Pipeline Spread H
Contractor	Precision			Report #	8337
Inspector	Dawn McCullough			Date/Time	9/24/2018 8:37 PM
Permit #	TBD	Inspection Type	VA SWPP	Station Begin	13190+00
State	VA	Inspection Area	Partial	Station End	13415+00
County	Franklin	Ground	Wet	Temperature (°F)	65.00
Municipality	N/A	Weather	Light Rain	Rain Gauge (in)	0.20
GPS Location	37.325449157541, -80.0287895836681			Rain Accumulation Time (days)	1.00

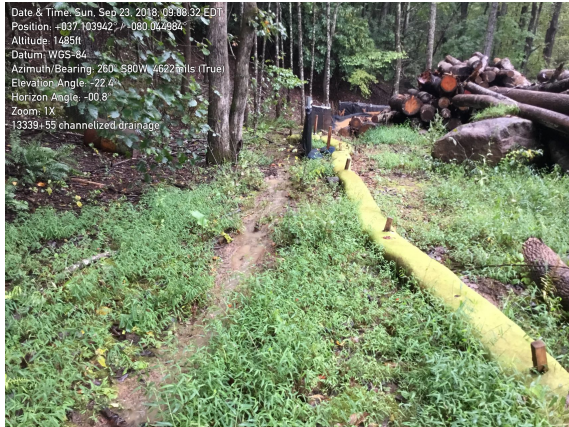
A/E	124300138	Date/Time	9/24/2018 8:37 PM	Report #	8337
Pictures					
<p>Date & Time: Sun, Sep 23, 2018, 09:08:32 EDT Position: +037.1039427 / -080.027882 Altitude: 1485ft Datum: WGS-84 Azimuth/Bearing: 260° S80W 1622mils (True) Elevation Angle: -22.4° Horizon Angle: -00.8° Zoom: 1X 13339+55 channelized drainage</p>

GPS Location	37.3256100823359, -80.0287459189872		GPS Location	37.3256395546343, -80.0288081049126	
Description	Please see photo for coordinates. Sta. No. 13339+55, drainage along LOD.		Description	Please see photo for coordinates. S-GH9, geotech fabric failure. No sediment impacts to stream.	
<p>Date & Time: Sun, Sep 23, 2018, 09:54:02 EDT Position: +037.103649 / -080.042776 Altitude: 1507ft Datum: WGS-84 Azimuth/Bearing: 119° S62E 2098mils (True) Elevation Angle: -00.0° Horizon Angle: -01.5° Zoom: 1X 13345+50</p>

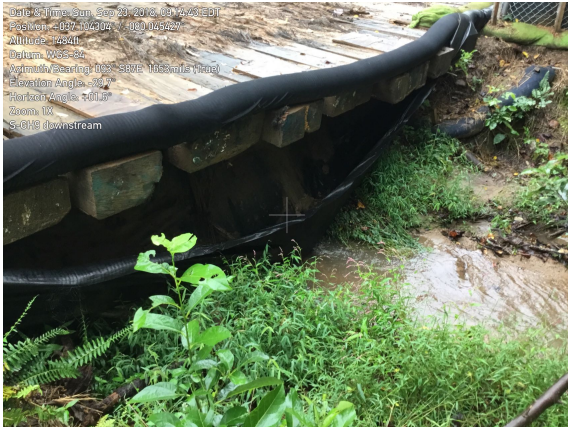
<p>Date & Time: Sun, Sep 23, 2018, 09:14:53 EDT Position: +037.1042047 / -080.028227 Altitude: 1484ft Datum: WGS-84 Azimuth/Bearing: 100° S10E 3022mils (True) Elevation Angle: -19.8° Horizon Angle: -01.5° Zoom: 1X S-GH9 downstream</p>

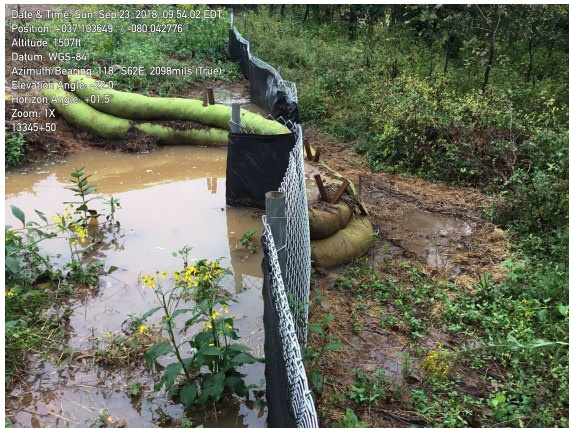
GPS Location	37.3256440367897, -80.0288480055332		GPS Location	37.3255345272248, -80.0288912561536	
Description	Please see photo for coordinates. Sta. No. 13345+50, outlet overwhelmed at bottom of drainage area. Sediment observed off ROW.		Description	Please see photo for coordinates. Sta. No. 13360+00, outlet overwhelmed. Small amount of sediment into logging area.	
<p>Date & Time: Sun, Sep 23, 2018, 08:29:27 EDT Position: +037.092654 / -080.027357 Altitude: 1256ft Datum: WGS-84 Azimuth/Bearing: 100° S60W 1320mils (True) Elevation Angle: -15.5° Horizon Angle: -01.2° Zoom: 1X 13314+00</p>

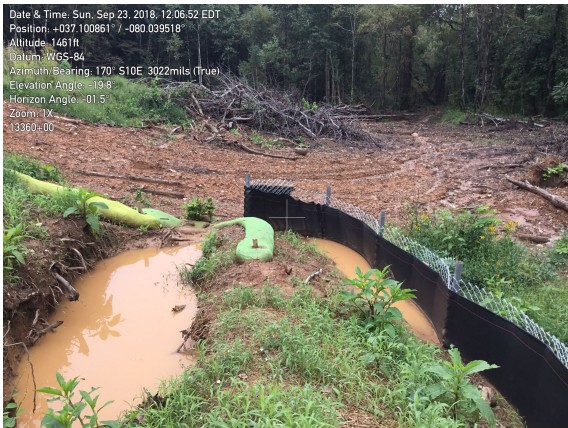
<p>Date & Time: Sun, Sep 23, 2018, 12:06:52 EDT Position: +037.1008617 / -080.038618 Altitude: 1461ft Datum: WGS-84 Azimuth/Bearing: 170° S10E 3022mils (True) Elevation Angle: -19.8° Horizon Angle: -01.5° Zoom: 1X 13360+00</p>

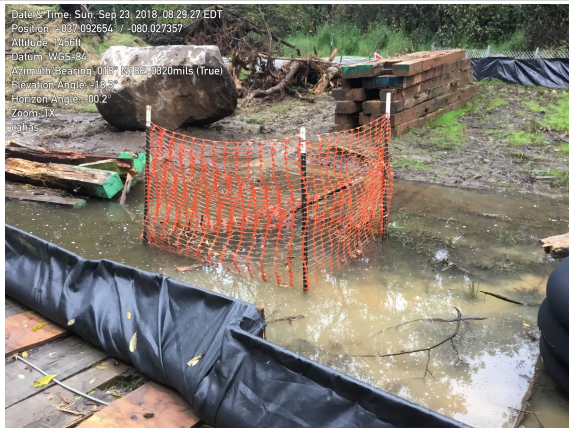
Description	Please see photo for coordinates. ~ Sta. No. 13314+00, wetland drainage flooding area backfilled area from completed road bore.		Description	Please see photo for coordinates. Sta. No. 13249+37, ROW stabilized. Outlets functioning acceptably with no off ROW impacts.

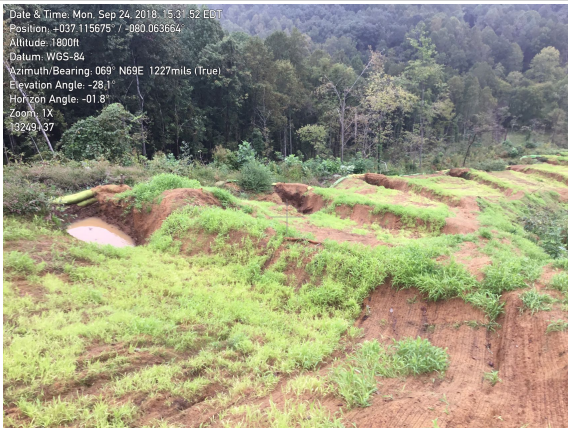
<p>Date & Time: Mon, Sep 24, 2018, 15:31:52 EDT Position: +037.1156757 / -080.063664 Altitude: 1800ft Datum: WGS-84 Azimuth/Bearing: 069° N69E 1227mils (True) Elevation Angle: -28.1° Horizon Angle: -01.8° Zoom: 1X 13249+37</p>
