Visual Site Inspection Report

Project Name	H-600 Pipeline Spread H	AFE	124300138	Spread	H-600 Pipeline Spread H
Contractor	Precision			Report #	726
Inspector	Dennis Evans			Date/Time	4/2/2018 4:57 PM
Permit #	TBD	Inspection Type	Weekly	Station Begin	11989+19
State	VA	Inspection Area	Partial	Station End	12119+17
County	Montgomery	Ground	Damp	Temperature (°F)	63.00
Municipality	N/A	Weather	Cloudy	Rain Gauge (in)	0.00
GPS Location	37.2799279215161, -80.0290327426791			Rain Accumulation Time (days)	0.00

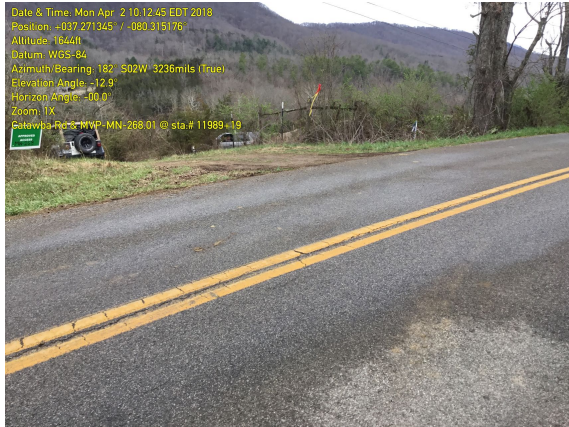
A/E	124300138	Date/Time	4/2/2018 4:57 PM	Report #	726
Pictures					
<p>Date & Time: Mon Apr 2 10:12:45 EDT 2018 Position: +037 271345° / -080 315176° Altitude: 1624ft Datum: WGS-84 Azimuth/Bearing: 182 S02W 3236mils (true) Elevation Angle: -12.9° Horizon Angle: -10.0° Zoom: 1X Catawba Rd @ MVP-MN-268.01 @ sta # 11989+19</p>

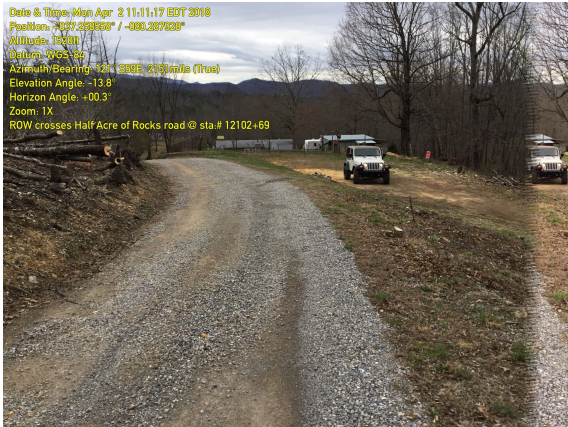
<p>Date & Time: Mon Apr 2 11:11:17 EDT 2018 Position: +037 279925° / -080 029331° Altitude: 1320ft Datum: WGS-84 Azimuth/Bearing: 042 N04E 0910mils (true) Elevation Angle: -13.8° Horizon Angle: +00.3° Zoom: 1X ROW crosses Half Acre of Rocks road @ sta # 12102+69</p>

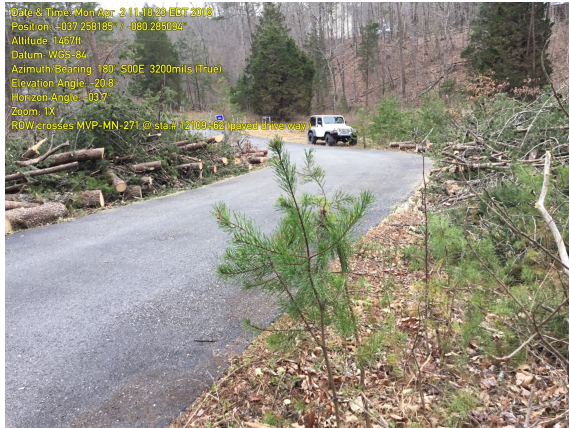
GPS Location	37.2802721719357, -80.0289580335825		GPS Location	37.2799254069452, -80.0293313060701	
Description	Catawba Rd. @ MVP-MN-268.01 Sta:# 11989+19. See photo for accurate coordinates.		Description	ROW crossing @ Half Acre of Rocks Rd Sta:# 12102+69. See photo for accurate coordinates.	
<p>Date & Time: Mon Apr 2 11:25:49 EDT 2018 Position: +037 280118° / -080 029169° Altitude: 1462ft Datum: WGS-84 Azimuth/Bearing: 180 S00E 3200mils (true) Elevation Angle: -20.8° Horizon Angle: +03.7° Zoom: 1X ROW crosses MVP-MN-271 @ sta # 12109+62 (view from west)</p>

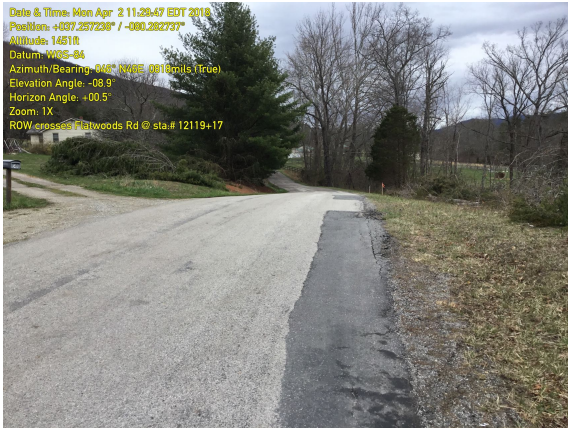
<p>Date & Time: Mon Apr 2 11:25:49 EDT 2018 Position: +037 279949° / -080 029297° Altitude: 1451ft Datum: WGS-84 Azimuth/Bearing: 042 N04E 0910mils (true) Elevation Angle: -08.9° Horizon Angle: +00.5° Zoom: 1X ROW crosses Flatwoods Rd @ sta # 12119+17</p>

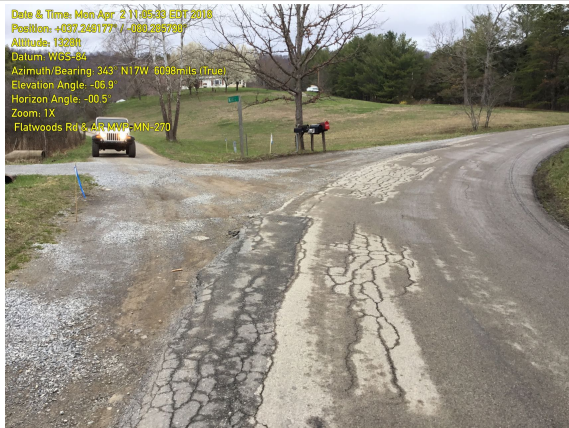
GPS Location	37.2801108984624, -80.0291694515199		GPS Location	37.2799490858217, -80.0292975270003	
Description	ROW crossing @ MVP-MN-271 @ Sta:# 12109+62. See photo for accurate coordinates.		Description	ROW crossing @ Flatwoods Rd. @ Sta:# 12119+17. See photo for accurate coordinates.	
<p>Date & Time: Mon Apr 2 11:25:49 EDT 2018 Position: +037 246177° / -080 029700° Altitude: 1320ft Datum: WGS-84 Azimuth/Bearing: 343 N17W 6088mils (true) Elevation Angle: -06.9° Horizon Angle: -00.5° Zoom: 1X Flatwoods Rd @ MVP-MN-270</p>

Insert image here			
GPS Location	37.2799599403863, -80.0292935875058		GPS Location		
Description	Flatwoods and MVP- MN-270 no station # available. See photo for accurate coordinates.		Description
