Visual Site Inspection Report

Project Name	H-600 Pipeline Spread H	AFE	124300138	Spread	H-600 Pipeline Spread H
Contractor	Precision			Report #	834
Inspector	Dennis Evans			Date/Time	4/7/2018 7:00 PM
Permit #	TBD	Inspection Type	Weekly	Station Begin	13690+91
State	VA	Inspection Area	Partial	Station End	12640+00
County	Franklin	Ground	Wet	Temperature (°F)	54.00
Municipality	N/A	Weather	Light Rain	Rain Gauge (in)	0.20
GPS Location	37.187614208122, -80.1741150208564			Rain Accumulation Time (days)	1.00

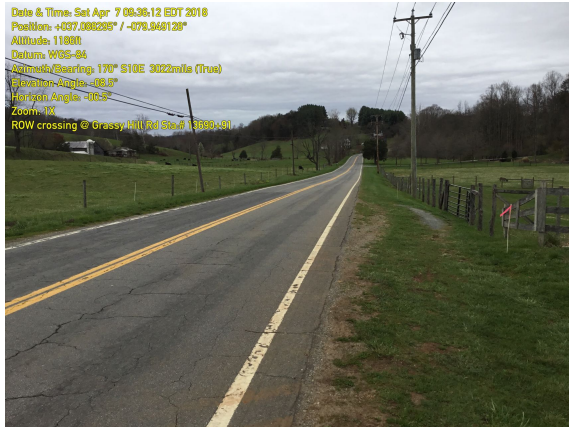
A/E	124300138	Date/Time	4/7/2018 7:00 PM	Report #	834
Pictures					
<p>Date & Time: Sat Apr 7 06:36:12 EDT 2018 Position: +037.006285° / -079.948128° Altitude: 11800' Datum: WGS-84 Azimuth/Bearing: 170° S10E 3022mils (True) Elevation Angle: -08.3° Horizon Angle: -00.3° Zoom: 1X ROW crossing @ Grassy Hill Rd @ Sta.# 13690+91</p>

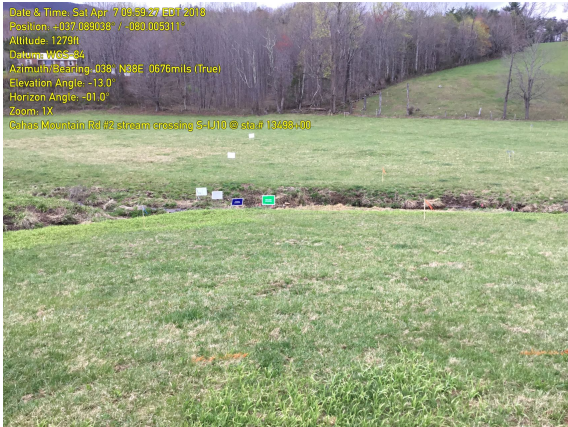
<p>Date & Time: Sat Apr 7 06:30:27 EDT 2018 Position: +037.088933° / -80.005311° Altitude: 12790' Datum: WGS-84 Azimuth/Bearing: +036° N08E 0676mils (True) Elevation Angle: -13.0° Horizon Angle: -01.0° Zoom: 1X Cahas Mountain Rd #2 stream crossing S-IJ10 @ Sta.# 13498+00</p>

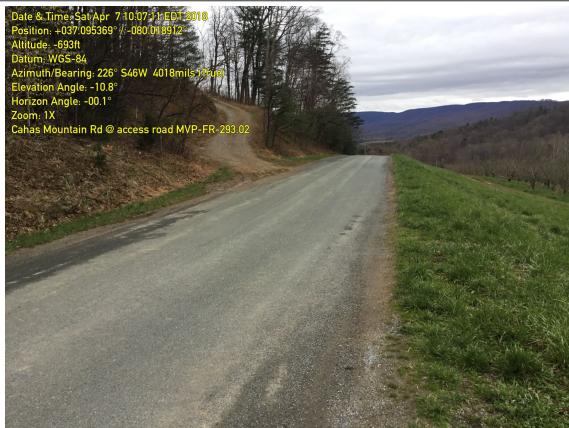
GPS Location	37.0881933113905, -79.9488704000413	GPS Location	37.0889792824509, -80.0053624995798		
Description	ROW crossing @ Grassy Hill Rd Sta:# 13690+91	Description	Cahas Mountain Rd #2 stream crossing S-IJ10 @ Sta:# 13498+00		
<p>Date & Time: Sat Apr 7 10:07:22 EDT 2018 Position: +037.095369° / -80.017468° Altitude: -693ft Datum: WGS-84 Azimuth/Bearing: 226° S46W 4018mils (True) Elevation Angle: -10.8° Horizon Angle: -00.1° Zoom: 1X Cahas Mountain Rd @ access road MVP-FR-293.02</p>

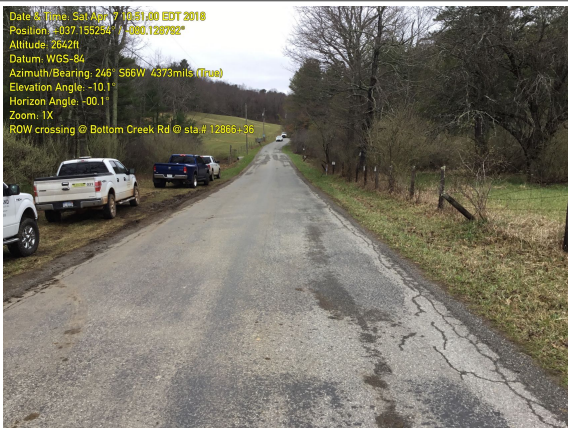
<p>Date & Time: Sat Apr 7 06:51:00 EDT 2018 Position: +037.155241° / -80.128782° Altitude: 2642ft Datum: WGS-84 Azimuth/Bearing: 246° S66W 4373mils (True) Elevation Angle: -10.1° Horizon Angle: -00.1° Zoom: 1X ROW crossing @ Bottom Creek Rd @ Sta.# 12866+36</p>

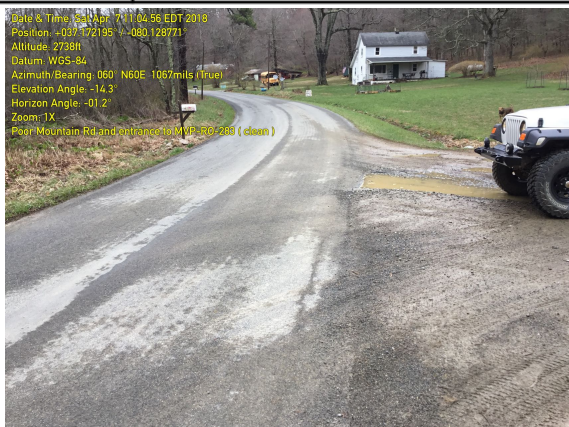
GPS Location	37.0966313314038, -80.0174689852446	GPS Location	37.1551091038037, -80.1293332782389		
Description	Cahas Mountain Rd @ access road MVP-FR-293.02	Description	ROW crossing @ Bottom Creek Rd @ Sta:# 12866+36		
<p>Date & Time: Sat Apr 7 11:04:56 EDT 2018 Position: +037.172195° / -80.128721° Altitude: 2738ft Datum: WGS-84 Azimuth/Bearing: 060° N60E 1067mils (True) Elevation Angle: -14.2° Horizon Angle: -01.2° Zoom: 1X Poor Mountain Rd and entrance to MVP-RO-283 (clean)</p>

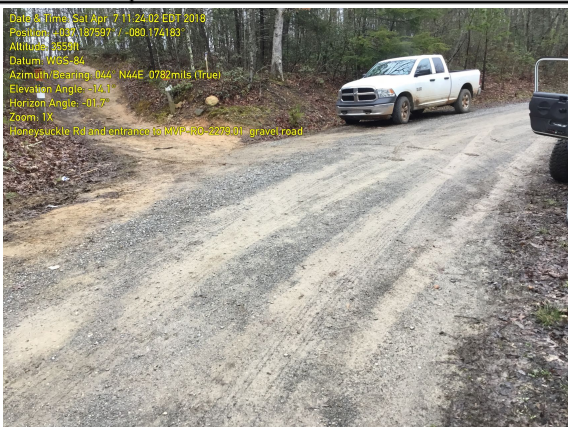
<p>Date & Time: Sat Apr 7 11:24:02 EDT 2018 Position: +037.187597° / -80.174183° Altitude: 3550ft Datum: WGS-84 Azimuth/Bearing: 006° N44E 0780mils (True) Elevation Angle: -14.1° Horizon Angle: -01.3° Zoom: 1X Honeysuckle Rd and entrance to MVP-RO-279.01 gravel road</p>
