# Visual Site Inspection Report

<b>Project Name</b>	H-600 Pipeline Spread H	<b>AFE</b>	124300138	<b>Spread</b>	H-600 Pipeline Spread H
<b>Contractor</b>	Precision			<b>Report #</b>	2714
<b>Inspector</b>	Dennis Evans			<b>Date/Time</b>	6/5/2018 6:10 PM
<b>Permit #</b>	TBD	<b>Inspection Type</b>	VA SWPP	<b>Station Begin</b>	12005+00
<b>State</b>	VA	<b>Inspection Area</b>	Partial	<b>Station End</b>	12371+00
<b>County</b>	Franklin	<b>Ground</b>	Dry	<b>Temperature (°F)</b>	83.00
<b>Municipality</b>	N/A	<b>Weather</b>	Sunny	<b>Rain Gauge (in)</b>	0.00
<b>GPS Location</b>	37.2796730997539, -80.0292911833015			<b>Rain Accumulation Time (days)</b>	4.00

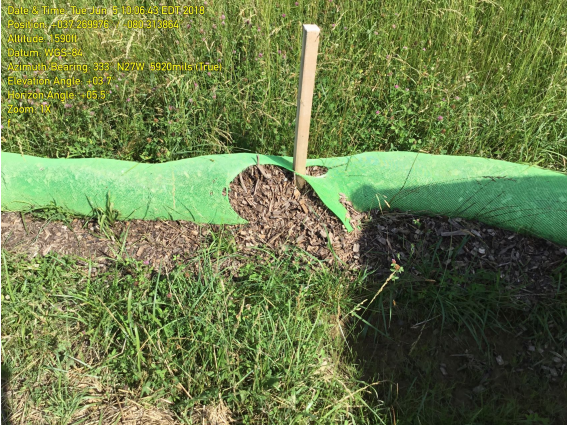
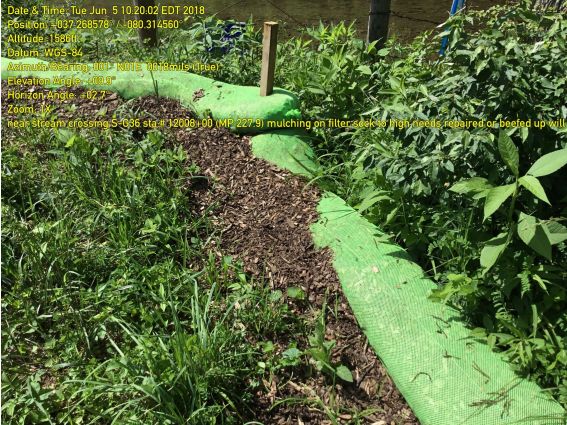
<b>GPS Location</b>	37.2796730997539, -80.0292911833015	<b>GPS Location</b>	37.2796730997539, -80.0292911833015		
<b>Description</b>	Filter sock needs repaired See photo for accurate coordinates.	<b>Description</b>	Mulching to high and filter sock walked down See photo for accurate coordinates.

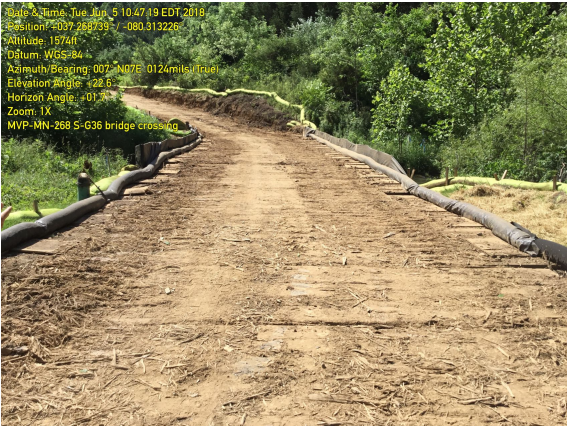
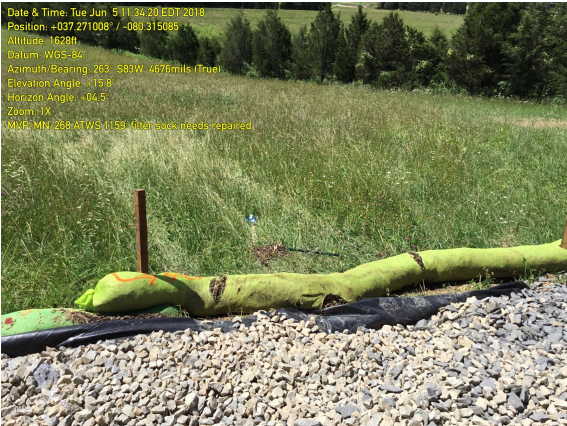
<b>GPS Location</b>	37.2794598544872, -80.0294659894087	<b>GPS Location</b>	37.2794604888457, -80.0294682729771		
<b>Description</b>	Bridges need to be swept and dirt shoveled off of bridge daily. See photo for accurate coordinates.	<b>Description</b>	Replace filter sockUTV traffic owner I'm guessing. See photo for accurate coordinates.

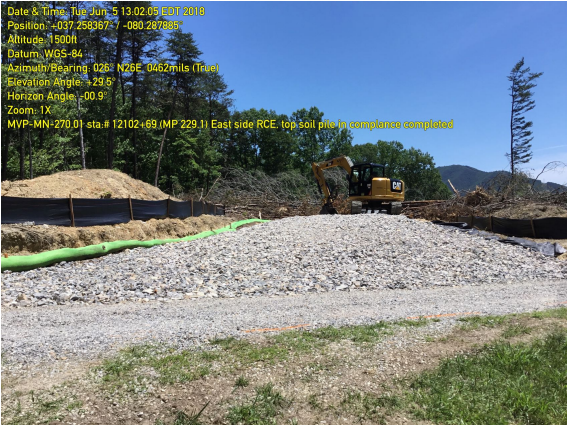
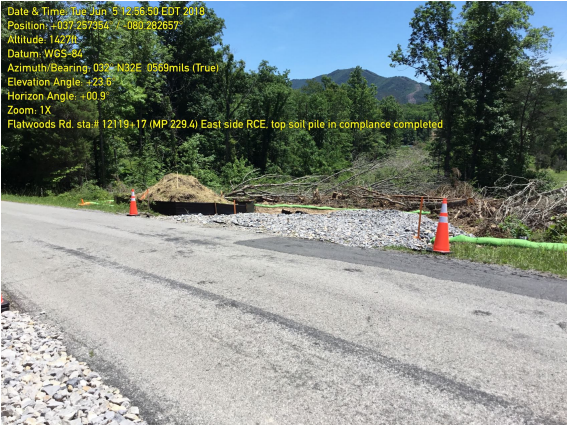
<b>GPS Location</b>	37.279672258971, -80.0292917494552	<b>GPS Location</b>	37.2794222008322, -80.0294842204821		
<b>Description</b>	MVP-MN270.01 in compliance See photo for accurate coordinates.	<b>Description</b>	Flatwoods Rd RCE on East side in compliance See photo for accurate coordinates.
