Visual Site Inspection Report

Project Name	H-600 Pipeline Spread H	A/E	124300138	Spread	H-600 Pipeline Spread H
Contractor	Precision			Report #	3394
Inspector	Dennis Evans			Date/Time	6/21/2018 6:25 PM
Permit #	TBD	Inspection Type	VA SWPP	Station Begin	12993+15
State	VA	Inspection Area	Partial	Station End	12990+00
County	Roanoke	Ground	Dry	Temperature (°F)	86.00
Municipality	N/A	Weather	Cloudy	Rain Gauge (in)	0.00
GPS Location	37.1285940846774, -80.1298294869066			Rain Accumulation Time (days)	1.00

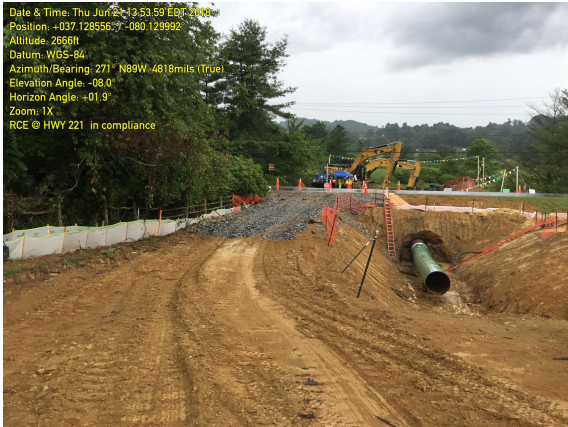
<p>Date & Time: Thu Jun 21 13:53:59 EDT 2018 Position: +037.128566° / -080.129992° Altitude: 2656ft Datum: WGS-84 Azimuth/Bearing: 271° N89W 4018mils (True) Elevation Angle: -08.0° Horizon Angle: +01.9° Zoom: 1X RCE @ HWY 221 in compliance</p>

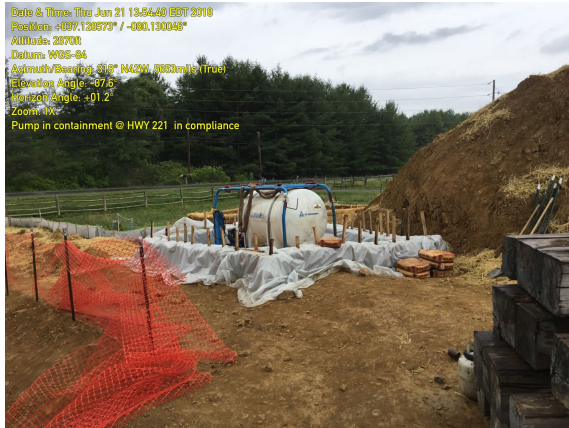
GPS Location	37.1285606408837, -80.1298000664265	GPS Location	37.1283462737101, -80.1297565643491		
Description	S-B21 below de-watering structure is clear See photo for accurate coordinates	Description	RCE @ Hwy 221 is in compliance		
<p>Date & Time: Thu Jun 21 13:54:40 EDT 2018 Position: +037.128373° / -080.130048° Altitude: 2670ft Datum: WGS-84 Azimuth/Bearing: 318° N42W 5963mils (True) Elevation Angle: -07.6° Horizon Angle: +01.2° Zoom: 1X Pump in containment @ HWY 221 in compliance</p>

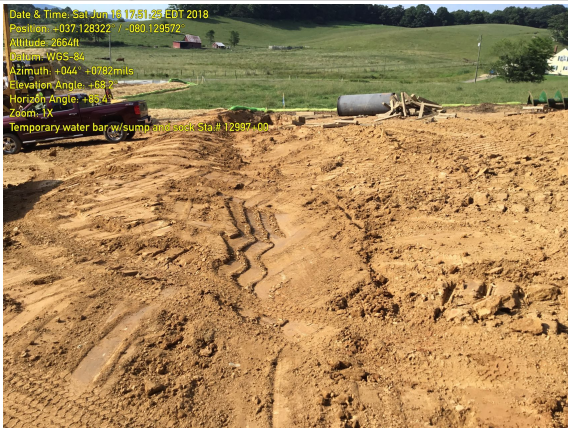
GPS Location	37.1283694077629, -80.1298378688098	GPS Location	37.1283782087612, -80.129817165509		
Description	Pump is in containment is in compliance	Description	Top soil pile is stabilized		
<p>Date & Time: Thu Jun 21 13:25:47 EDT 2018 Position: +037.128644° / -080.130227° Altitude: 2676ft Datum: WGS-84 Azimuth/Bearing: 339° N21W 6927mils (True) Elevation Angle: -10.6° Horizon Angle: +02.6° Zoom: 1X De-watering structure @ HWY 221 road bore in compliance</p>  		<p>Date & Time: Sat Jun 16 17:51:29 EDT 2018 Position: +037.128322° / -080.129572° Altitude: 2654ft Datum: WGS-84 Azimuth: 104.4° 0709mils Elevation Angle: -06.3° Horizon Angle: 063.4° Zoom: 1X Temporary water bar/sump on road Sta # 12997+00</p>
