Visual Site Inspection Report

Project Name	H-600 Pipeline Spread H	A/E	124300138	Spread	H-600 Pipeline Spread H
Contractor	Precision			Report #	3705
Inspector	Dennis Evans			Date/Time	6/27/2018 6:24 PM
Permit #	TBD	Inspection Type	VA SWPP	Station Begin	12991+00
State	VA	Inspection Area	Partial	Station End	12999+30
County	Roanoke	Ground	Wet	Temperature (°F)	79.00
Municipality	N/A	Weather	Cloudy	Rain Gauge (in)	0.00
GPS Location	37.1272860858403, -80.130673635867			Rain Accumulation Time (days)	1.00

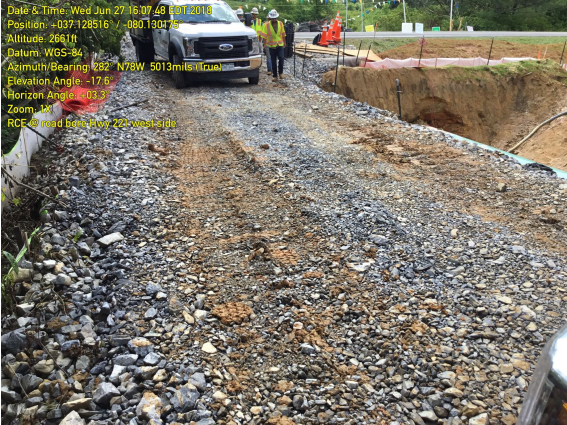
GPS Location	37.2794110094113, -80.0295723822272	GPS Location	37.2795143165041, -80.0291837007553		
Description	RCE on West side of Hwy 221, will be roughed up at the end of the day. See photo for accurate coordinates	Description	Top soil pile stabilized See photo for accurate coordinates

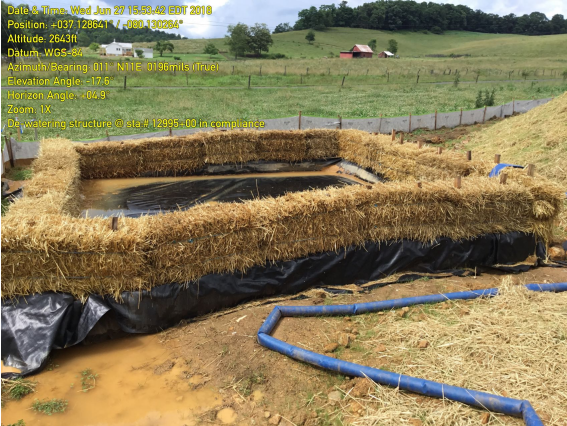
GPS Location	37.2800979065125, -80.0292510912568	GPS Location	37.2801609803338, -80.0293554459513		
Description	De-Watering structure @ Sta:# 12995+00 is in compliance. See photo for accurate coordinates	Description	De-Watering structure @ Sta:# 12991+00 is in compliance. See photo for accurate coordinates

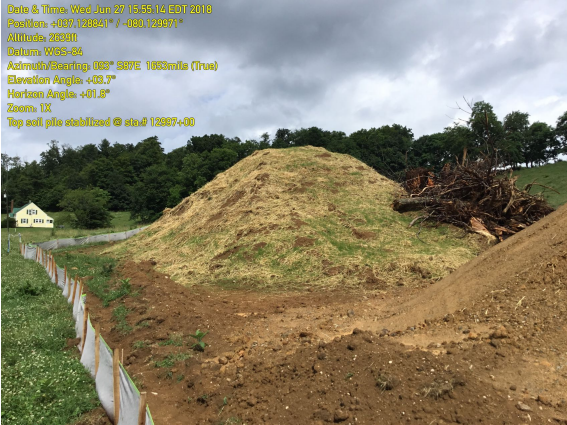
GPS Location	37.2799918335278, -80.0293048192561	GPS Location	37.2797631752093, -80.0292203296721		
Description	Top soil @ 12996+50 is stabilized. See photo for accurate coordinates	Description	Water bar, sump, and J Hook need maintenance. See photo for accurate coordinates.
