Visual Site Inspection Report

Project Name	H-600 Pipeline Spread H	AFE	124300138	Spread	H-600 Pipeline Spread H
Contractor	Precision			Report #	4579
Inspector	Dennis Evans			Date/Time	7/13/2018 6:20 PM
Permit #	TBD	Inspection Type	VA SWPP	Station Begin	12991+00
State	VA	Inspection Area	Partial	Station End	13024+06
County	Roanoke	Ground	Dry	Temperature (°F)	86.00
Municipality	N/A	Weather	Sunny	Rain Gauge (in)	0.00
GPS Location	37.1255203150558, -80.1235497650505			Rain Accumulation Time (days)	1.00

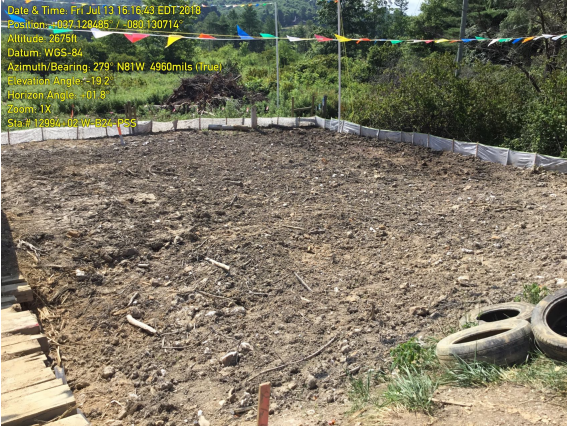
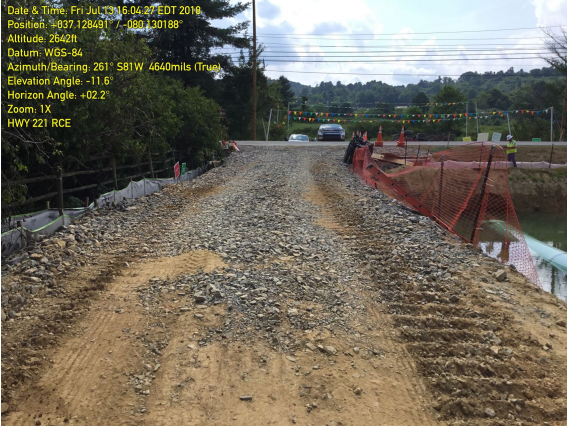
GPS Location	37.2797494830227, -80.0294066045884	GPS Location	37.2799992096026, -80.0294557773322		
Description	Sta:# 12994+02 W-B24-PSS , MP 246.0 See photo for accurate coordinates	Description	Sta:# 12994+02 RCE Hwy 221, MP 246.0 See photo for accurate coordinates

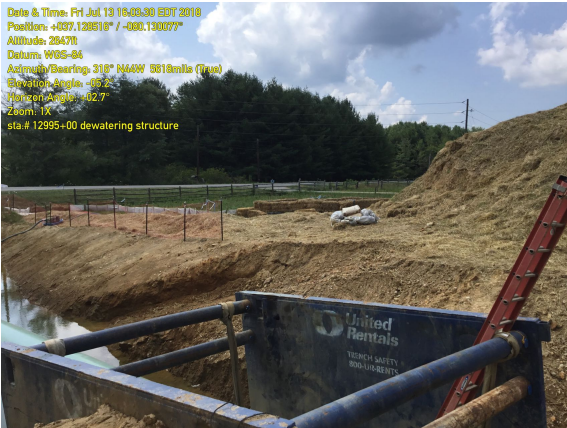
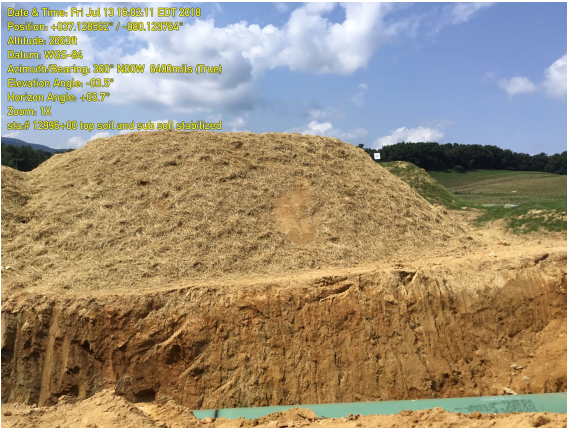
GPS Location	37.2800118662764, -80.0294135325402	GPS Location	37.2800697433178, -80.0292577129603		
Description	Sta:# 12995+00 dewatering structure, MP 246.0. See photo for accurate coordinates	Description	Sta:# 12996+00 top soil and sub soil stabilized.MP 246.0 See photo for accurate coordinates

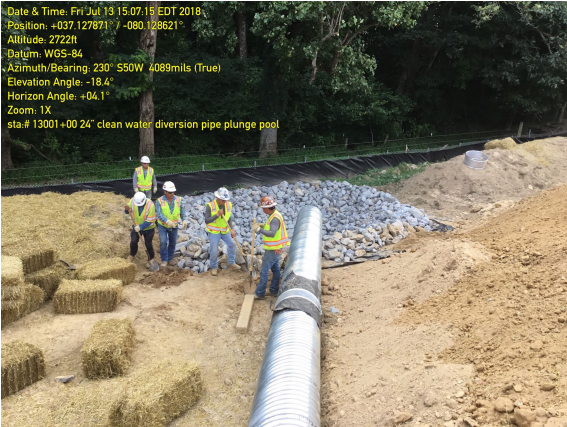
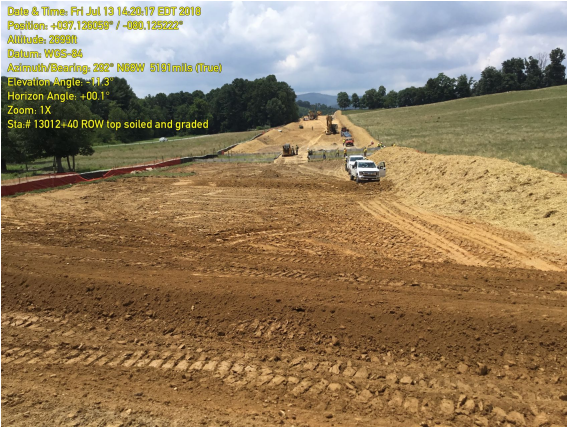
GPS Location	37.2800800111492, -80.0292661786825	GPS Location	37.2800428374086, -80.0291665178538		
Description	Sta:# 13001+00 plunge pool installed MP 246.0. See photo for accurate coordinates.	Description	Sta:# 13012+40 ROW on BRP top soiled and graded, MP 246.3. See photo for accurate coordinates.
