Visual Site Inspection Report

Project Name	H-600 Pipeline Spread H	AFE	124300138	Spread	H-600 Pipeline Spread H
Contractor	Precision			Report #	5177
Inspector	Dennis Evans			Date/Time	7/25/2018 5:40 PM
Permit #	TBD	Inspection Type	VA SWPP	Station Begin	12994+02
State	VA	Inspection Area	Partial	Station End	13024+06
County	Roanoke	Ground	Wet	Temperature (°F)	73.00
Municipality	N/A	Weather	Heavy Rain	Rain Gauge (in)	0.10
GPS Location	37.2796510252066, -80.0294917477588			Rain Accumulation Time (days)	1.00

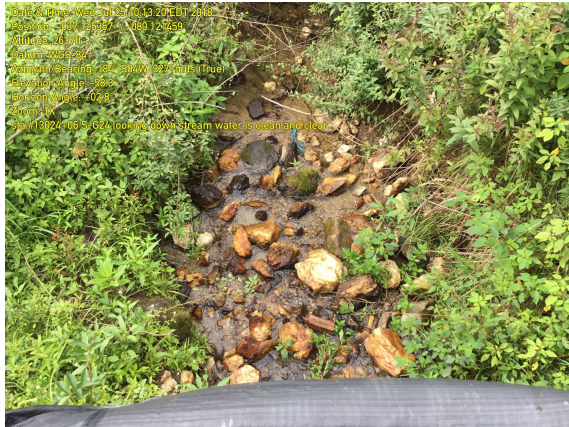
<p>Date & Time: Wed Jul 25 10:13:20 EDT 2018 Position: +037.125047° / -080.125051° Altitude: 2620ft Datum: WGS-84 Azimuth/Bearing: 082° N82E 1459mils (True) Elevation Angle: +01.3° Horizon Angle: +07.5° Zoom: 1X Sta.#13024+06 S-G24 looking down stream water system installed</p>

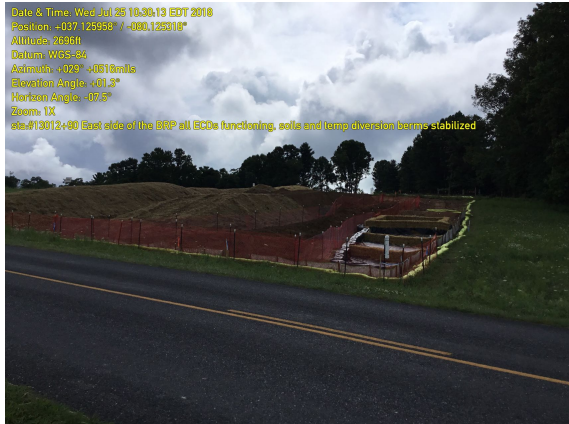
<p>Date & Time: Wed Jul 25 10:36:19 EDT 2018 Position: +037.125052° / -080.125018° Altitude: 2630ft Datum: WGS-84 Azimuth: +092° +0810mils Elevation Angle: +01.3° Horizon Angle: +07.5° Zoom: 1X Sta.#13012+40 East side of the BRP all ECDs functioning, soils and temp diversion berms stabilized</p>

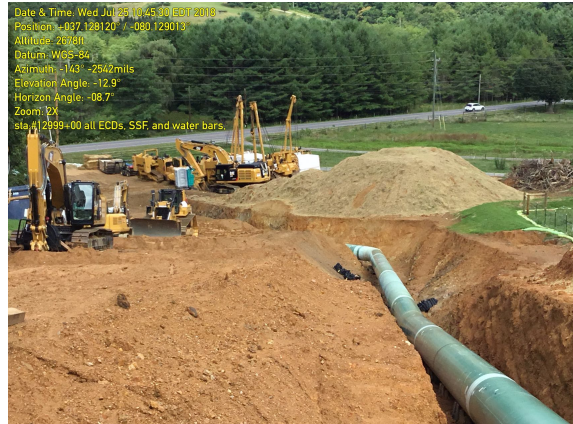
<p>Date & Time: Wed Jul 25 10:45:00 EDT 2018 Position: +037.129120° / -080.129017° Altitude: 2630ft Datum: WGS-84 Azimuth: +143° +2542mils Elevation Angle: +12.9° Horizon Angle: +08.7° Zoom: 2X Sta.#12999+00 all ECDs, SSF and water bars</p>			
GPS Location	37.280197232065, -80.0293781609088	GPS Location	37.2801583819438, -80.0293678511679		
Description	Sta:# 13012+90 East side of the BRP. See photo for accurate coordinates.	Description	Sta:#12999+00 looking down the ROW. See photo for accurate coordinates.

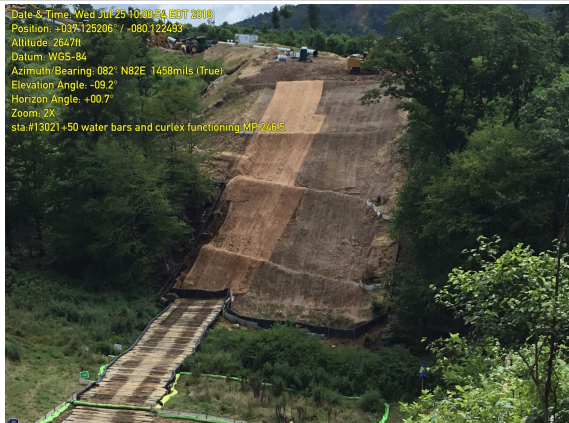
<p>Date & Time: Wed Jul 25 10:06:55 EDT 2018 Position: +037.125205° / -080.125433° Altitude: 2627ft Datum: WGS-84 Azimuth/Bearing: 082° N82E 1459mils (True) Elevation Angle: +09.2° Horizon Angle: +00.7° Zoom: 2X Sta.#13021+50 water bars and curlex functioning MP 206.5</p>

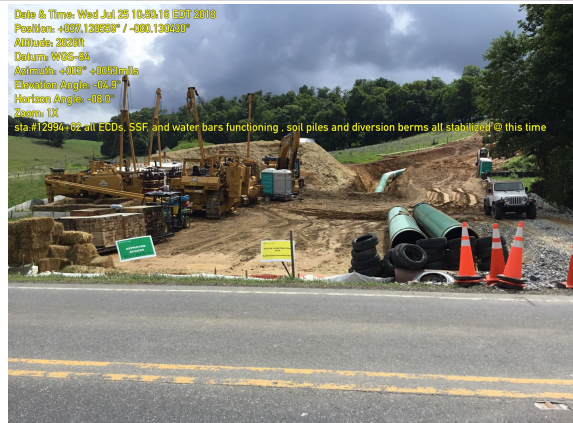
<p>Date & Time: Wed Jul 25 10:50:16 EDT 2018 Position: +037.128550° / -080.130630° Altitude: 2620ft Datum: WGS-84 Azimuth: +000° +0000mils Elevation Angle: +04.0° Horizon Angle: +05.0° Zoom: 1X Sta.#12994+02 all ECDs, SSF and water bars functioning - soil piles and diversion berms all stabilized @ this time</p>
